PARCEL 5 ADDITIONAL CHARACTERIZATION REPORT

CITY OF ALBUQUERQUE RAIL YARDS

Albuquerque, Bernalillo County, New Mexico

April 27, 2017

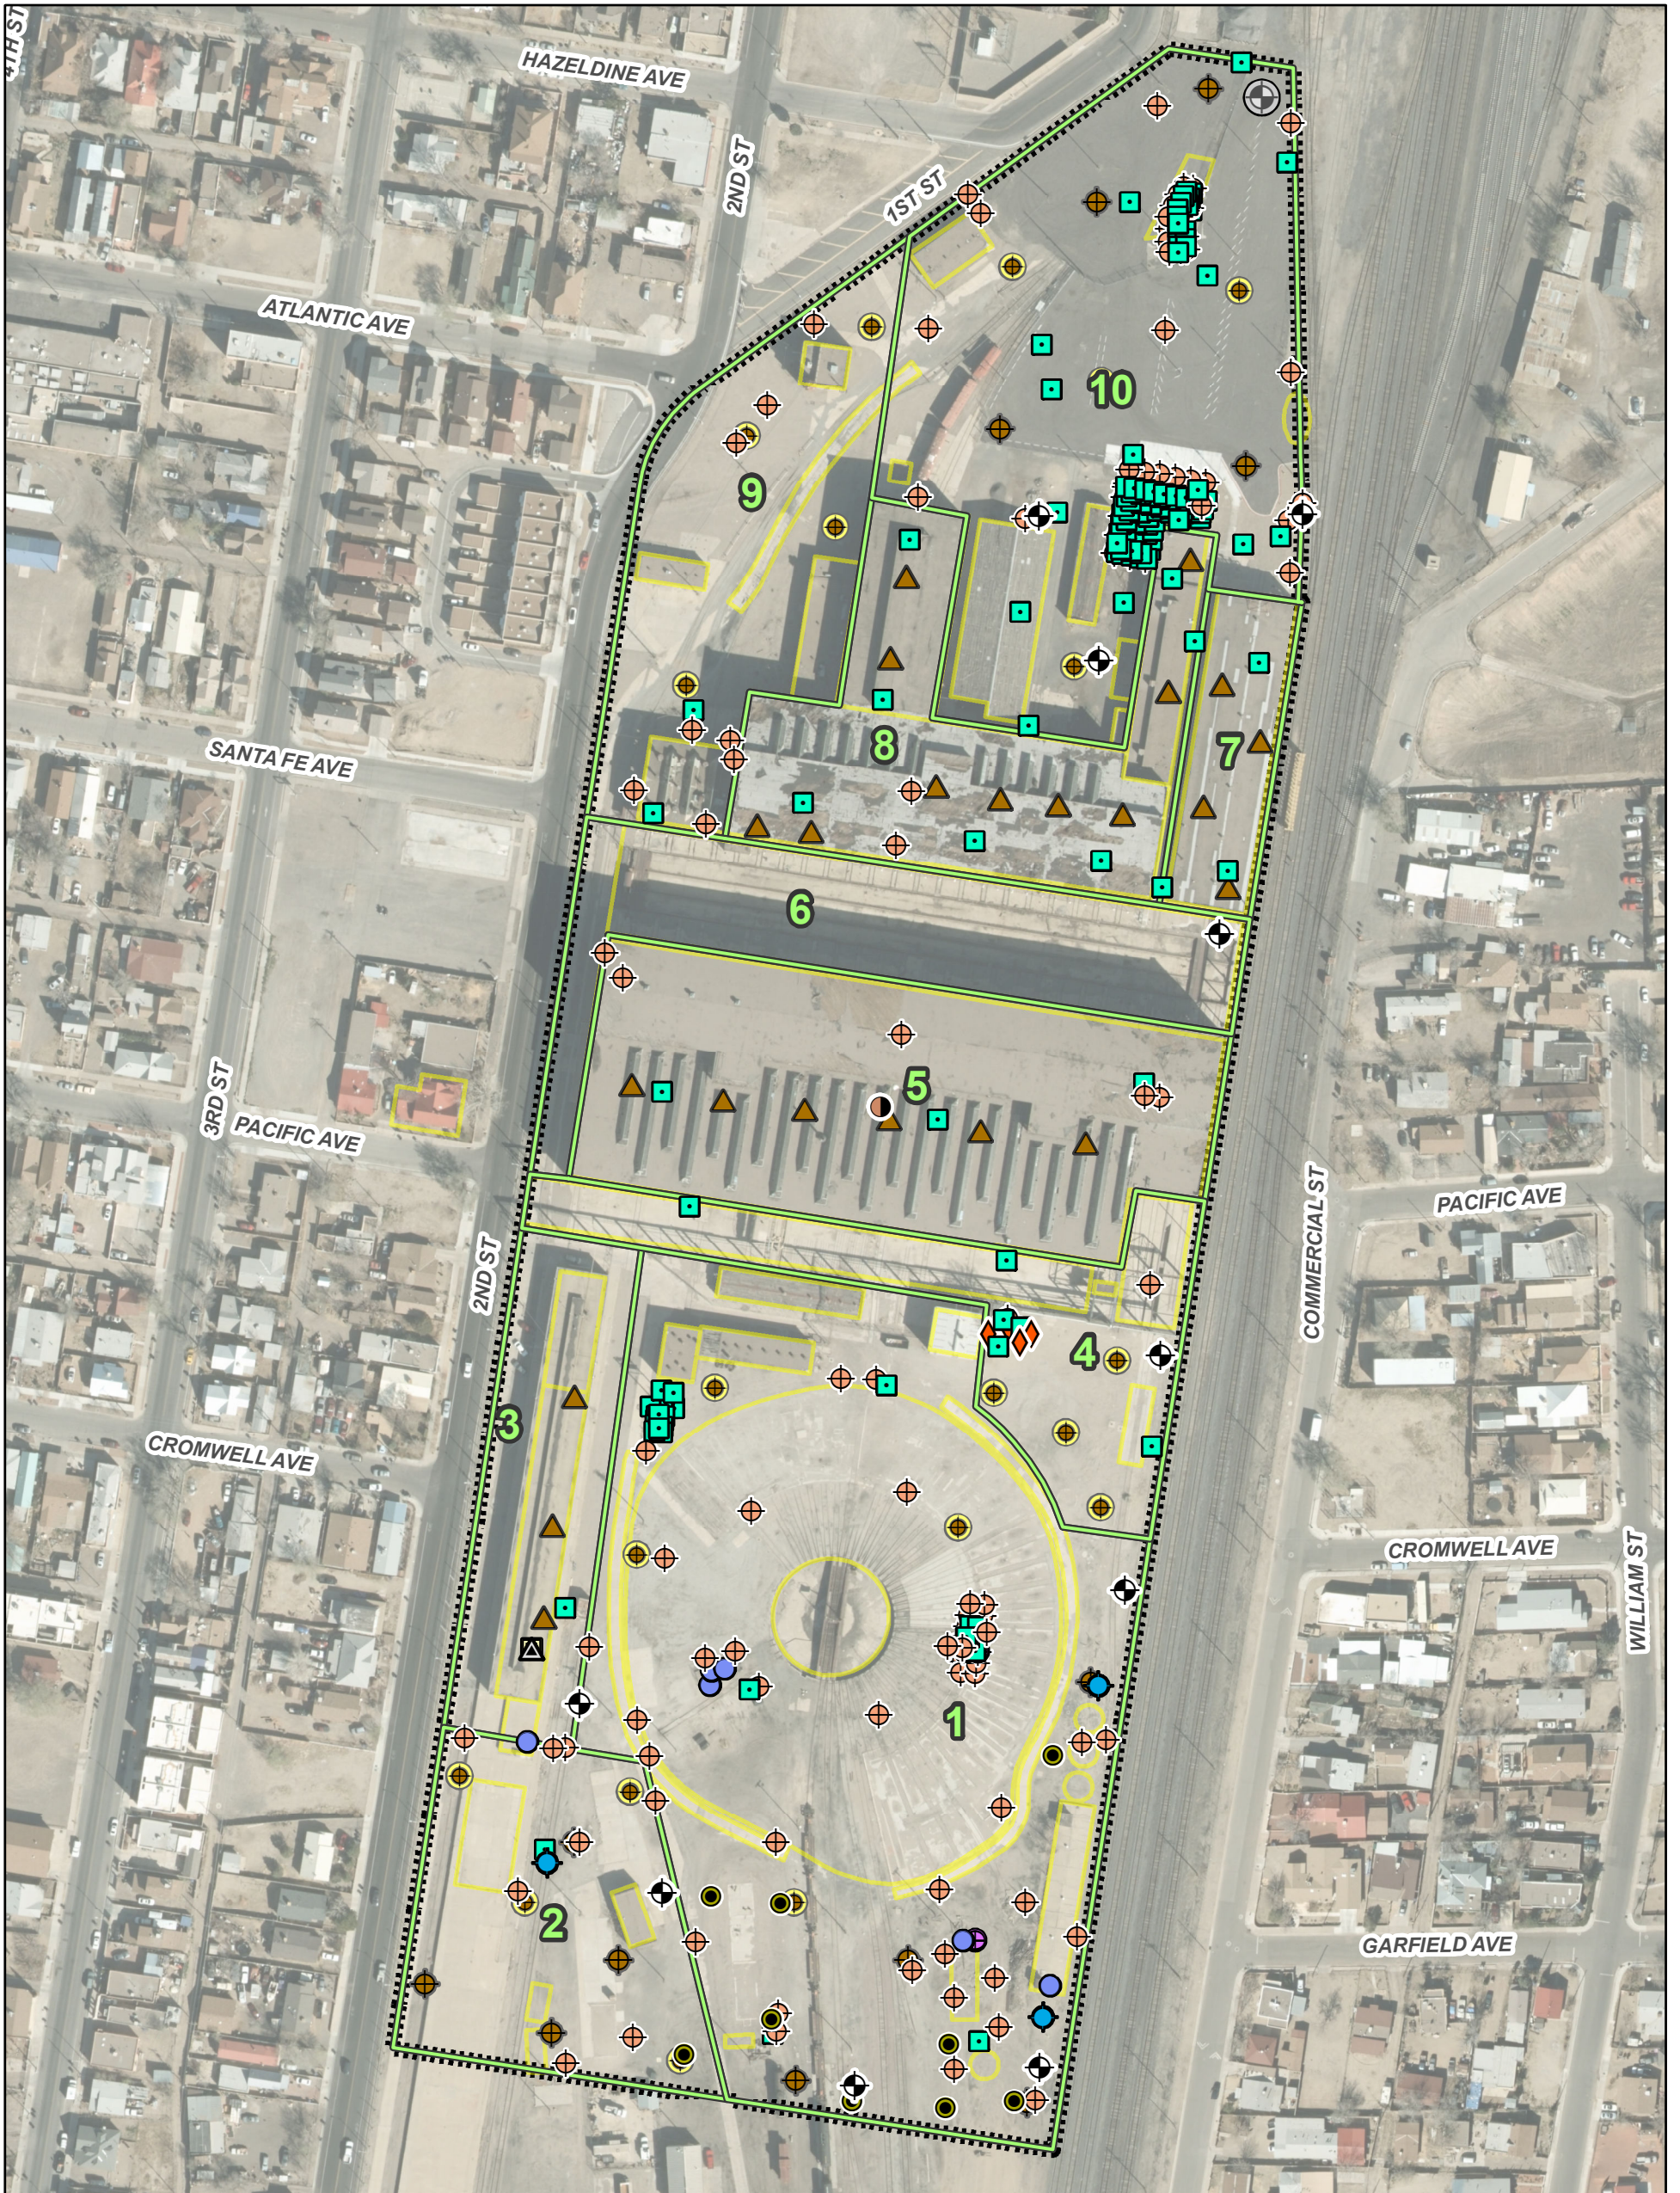
Figure 1	Site Location
Figure 2a	Site Plan, Parcels
Figure 2b	Parcel 5 2016 Sub-Slab Soil Vapor Sample Locations
Figure 3	Naphthalene Soil Gas/Sub-Slab Soil Vapor Residential VISL Exceedance

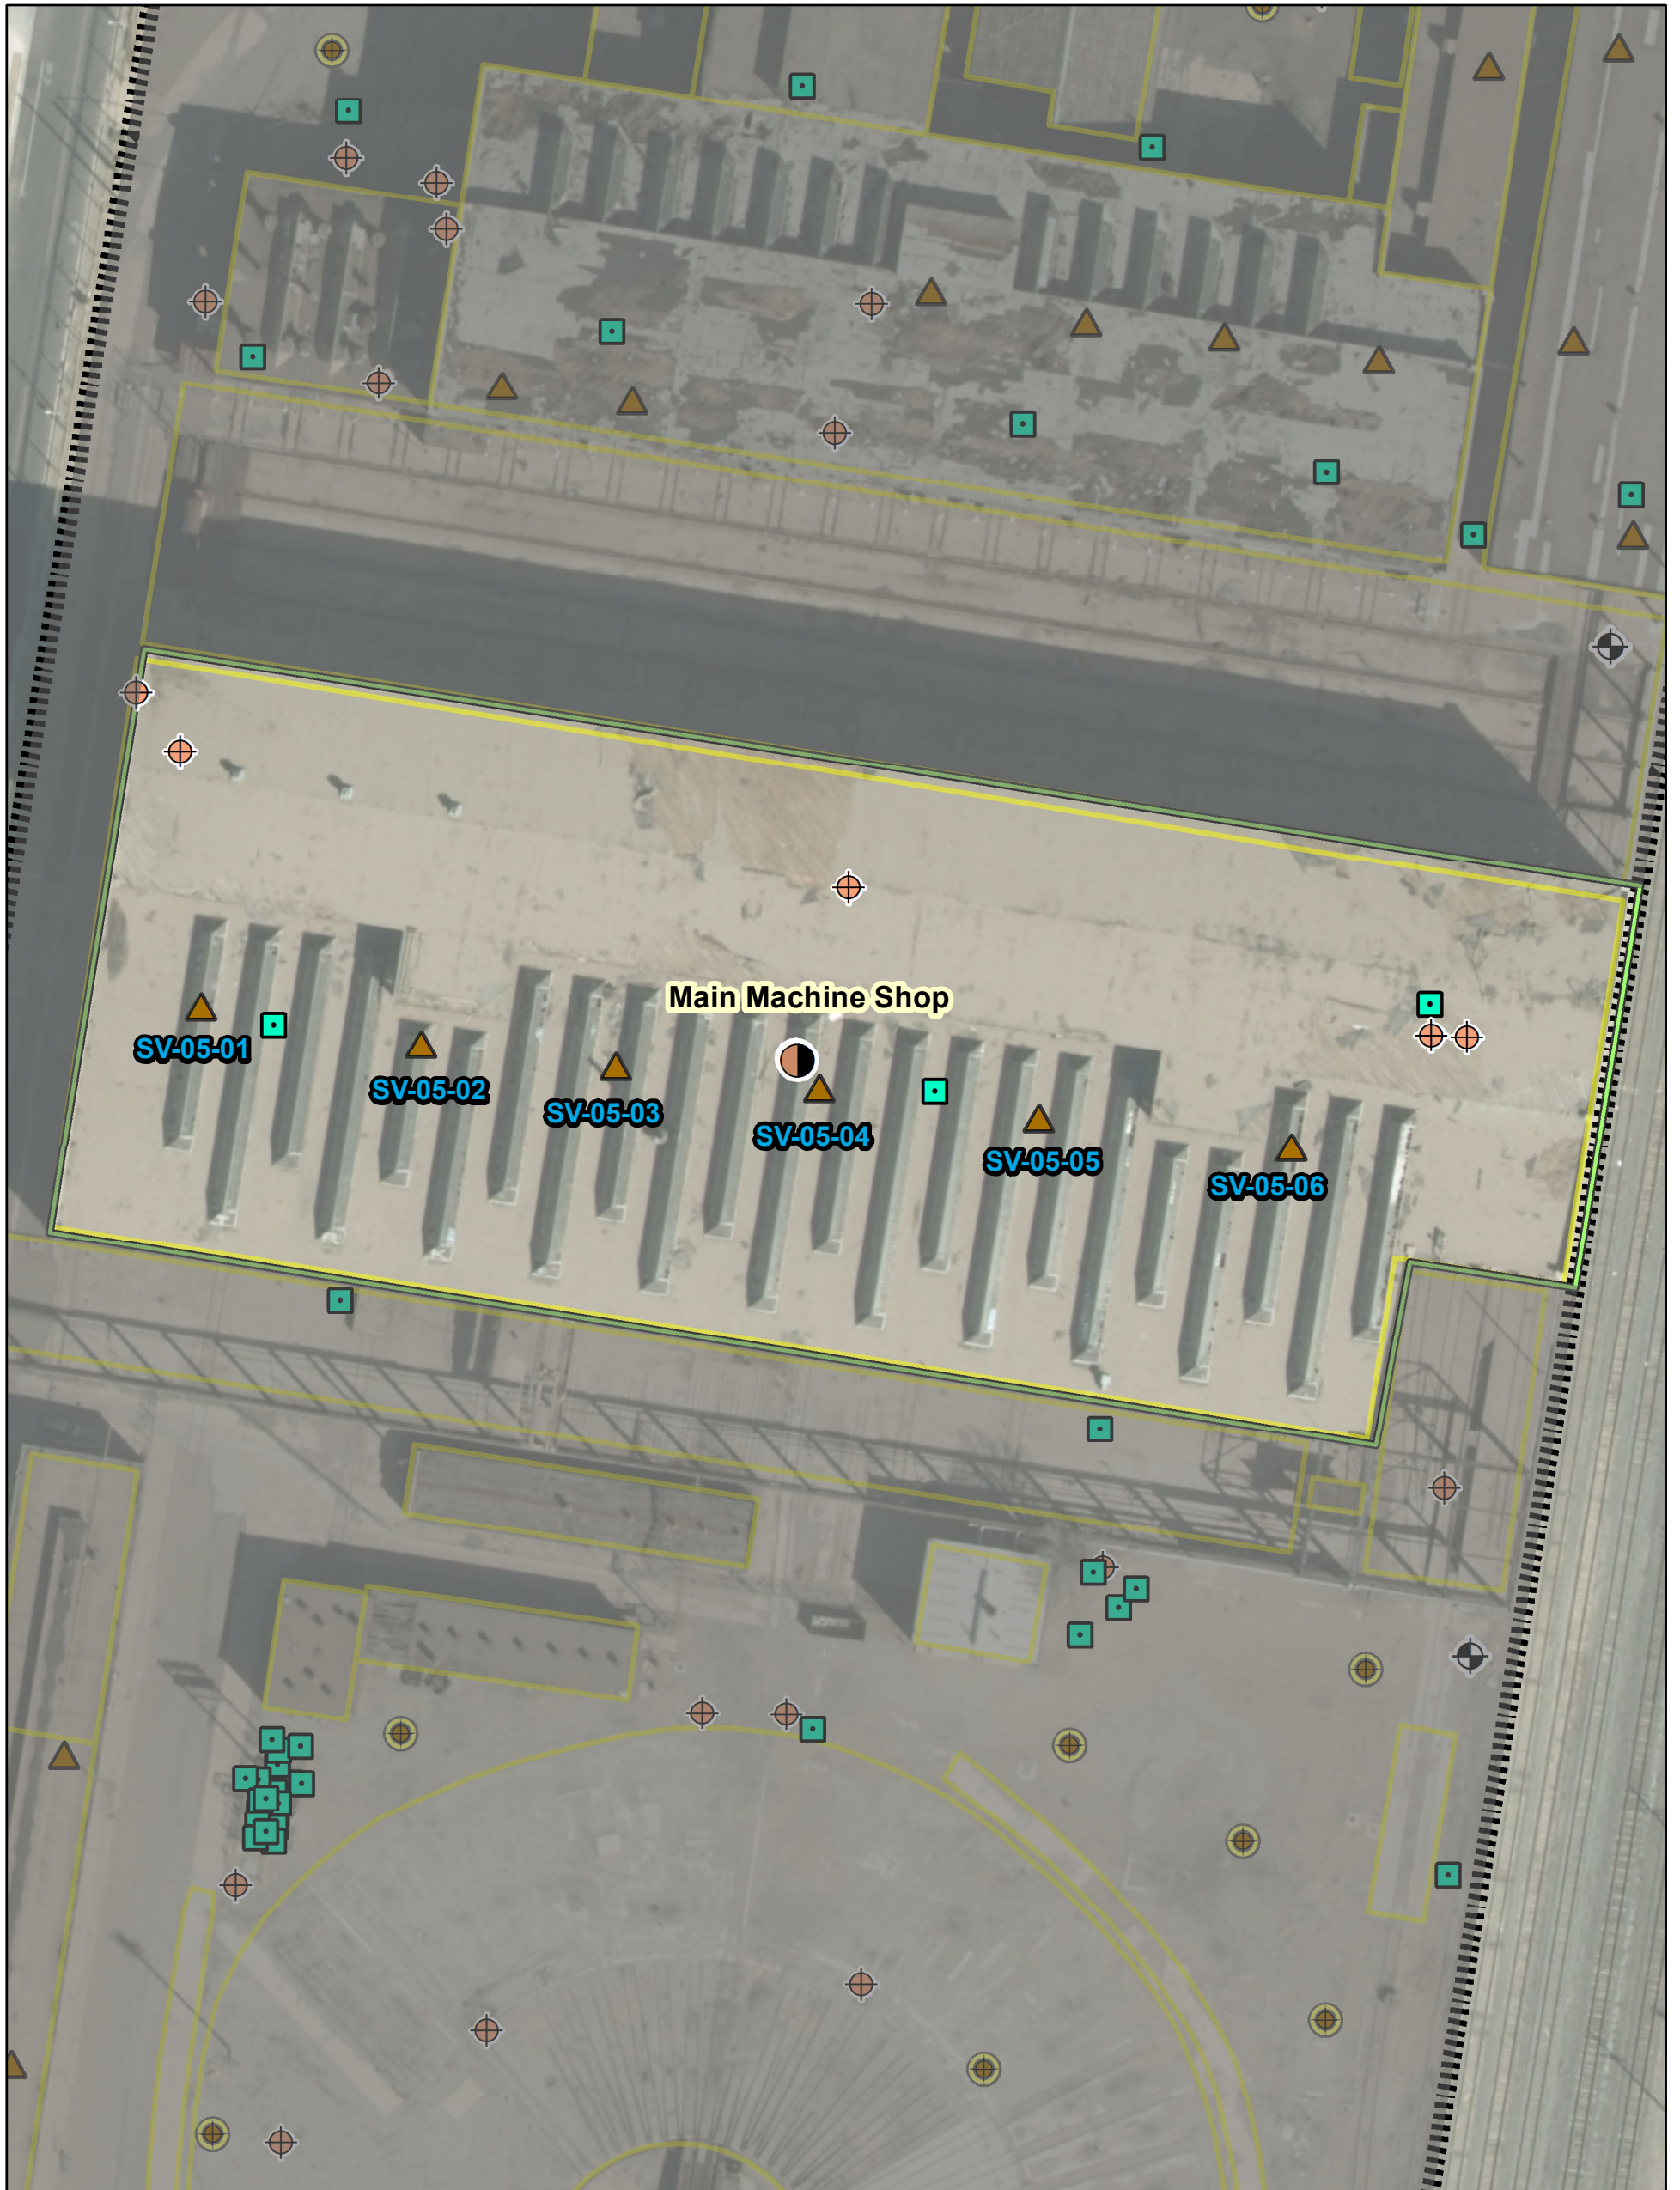
- Subslab Soil Vapor Sample (2016)
- Soil Boring/Soil Gas Sample (2016)
- Soil Boring Sample

The CSM identified that there was inadequate coverage with regard to sub-slab soil vapor data within Parcel 5. To fill this data gap, INTERA collected six sub-slab soil vapor samples within Parcel 5, in the Machine Shop. The results from the soil vapor sampling indicate that several constituents were detected above laboratory RLs including: 1,2,4-trimethylbenzene, 1,3-dichlorobenzene, 2-methylnaphthalene, ethylbenzene, naphthalene, o-xylene, p&m-xylene, and toluene. Additionally, naphthalene soil gas detections were greater than the NMED VISL at two sampling locations indicating a potential for soil vapor intrusion into any future or existing buildings within Parcel 5.
