SITE INVESTIGATION REPORT

Casa Grande/El Vado Motel, Lots 8A-1A, 8A-2A, 8A-3, Block 6 and Lots 24-39, Block 3, Albuquerque, New Mexico

March 15, 2010

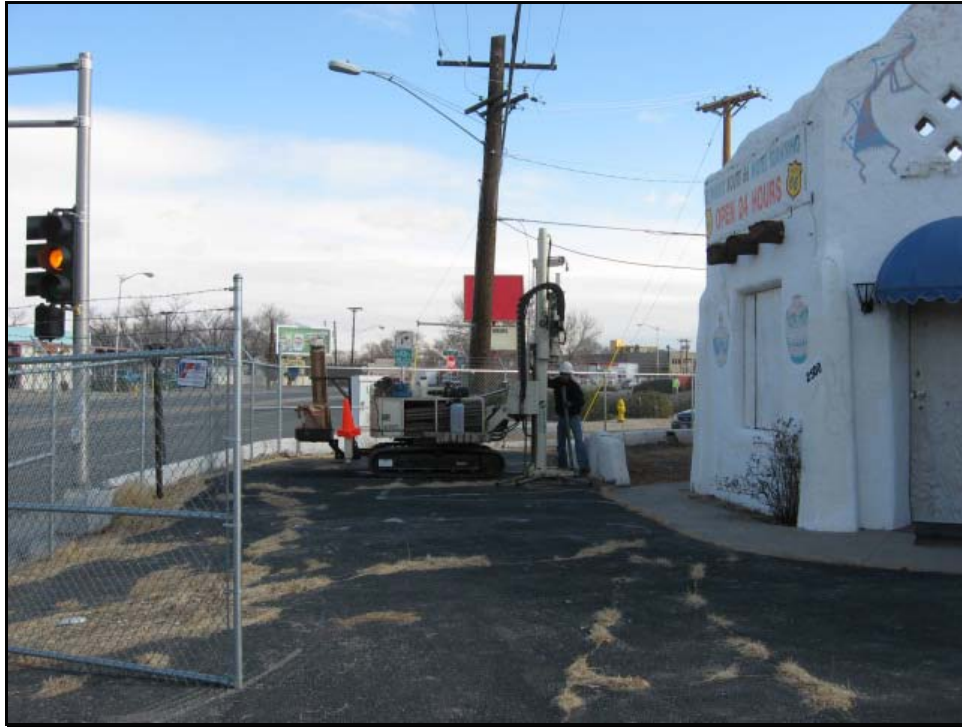
No. 1 – View of the advancing a soil boring in the front of the El Vado Motel, looking north.

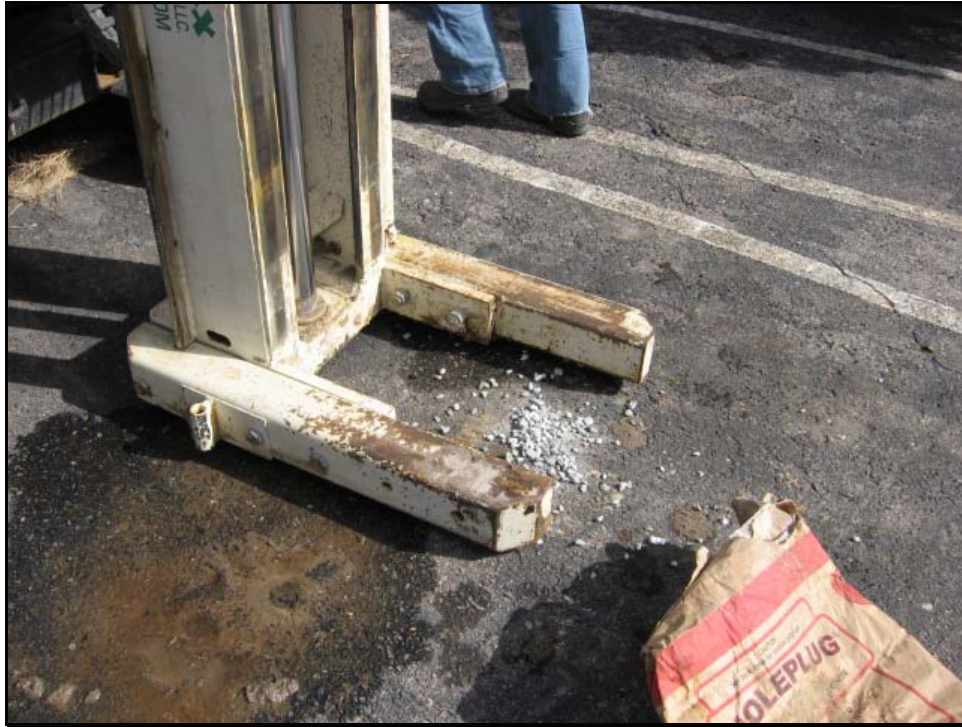
No. 3 – View of abandoning a soil boring with bentonite pellets.

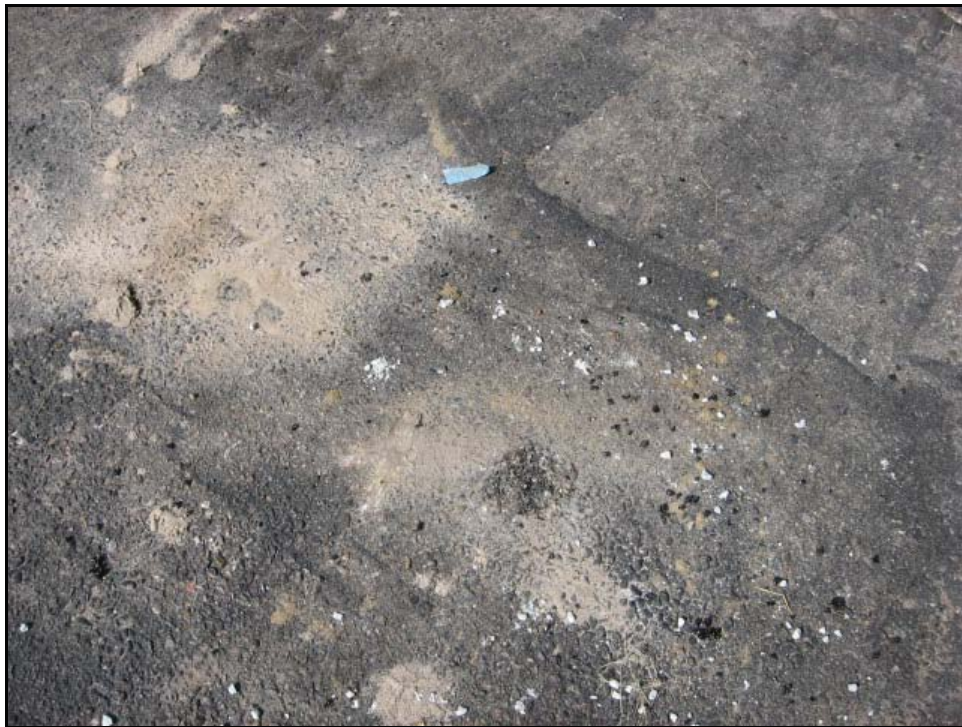
No. 4 – View of a typical asphalt patch using cold patch asphalt.
