The Secretary  
of the Interior's  
Standards for  
Rehabilitation &

# Illustrated Guidelines for Rehabilitating Historic Buildings

U.S. Department of the Interior  
National Park Service  
Cultural Resources  
Heritage Preservation Services

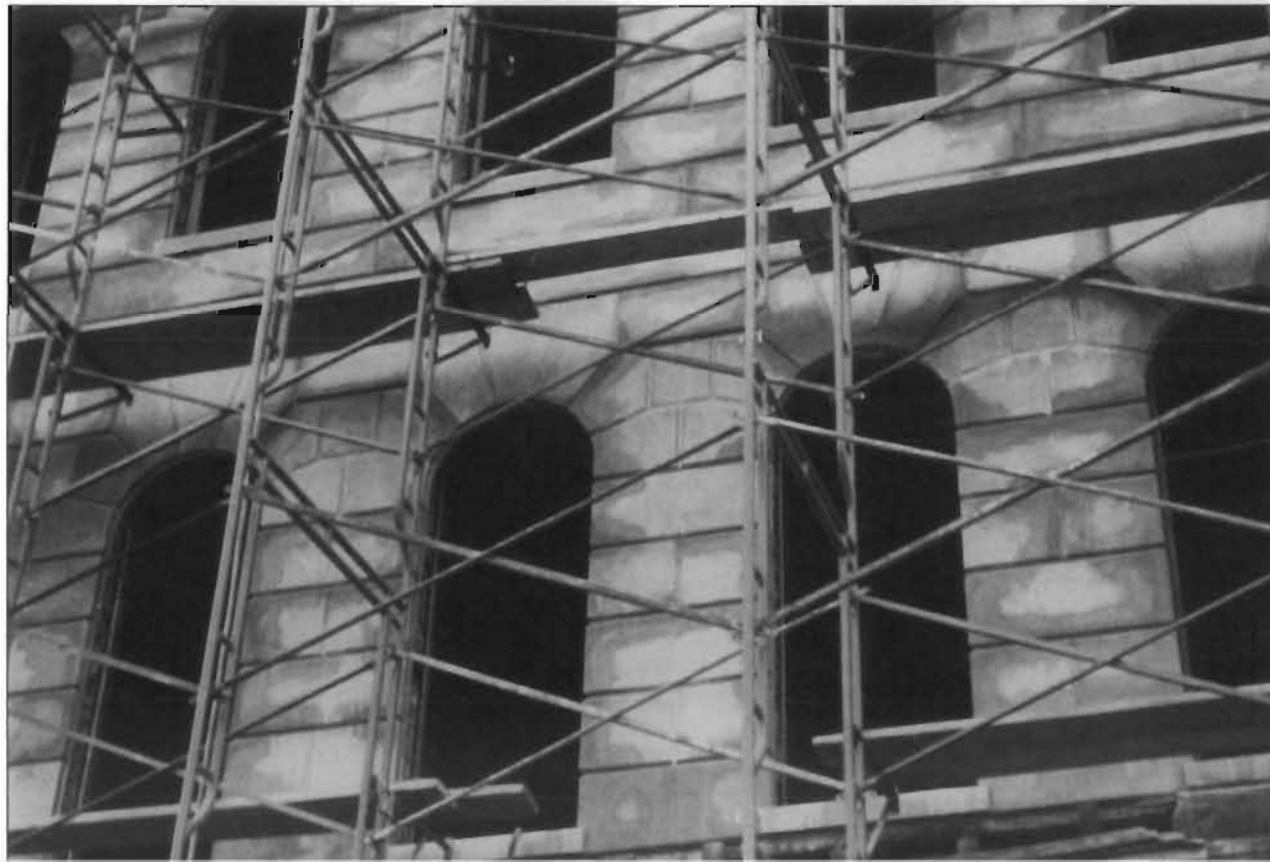
*Composite patching with a cementitious mixture is being used to repair eroded areas of this sandstone facade.*

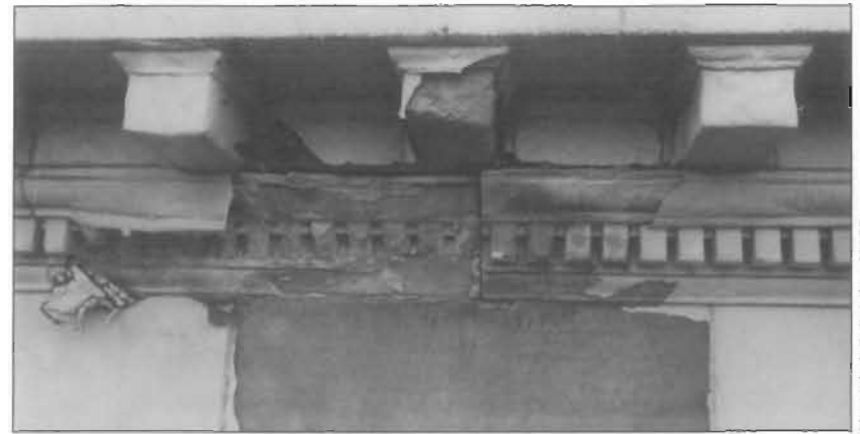
*Moisture from a faulty roof and drainage system has been trapped inside this limestone cornice by a waterproof coating, causing severe damage to the stone.*

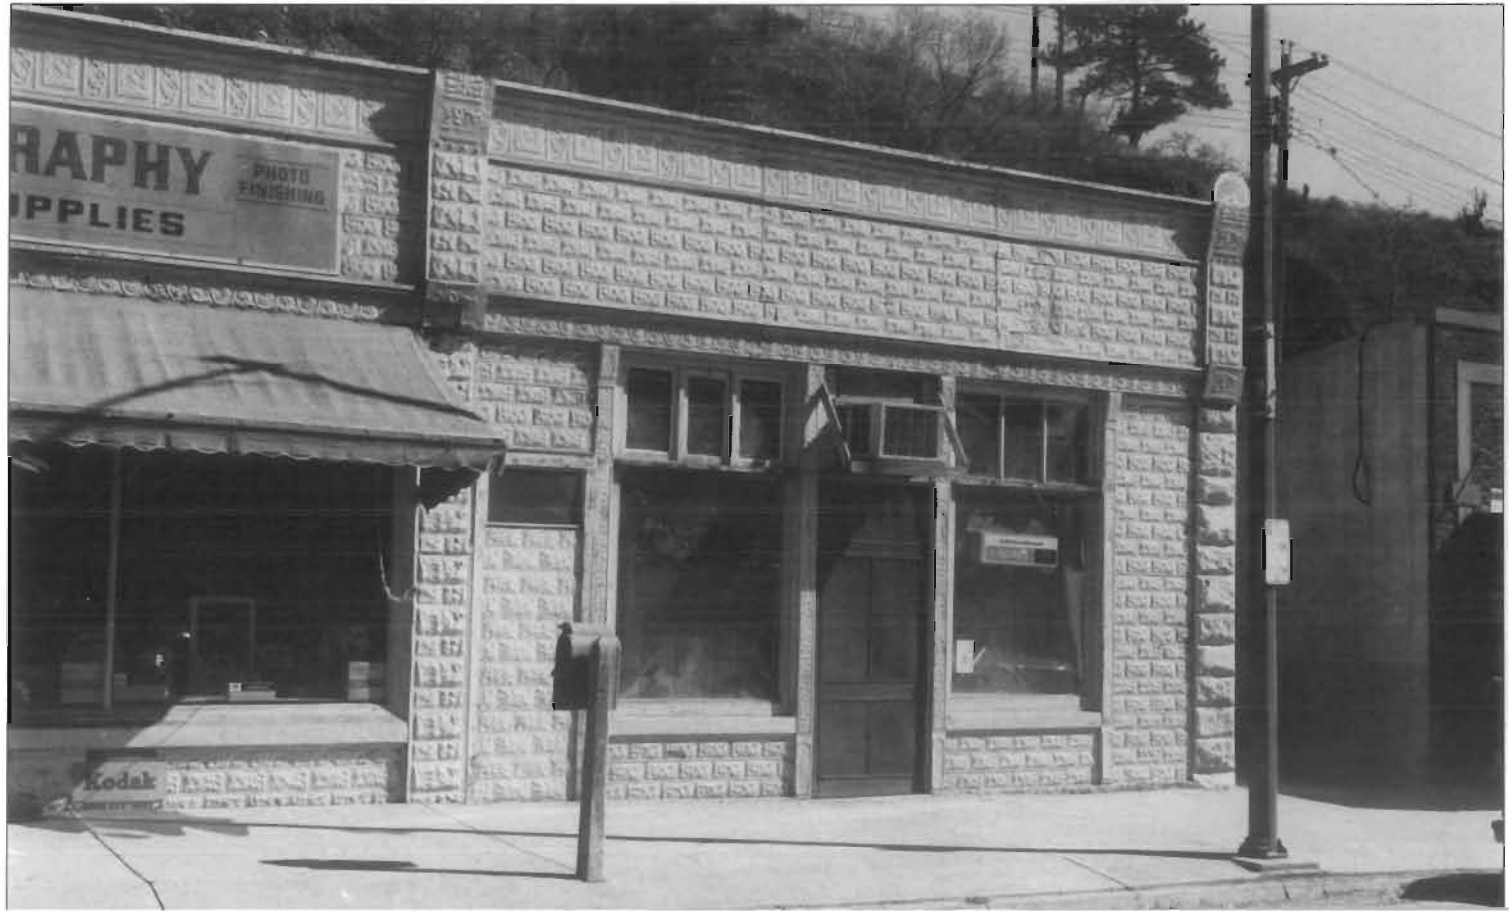
*Although these pressed metal storefronts have been well maintained over the years, gaps in the seams between the metal sheets above the door and slight stains along the cornice line indicate a possible roof leak. The roof should be investigated and repaired before the moisture results in rust and more severe metal deterioration.*

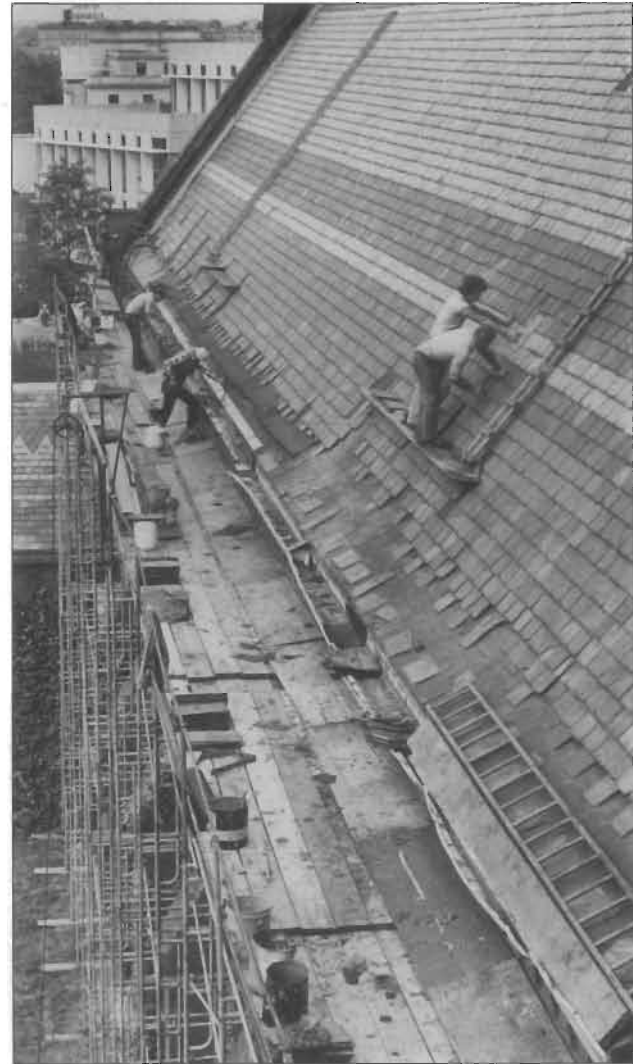
*Workmen are in the process of removing deteriorated roofing slates and replacing them with new matching slates.*

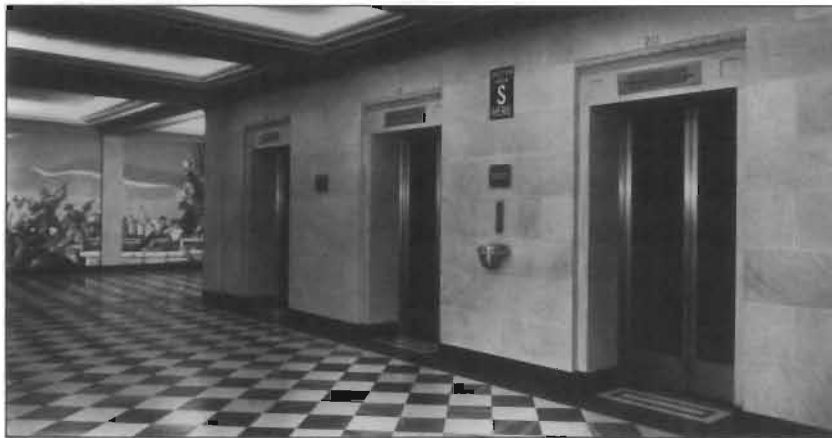
*The bronze elevator doors and light coffers play an important decorative role in this early-20th century administrative building.*
