**DART Air Monitoring  
TARGETING/INSPECTION REPORT**

<b>Inspection Date(s):</b>	April 25, through April 28, 2022		<b>Inspection Announced:</b> {No}		
<b>Name</b>					
<b>Email</b>					
<b>ERG Staff</b>					
Scott Sholar		Scott.Sholar@erg.com			
Alexia Scott		Alexia.Scott@erg.com			
<b>U.S. Environmental Protection Agency (EPA) Staff</b>					
Nicholas Bobbs		Bobbs.nicholas@epa.gov			
<b>New Mexico Environment Department (NMED) Staff</b>					
Frank Rodarte					
Drew Sloan					
<b>City of Albuquerque EHD Staff</b>					
Dwayne Salisbury					
<b>Facilities Inspected:</b>					
<b>Name</b>	<b>Address</b>	<b>Entry made to site</b>	<b>Detects Made*</b>	<b>Winds Favorable**</b>	<b>Canister Sample Collected</b>
<b>Albuquerque South Route</b>					
NuStar Energy	6348 Desert Rd, Albuquerque, NM 87105	No (4/25)	Yes (~570ppb) Dart	No	No
		Yes (4/26)	No	Yes	No
Phillips Loading Rack	6280-6363 Desert Rd, Albuquerque, NM 87105	No (4/25)	No	No	No
		No (4/26)	No	Yes	No
Western Refining	2040 2nd St SW, Albuquerque, NM 87102	No	No	Yes	No

From April 25 to April 28, 2022, Scott Sholar and Alexia Scott of ERG performed mobile air monitoring using the ERG Data Acquisition in Real Time (DART) in New Mexico.

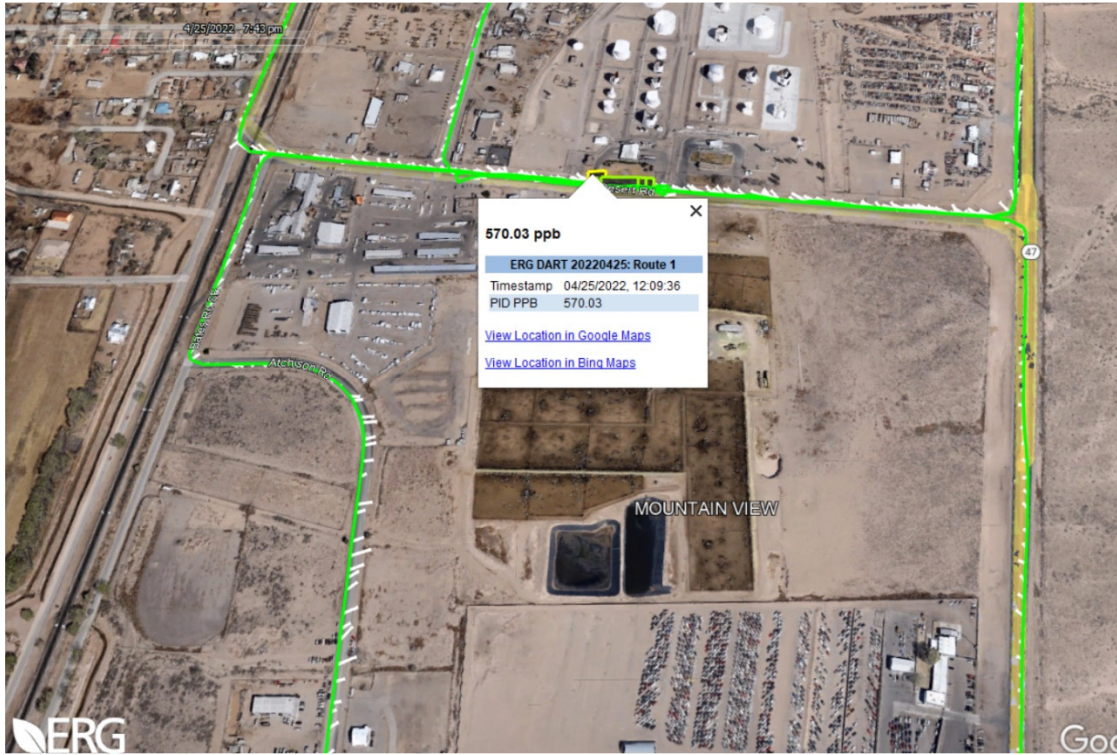
**Figure 8. Desert Rd Detects 04/25/22 AM Route**

On the morning of April 25th, while navigating along Desert Rd in south valley Albuquerque, NM, several measurements above 200ppb were recorded and a measurement of approximately 570ppb was made. A distinct volatile odor was perceived by ERG investigation staff while in the plume. The wind during this time period was coming generally from the south so the DART was upwind of the NuStar Energy facility. The Dart was driven south of Desert Rd around the other local facilities, but no apparent source of the measured plume could be found. Figure 8 provides an image of the April 25, 2022 morning drive detects (yellow bars) and background measurements (green bars) from the DART.

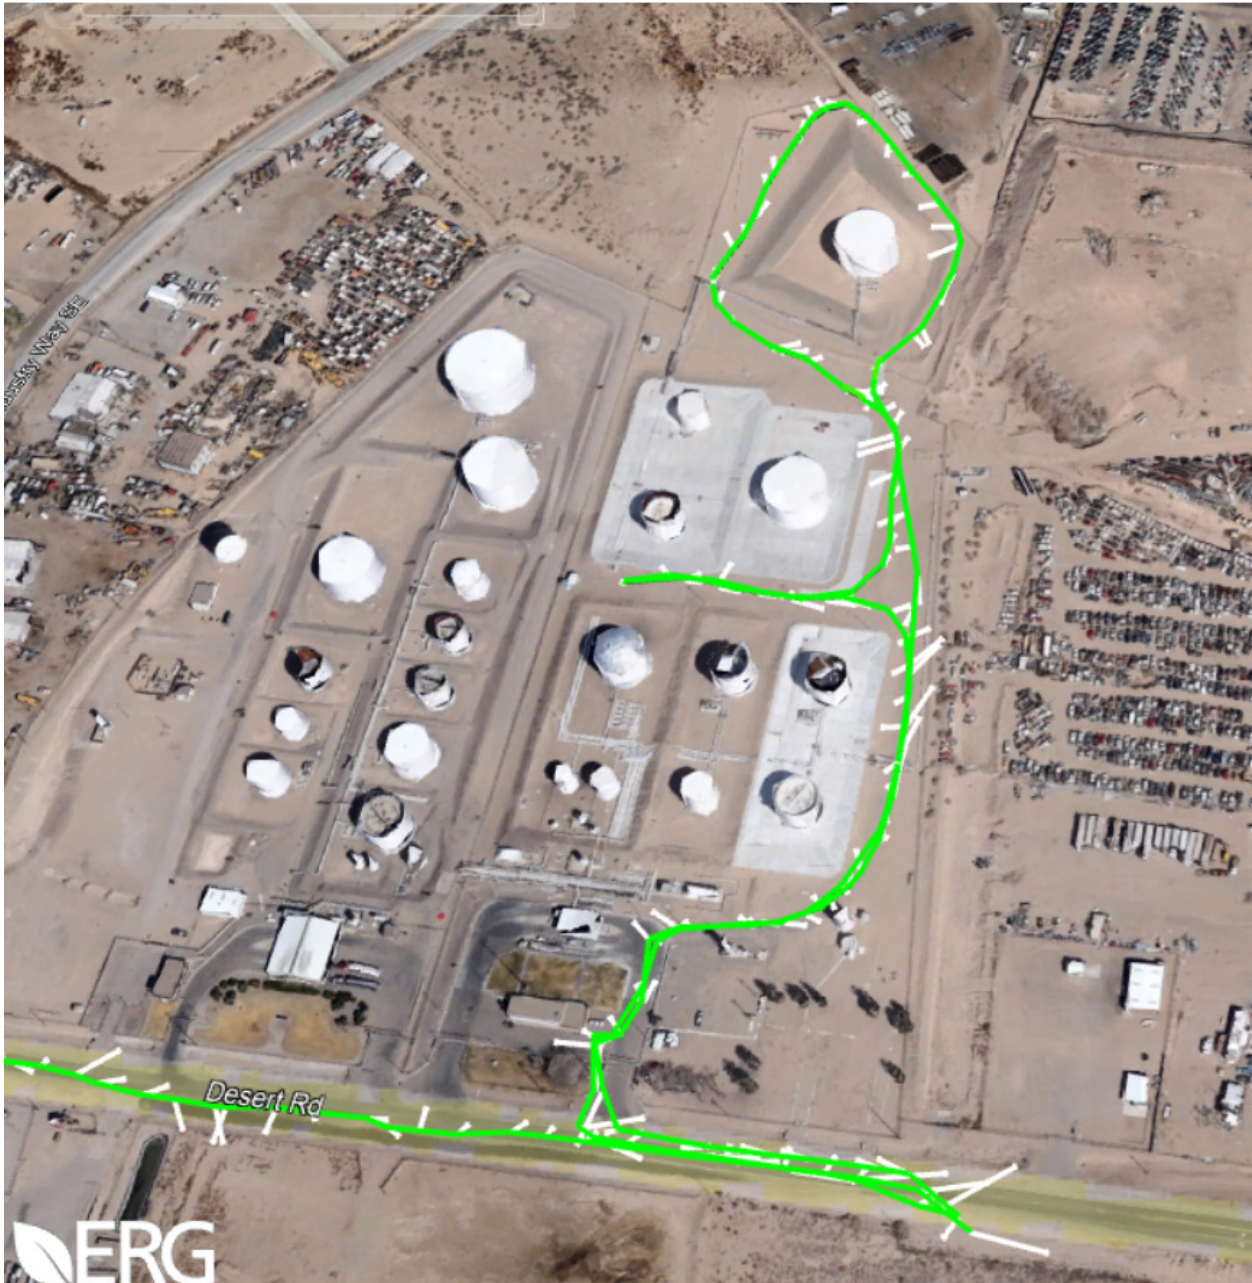
**Figure 9. NuStar Energy Onsite 04/26/22 AM Route**

On the morning of April 26, a second drive was performed onsite at the NuStar Energy facility. No detects were made during this drive. The winds were light with some wind gusts during this onsite inspection. No plume detects were made along Desert Rd on April 26. Figure 9 provides an image of the April 26, 2022 onsite drive measurements (green bars) from the DART.

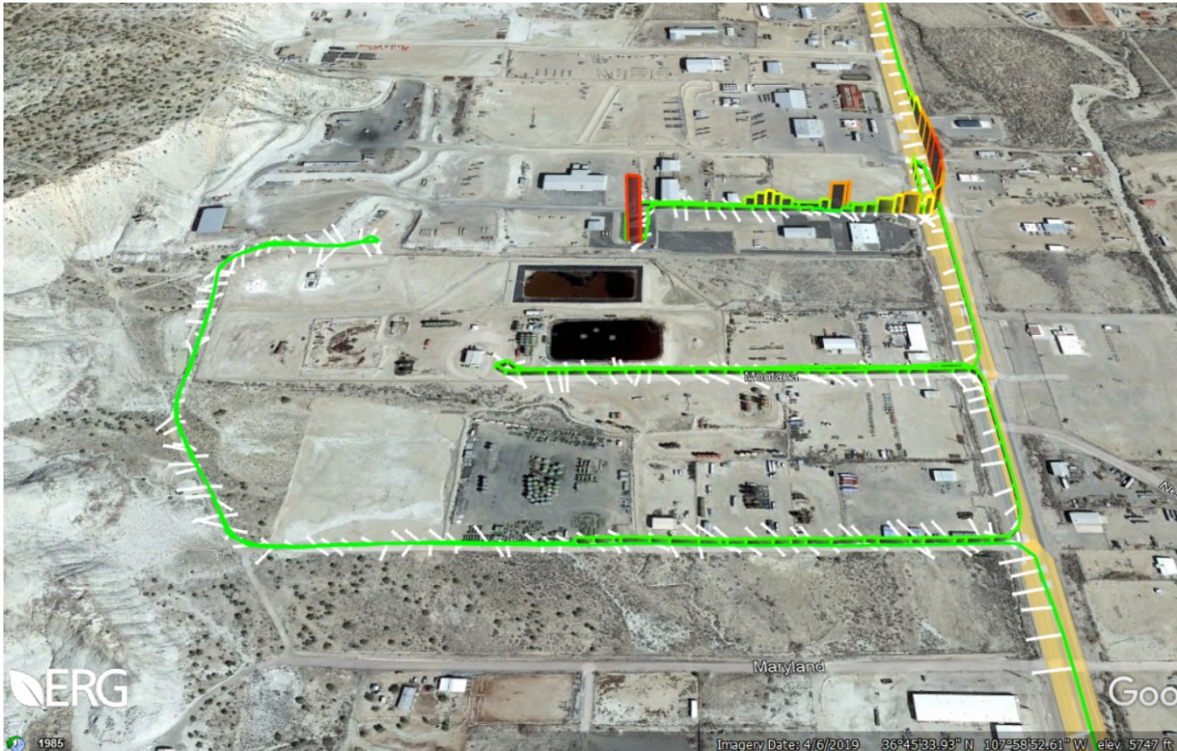
**Figure 11.** 04/27/22 PM Hilcorp – Central Condensate Storage Routes and Detects

While driving north of the Hilcorp – Central Condensate facility on April 27, 2022, the DART detected a plume of VOCs measuring up to 3ppm. A very strong odor of sulfur and fuel was noted while located in the plume. A canister sample was collected in this plume for analysis. A chain of custody form was completed for the sample and a copy can be found in Attachment 1. Figure 11 provides an image of the April 27, 2022, afternoon drive detects (red, orange, and yellow bars) and background measurements (green bars) from the DART.

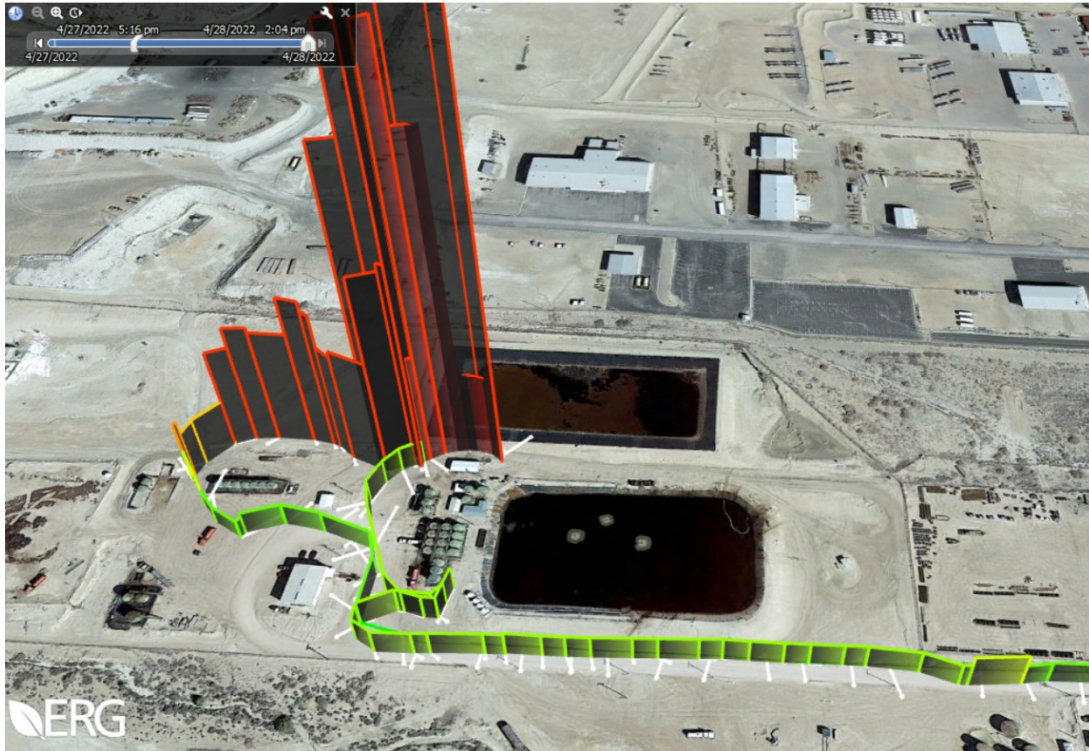
**Figure 12. 4/28/22 Hilcorp – Central Condensate Storage Onsite Routes and Detects**

On April 28, 2022 entry was made to the Hilcorp – Central Condensate facility. The DART detected VOCs greater than 3ppm near the eastern most tank batteries. A very strong odor of sulfur and fuel was noted in the measured plume. A canister sample was collected in this plume for analysis. A chain of custody form was completed for the sample and a copy can be found in Attachment 1. Figure 12 provides an image of the April 28, 2022 onsite detects (red, orange, and yellow bars) and background measurements (green bars) from the DART.
