**PHASE I ENVIRONMENTAL  
SITE ASSESSMENT  
SCHWARTZMAN LANDFILL  
ALONG I-25 SOUTH OF GIBSON AVE  
NORTH OF SUNPORT BOULEVARD  
ALBUQUERQUE, NEW MEXICO**

**City of Albuquerque  
Environmental Health Department  
Environmental Services Division  
Room 3023  
P.O. Box 1293  
Albuquerque, NM 87103**

**INTERA, INC.  
One Park Square  
6501 Americas Parkway NE, Suite 820  
Albuquerque, New Mexico 87110**

**July 6, 2005**

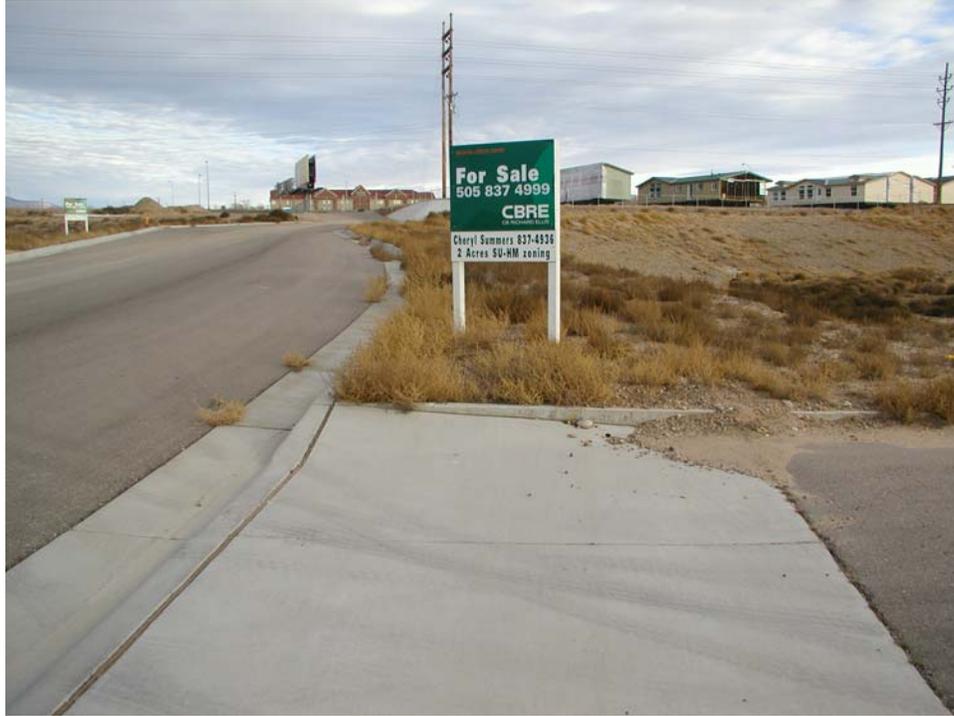
*No. 1 – North end of northwest quadrant looking due east along Karsten Court. Utilities in Karsten Court include water, sewer, storm, and sanitary sewer.*

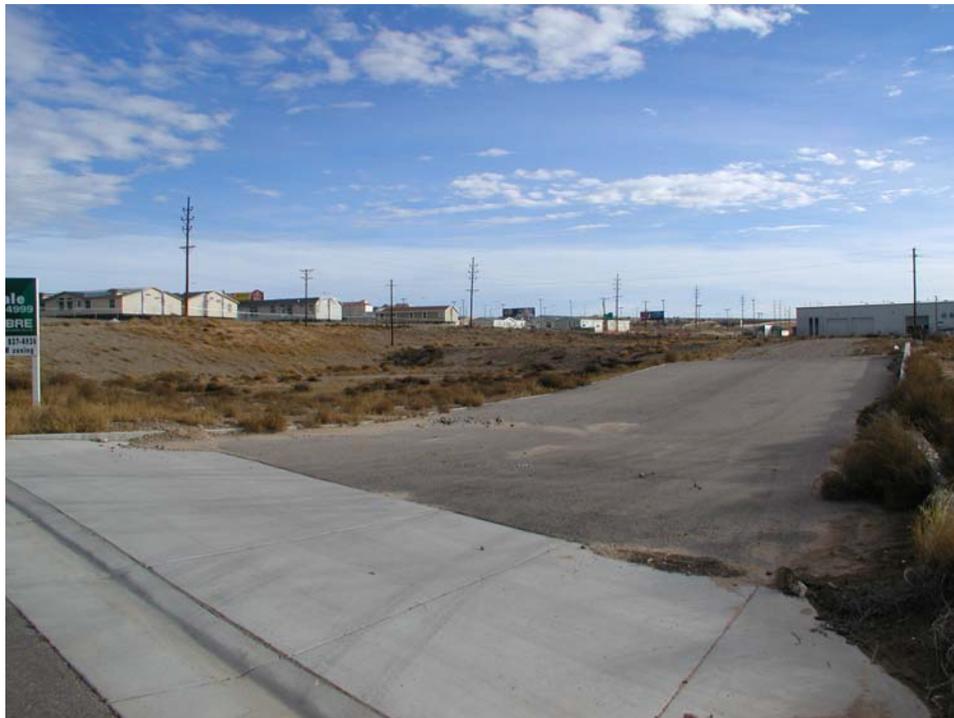
*No. 2 – The northwest quadrant from the northwest corner of the City-designated boundary of the Schwartzman Landfill. The depression beyond the paved entrance forms a retention basin for storm water accumulation. Photo taken looking southeast.*

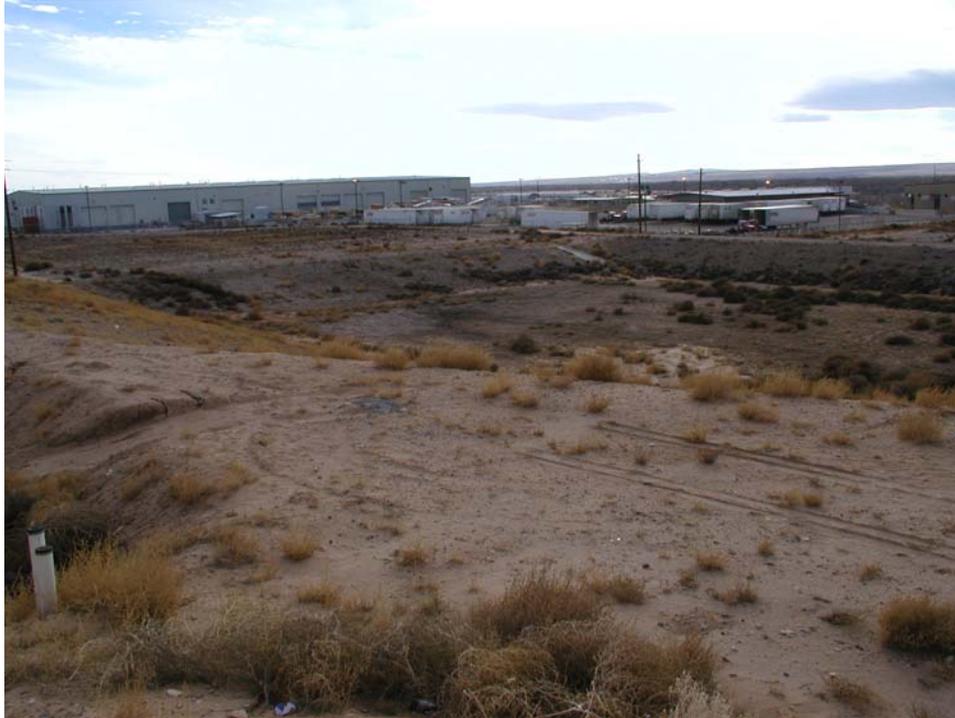
*No. 3 – Looking southwest across the north end of the northwest quadrant of the study area. The retention basin is in center of photograph with the Bullock’s Express trucking company and the Karsten Homes manufacturing facility in the background.*

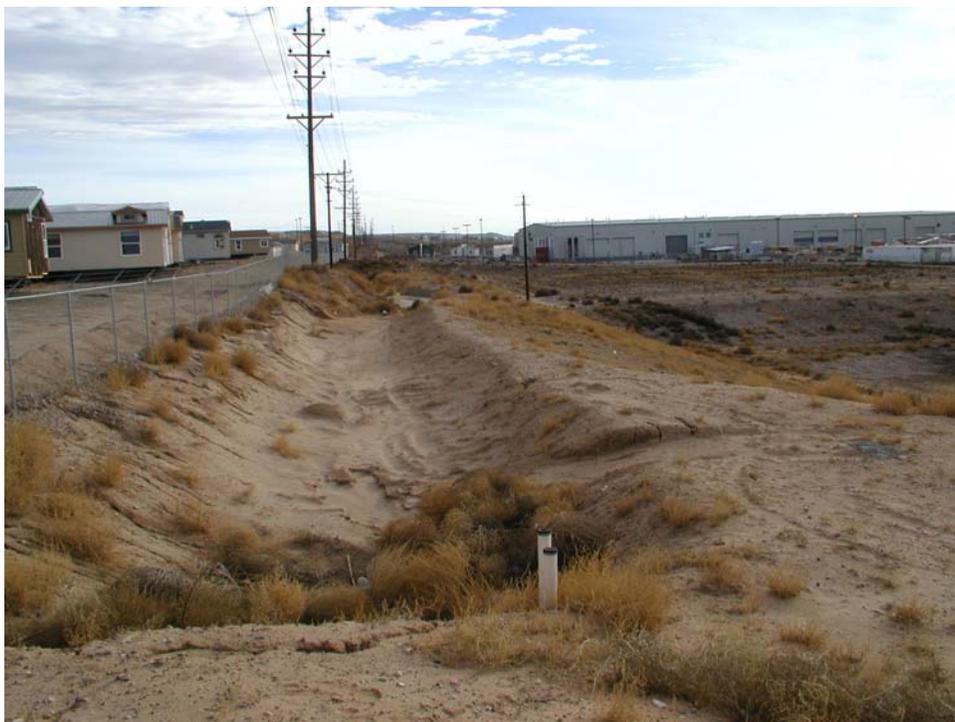
*No. 4 – Looking south along the drainage ditch that bisects the two lots at the northern end of the northwest quadrant of the Schwartzman Landfill.*

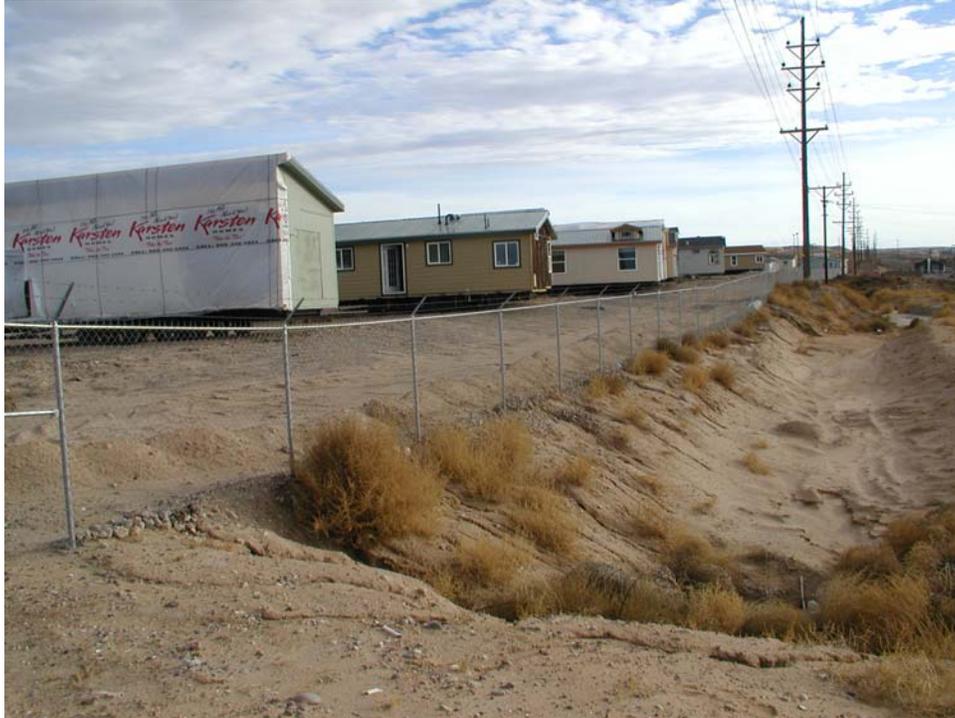
*No. 5 – Looking southeast at the lot containing the modular homes on the north end of the northwest quadrant of the landfill. Note the overhead power lines that run between the lots.*

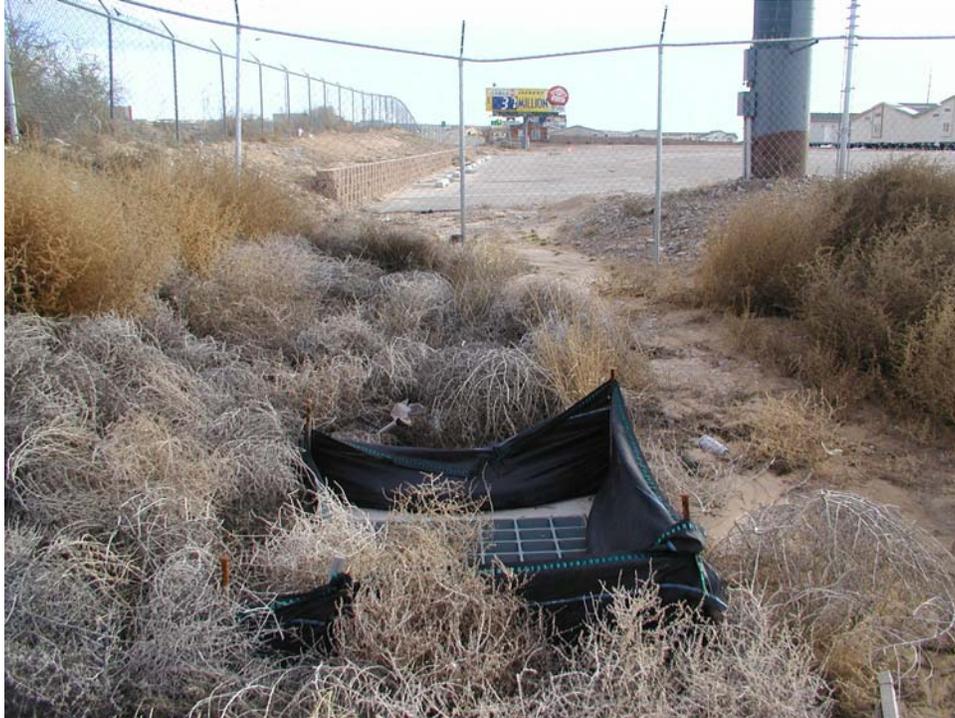
*No. 7 – Storm drain at near the northeast corner of the northwest quadrant, possibly drains to retention basin at northwest corner of landfill.*

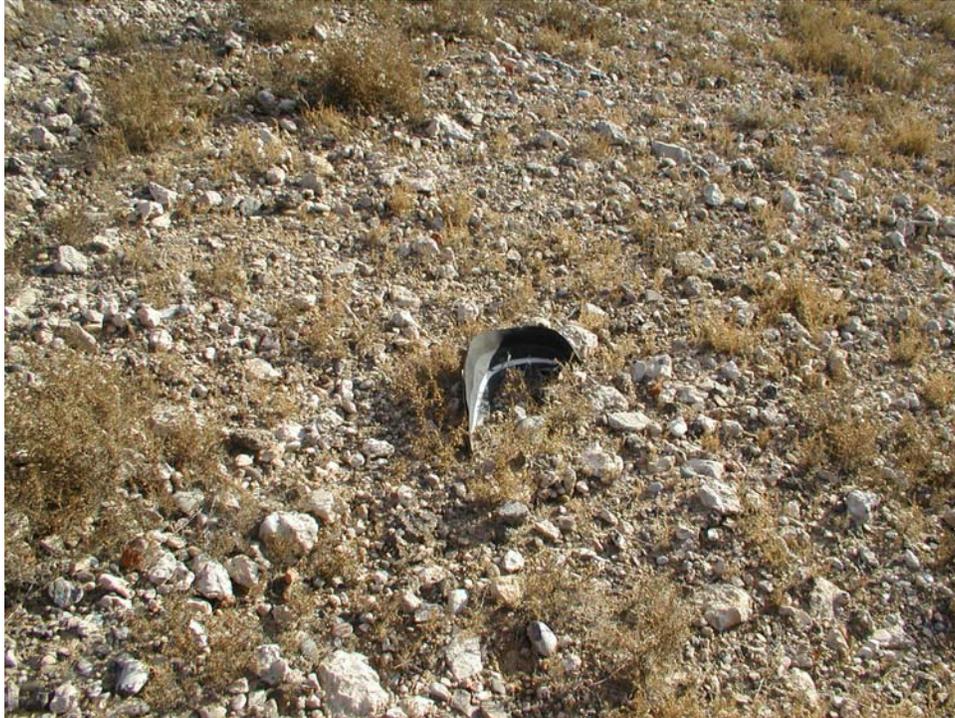
*No. 9 – Photograph of bank west (right) of the drainage ditch between the lots in the northwest quadrant of the landfill. What appears to be gravel is fragments of concrete, clay pipe, asphalt, and glass. Tires (shown) and other debris evident along the bank.*

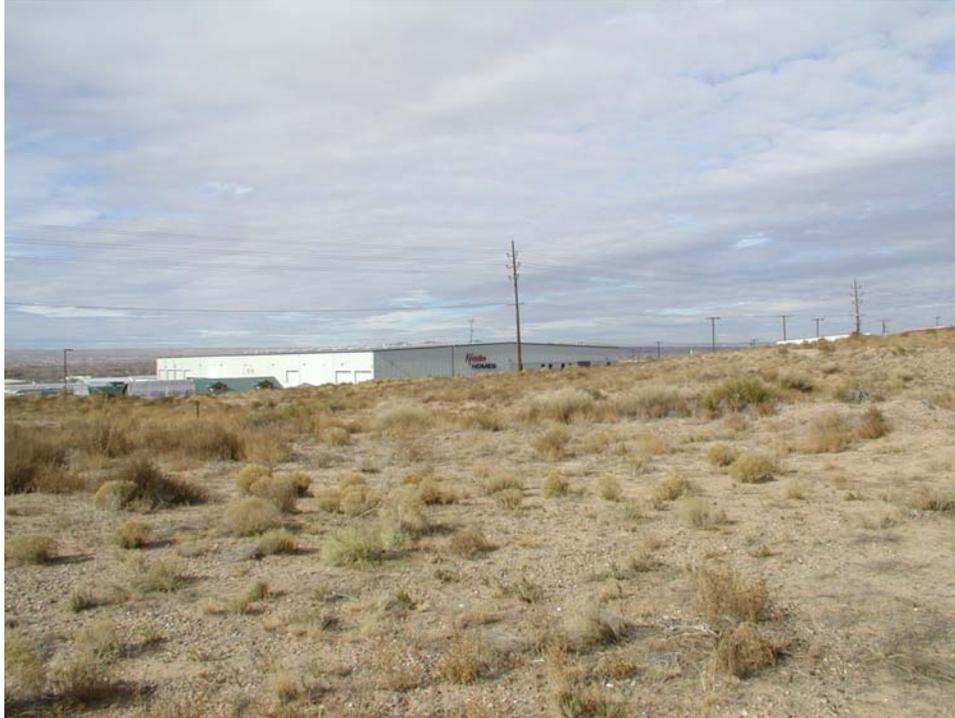
*No. 15 – Looking northwest from the southeast corner of the northwest quadrant of the landfill. Topography rises to the north until it reaches the Karsten Homes property where a steep bank drops down about 15 feet.*

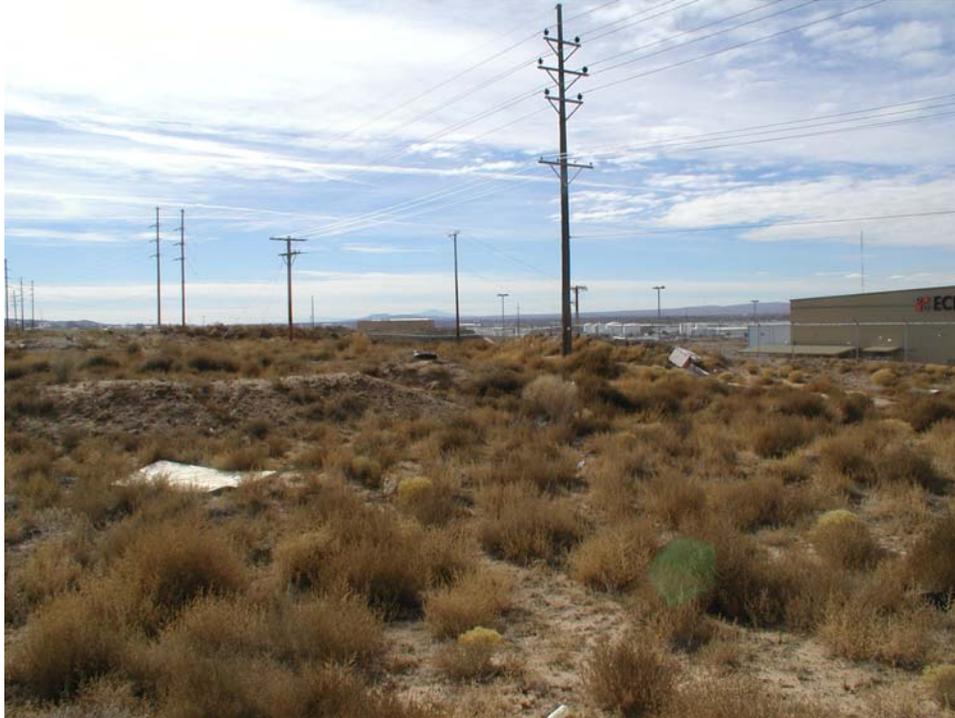
*No. 17 – Debris (couches, plywood, and tires shown) on the southern portion of the northwest quadrant appears to be from relatively recent illegal dumping.*

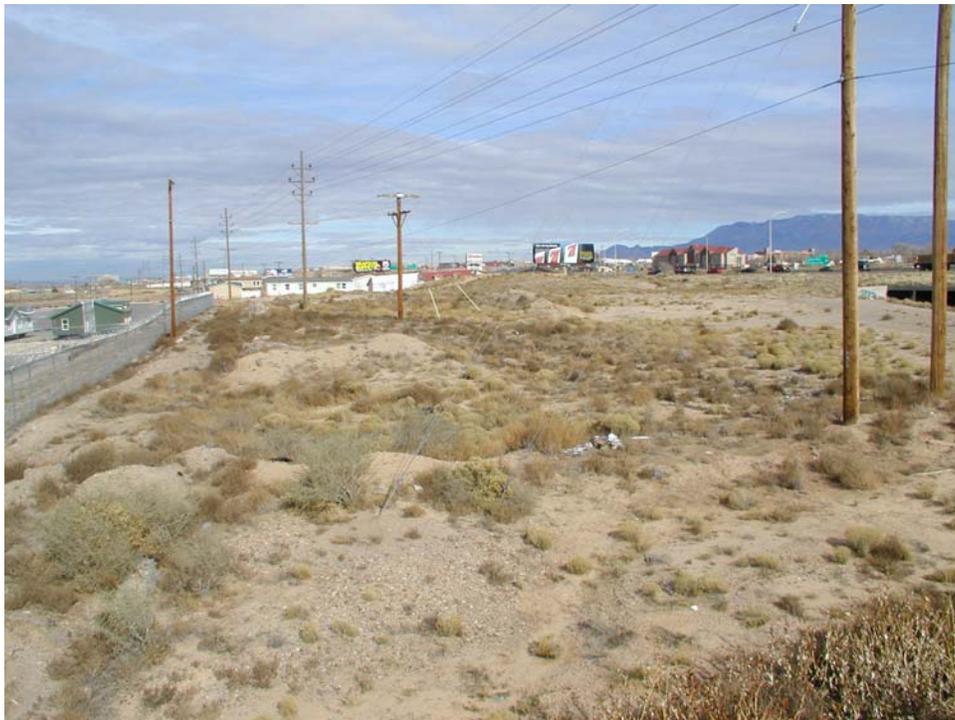
*No. 18 – Photograph taken looking across the northwest quadrant of the Schwartzman Landfill from the southern tip. Established boundary follows the fence line on the left side of the photo. The topography west of the fence drops off rapidly up to 20 feet (looking NNW).*

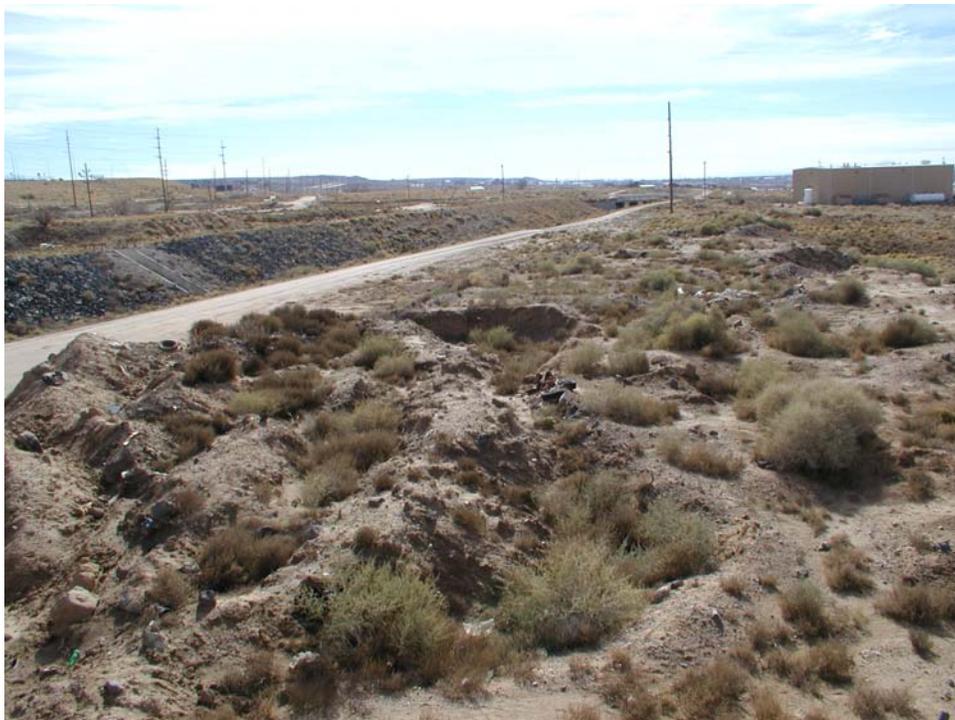
*No. 20 – Piles of soil mixed with refuse persist on the west side of the South Diversion Channel. These piles are not within bounds of the established landfill boundary. The source of the debris could be illegal dumping or resulting from dredging of the AMAFCA channel seen on the left side of the photograph (looking SSW).*

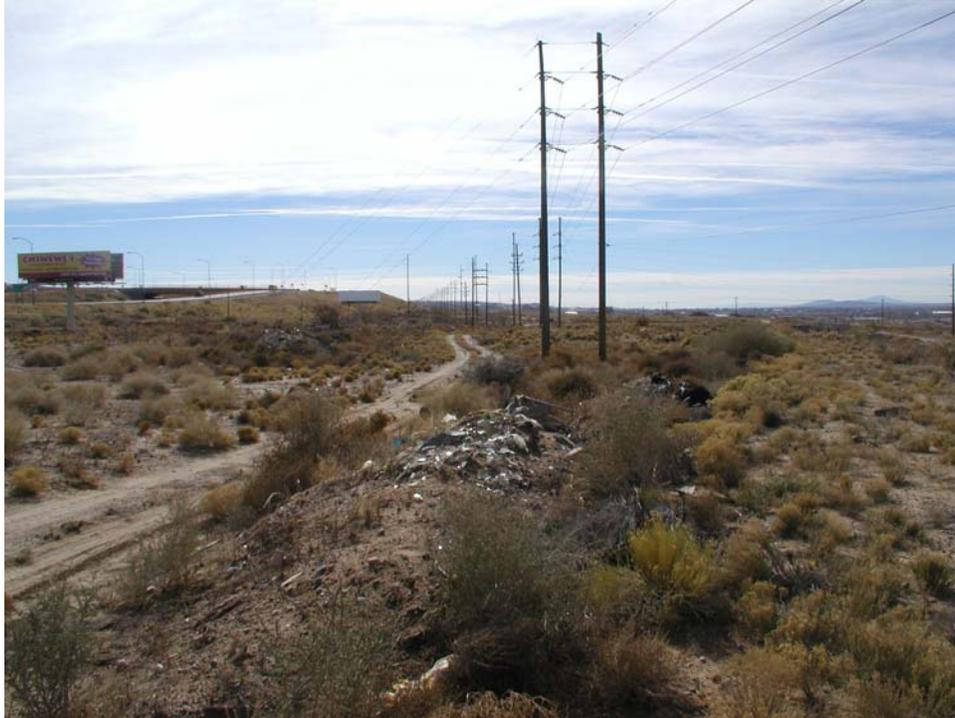
*No. 21 – Photograph looking south from the northern point of the southwest quadrant of the Schwartzman Landfill. Piles of trash in foreground are common across this quadrant and are typically construction related debris (asphalt, wood, concrete, plastic, etc.)*

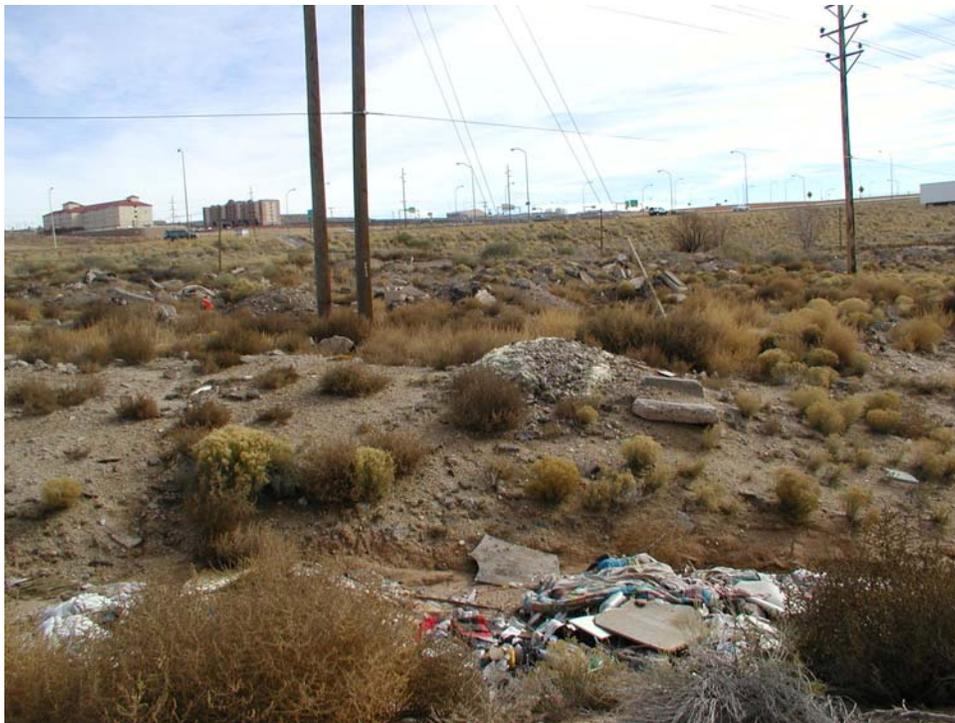
*No. 22 – Photograph taken looking ESE across portion of the southwest quadrant of the landfill. Residential waste (clothes, plastic, cardboard, etc.) in foreground with extensive piles of construction debris in background.*

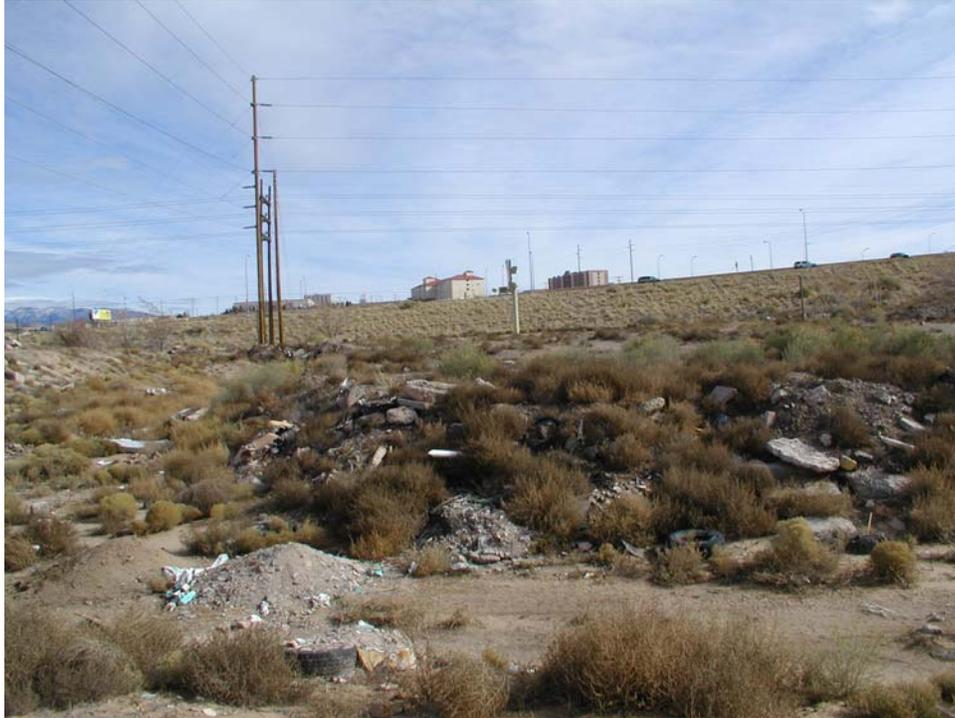
*No. 23 – Photograph taken from along AMAFCA service road on the west side of the southwest quadrant of the landfill. The mound in center/right of photo is a continuous pile of debris that appeared to be over 5,000 square feet in area.*

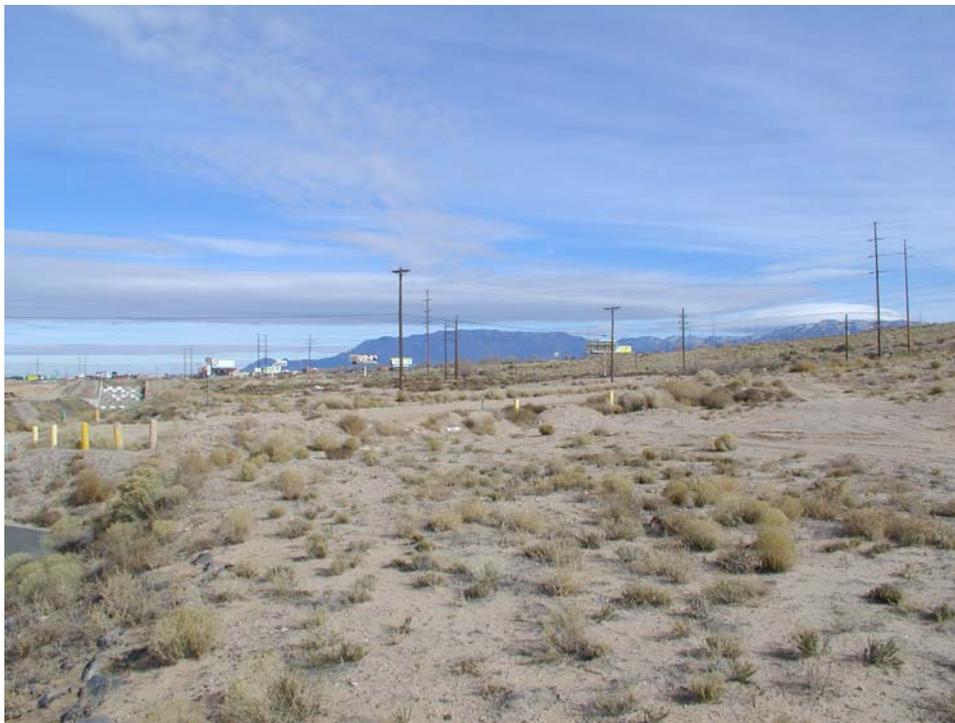
*No. 24 – Photograph taken from southwest corner of the designated boundary of the southwest quadrant of the landfill. The photo is looking northeast with the Southern Diversion channel on the left, Woodward Road in center of the photograph and bollards protecting buried electric and water lines.*

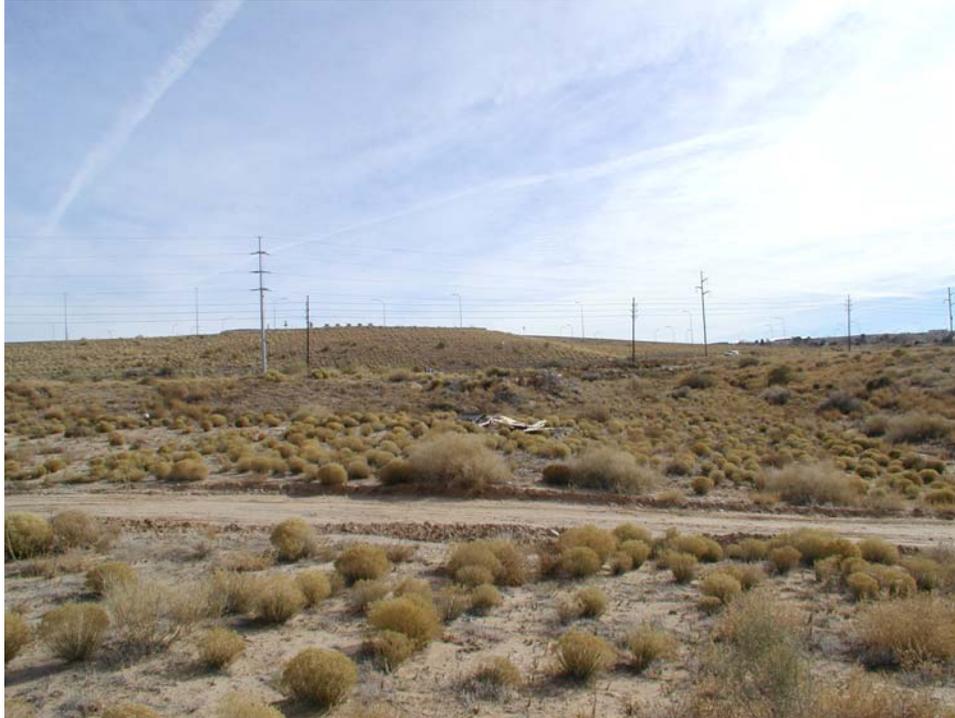
*No. 25 – Looking ESE along the designated southern boundary of the southwest quadrant. Isolated areas of debris were found on side of the gradual rise in topography in center of the photo.*

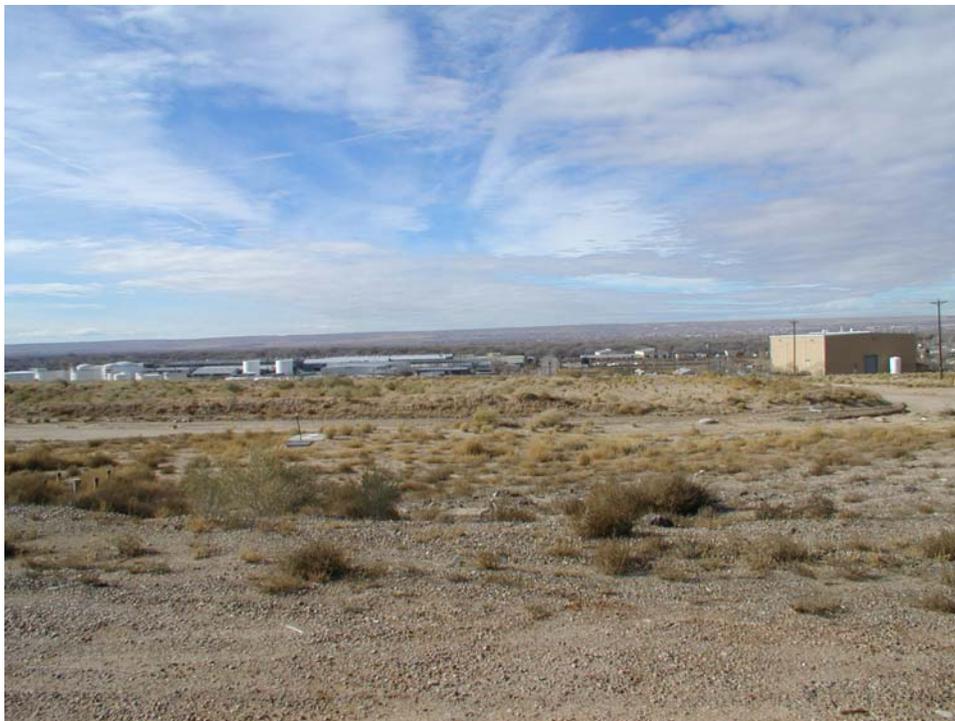
*No. 26 – Looking west along the designated southern boundary of the southwest quadrant. Environmental monitoring wells shown in left side of photo and adjacent to road on the right side of the photo.*

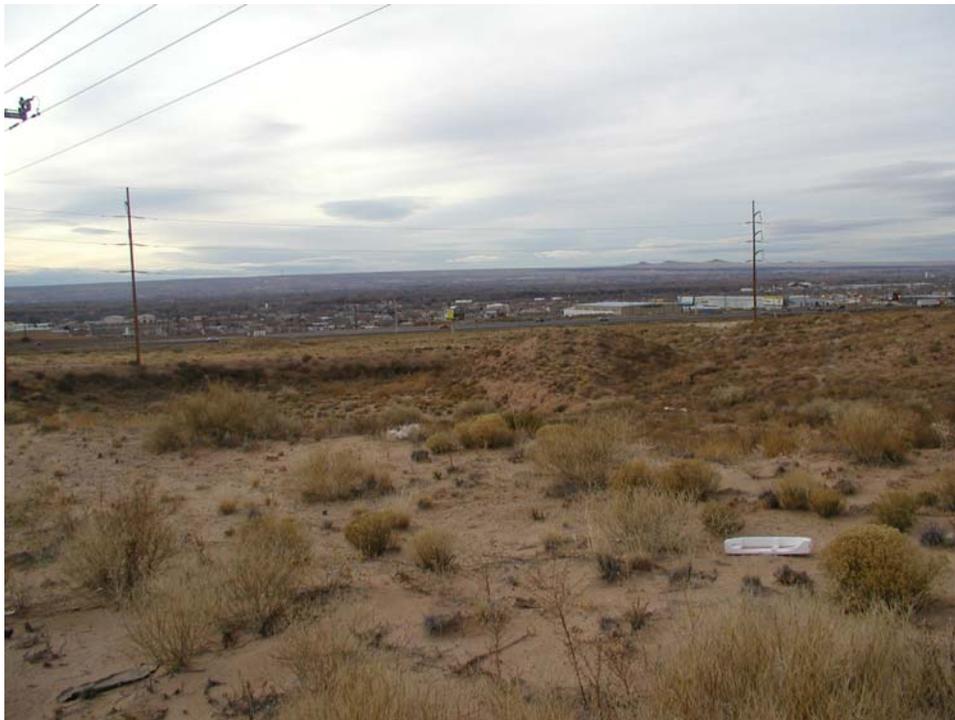
*No. 34 – Photograph of retention basin on SE end of the southeast quadrant to the landfill. Debris in photograph is likely wind deposited from construction project located in the opposite direction of this photograph (looking WWN).*

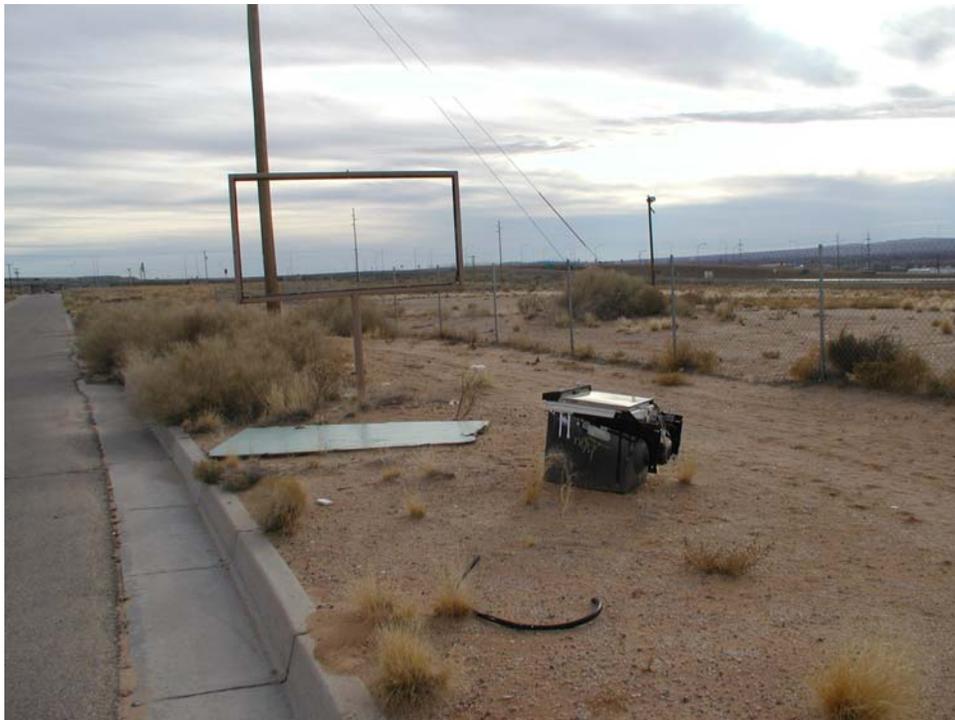
*No. 35 – Photograph taken from Transport Street of large metallic object emerging from the ground east of the road and within the established boundary of the SE quadrant of the landfill.*

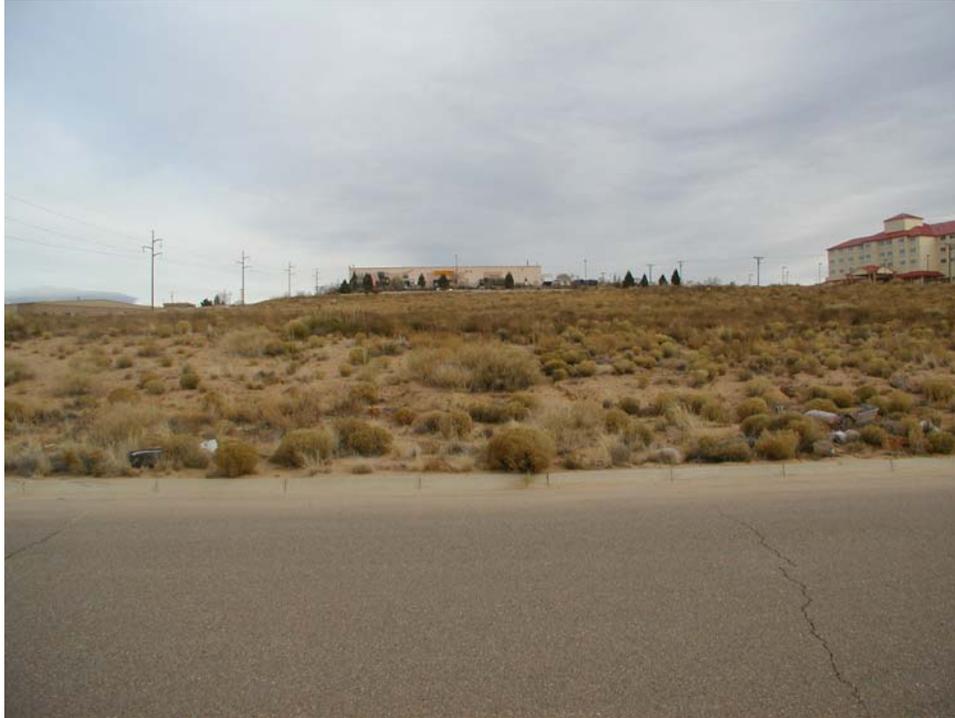
*No. 37 – Tires and other debris from illegal dumping along Transport Street. Photograph is looking east at an area within the designated southeast quadrant of the landfill.*

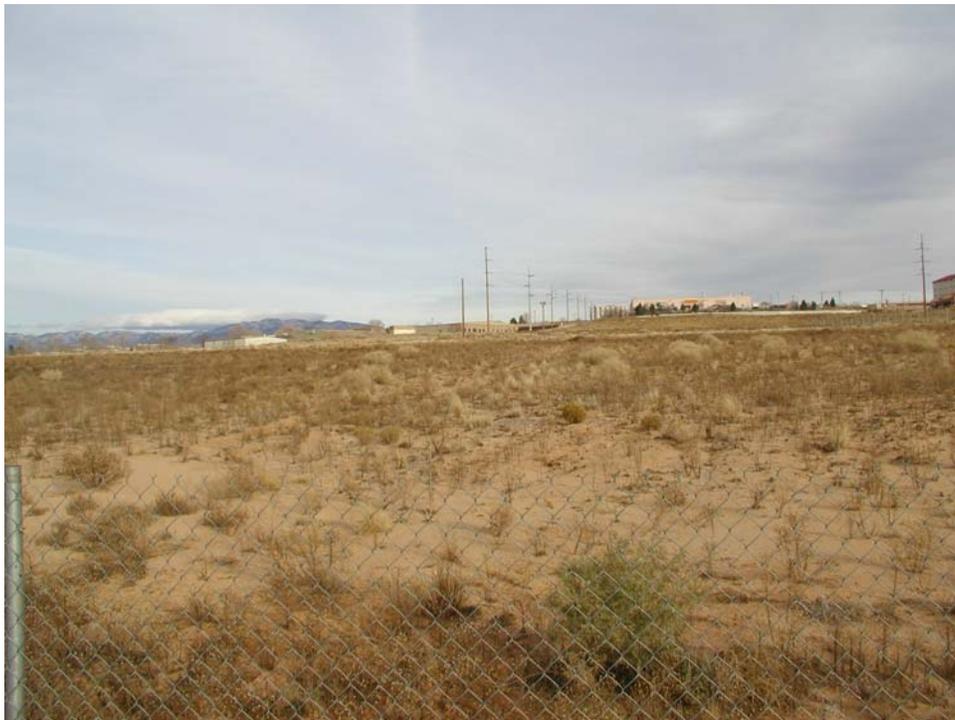
*No. 38 – Photograph of the central area of the southeast quadrant of the Schwartzman Landfill taken from the I-25 right-of-way along the west side of the landfill.*

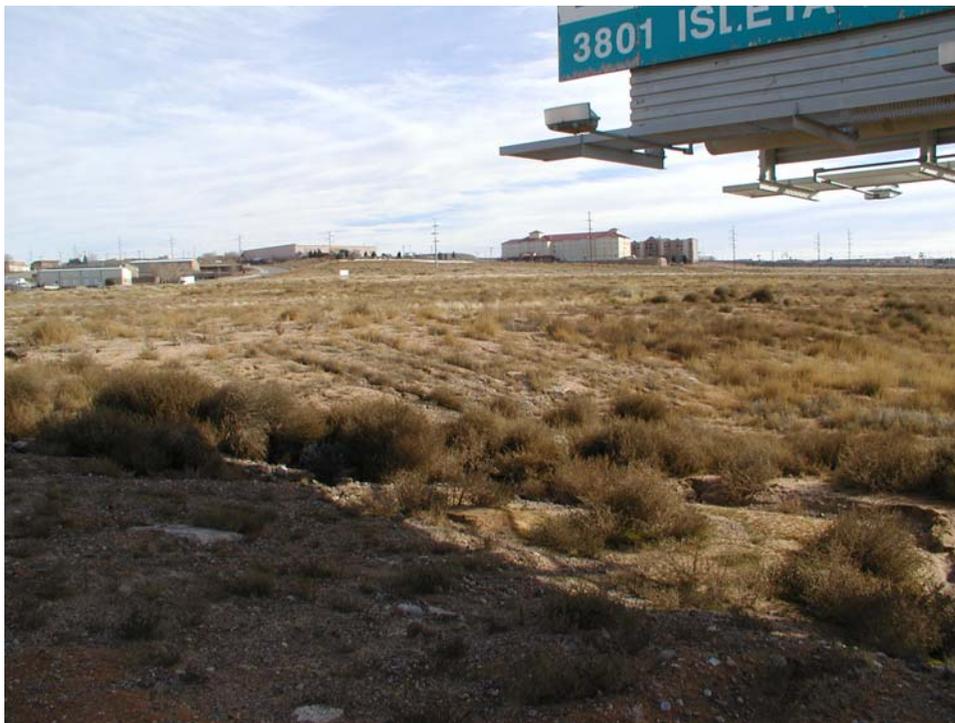
*No. 44 – Looking southeast across the southeast quadrant of the landfill from the South Diversion Channel where it intersects I-25. Note concrete debris in foreground.*

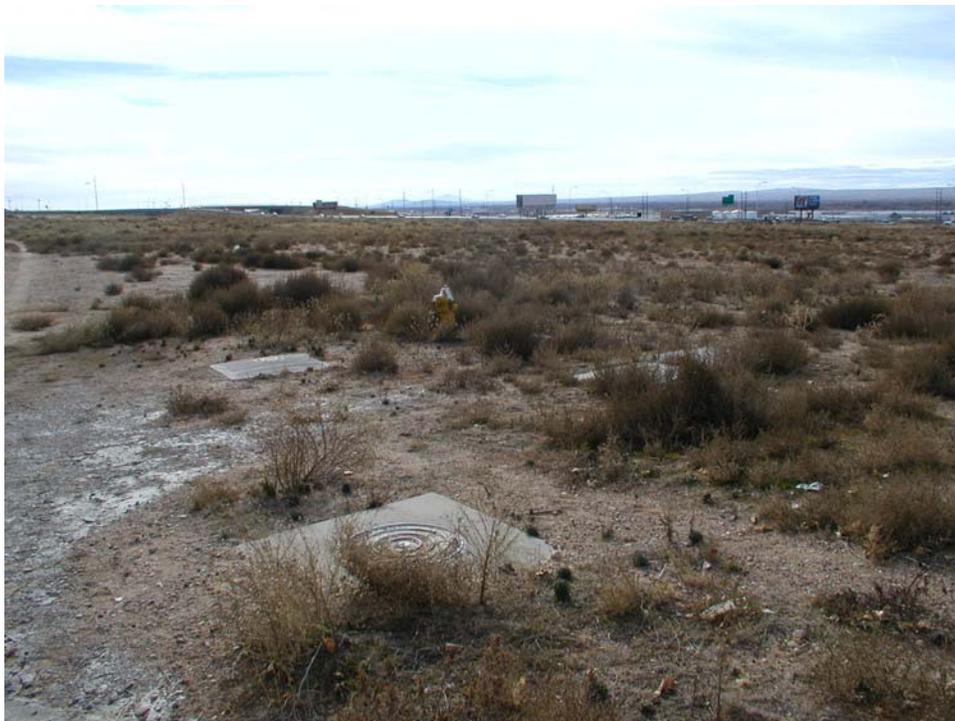
*No. 48 – Utilities (water and sewer) just south of the blocked terminus of Mulberry Street (photograph looking southwest).*

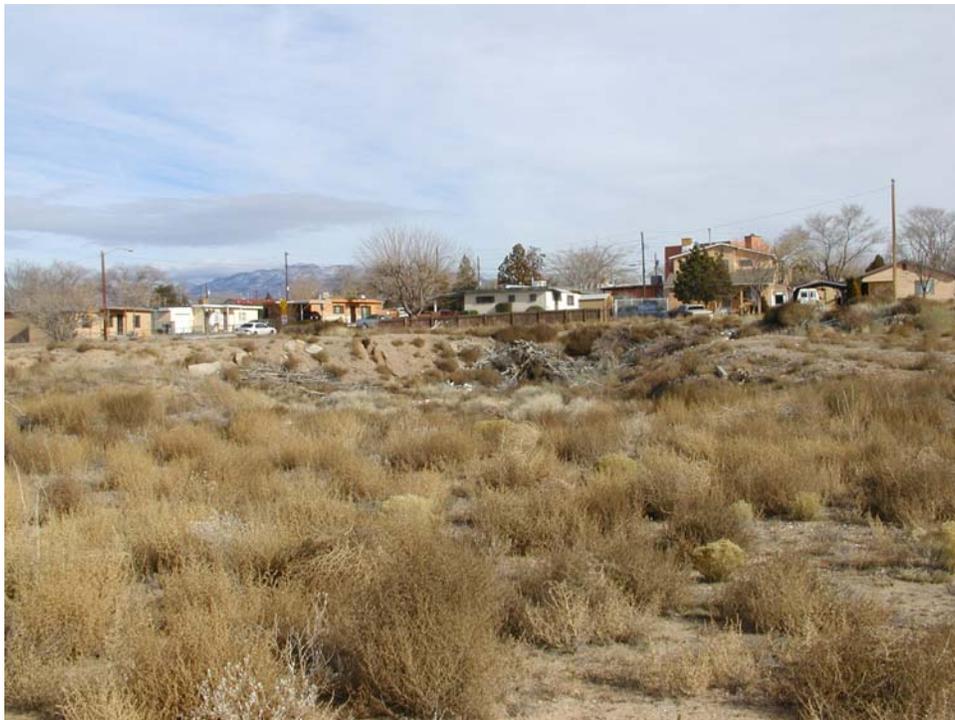
*No. 50 – Depression in the ground surface in the northern portion of the southeast quadrant of the landfill. The depression is observed in aerial photographs from as early as 1951. Landscape debris and some household trash observed from in the pit.*

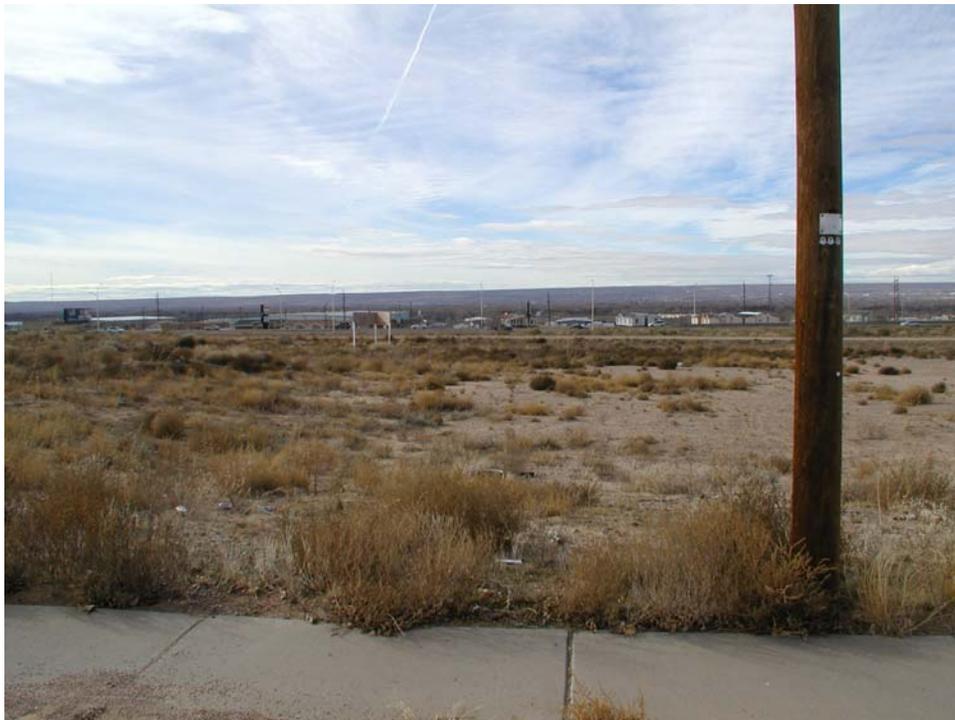
*No. 52 – From the northeast corner of the designated landfill boundary looking west along the northern boundary of the landfill at the southeast quadrant.*

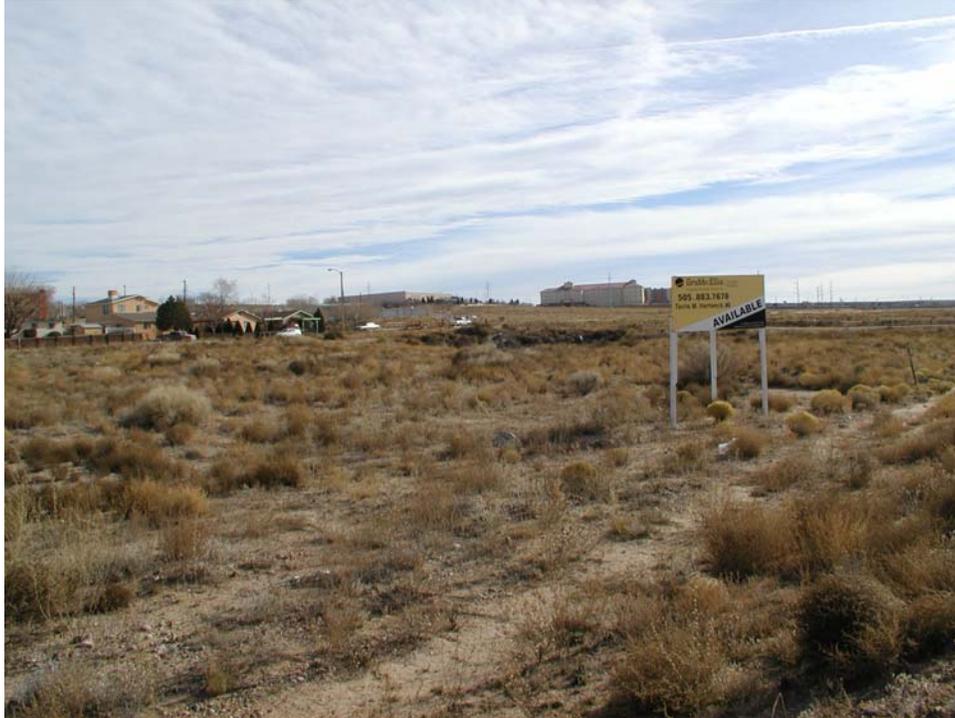
*No. 53 – Photograph from the northwest corner of the southeast quadrant looking across the northern portion of the quadrant (looking southeast).*

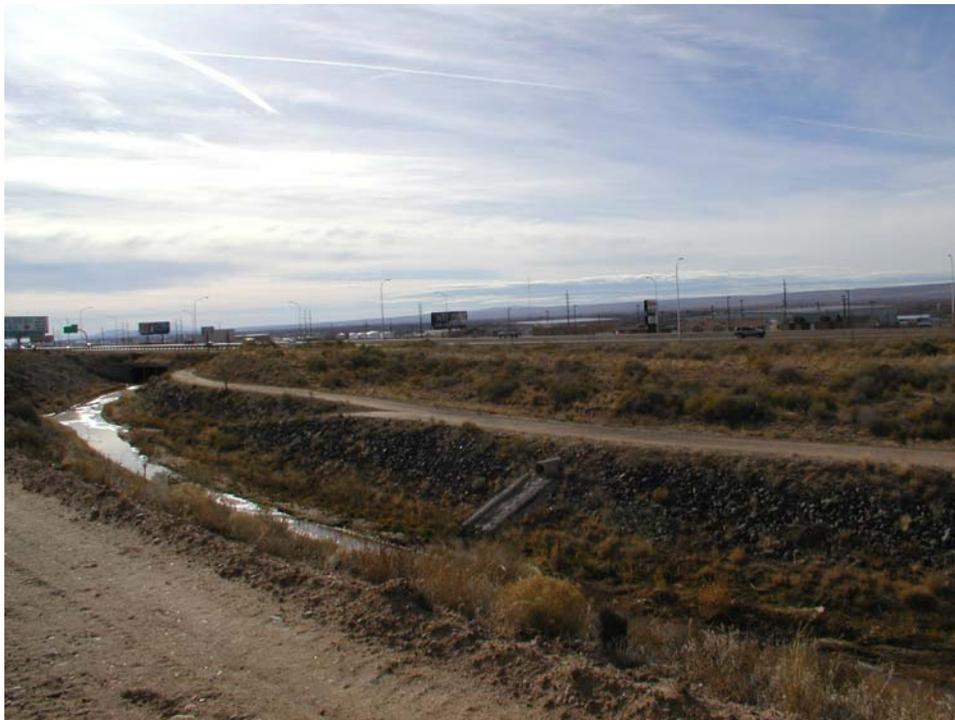
*No. 54 – Photograph taken looking southwest across the southern end of the northeast quadrant of the Schwartzman Landfill. The picture is taken from the northwest corner of the SE quadrant of the designated landfill.*

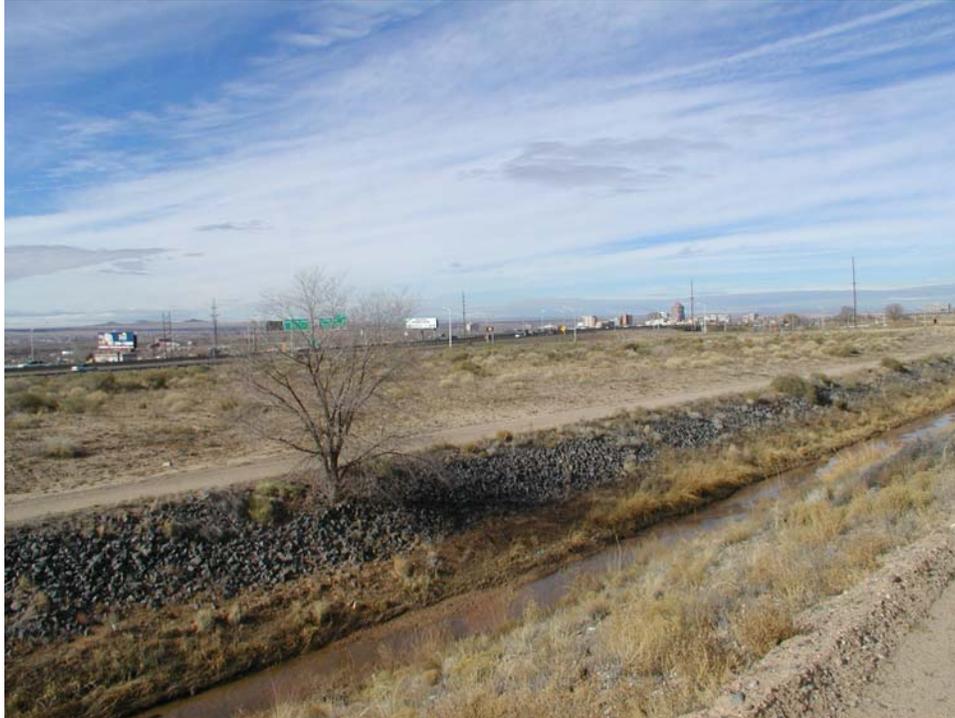
*No. 55 – Photograph taken looking northwest across the northeast quadrant of the Schwartzman Landfill. The picture is taken from the northwest corner of the SE quadrant of the designated landfill.*

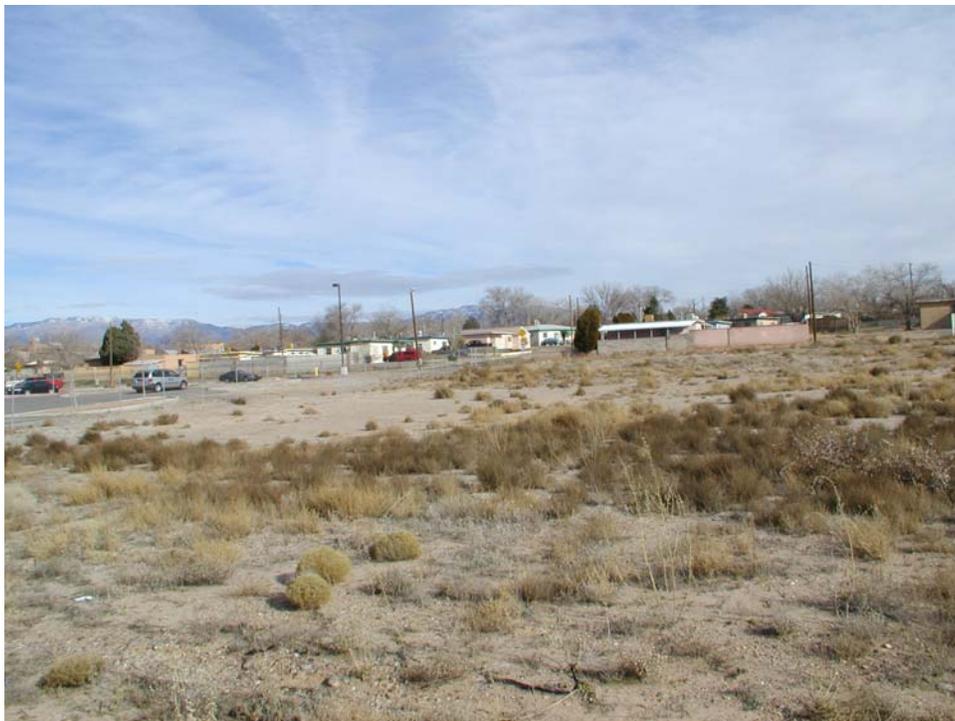
*No. 56 – Photograph taken looking northeast along the northern boundary of the southeast quadrant of the Schwartzman Landfill. The picture is taken from the northwest corner of the designated landfill quadrant.*

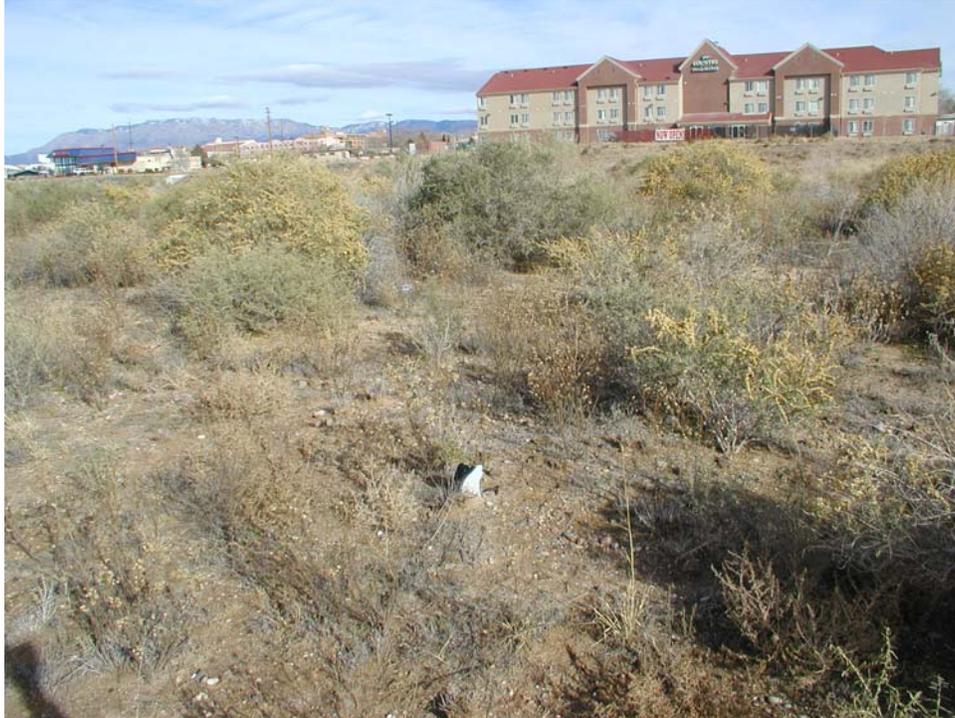
*No. 57 – Part of old tire emerging from the ground at a point approximately midway between the north and south points of the northeast quadrant of the landfill.*

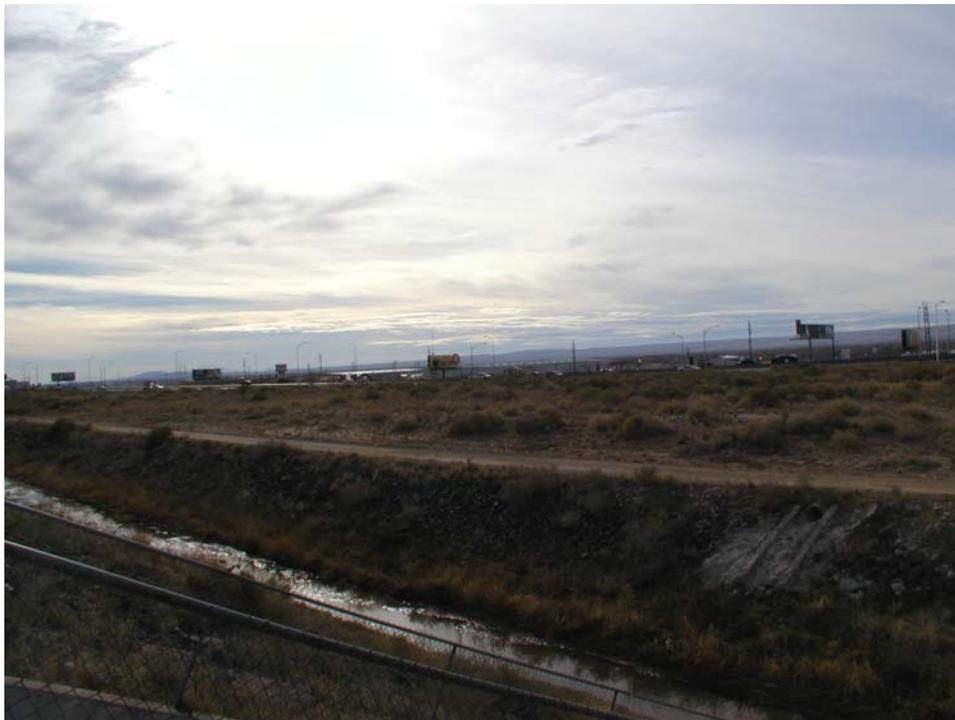
*No. 58 – Looking across the south end of the northeast quadrant of the landfill from a point opposite the landfill along the AMAFCA right-of-way.*
