**PHASE I ENVIRONMENTAL  
SITE ASSESSMENT  
SCHWARTZMAN LANDFILL  
ALONG I-25 SOUTH OF GIBSON AVE  
NORTH OF SUNPORT BOULEVARD  
ALBUQUERQUE, NEW MEXICO**

**City of Albuquerque  
Environmental Health Department  
Environmental Services Division  
Room 3023  
P.O. Box 1293  
Albuquerque, NM 87103**

**INTERA, INC.  
One Park Square  
6501 Americas Parkway NE, Suite 820  
Albuquerque, New Mexico 87110**

**July 6, 2005**

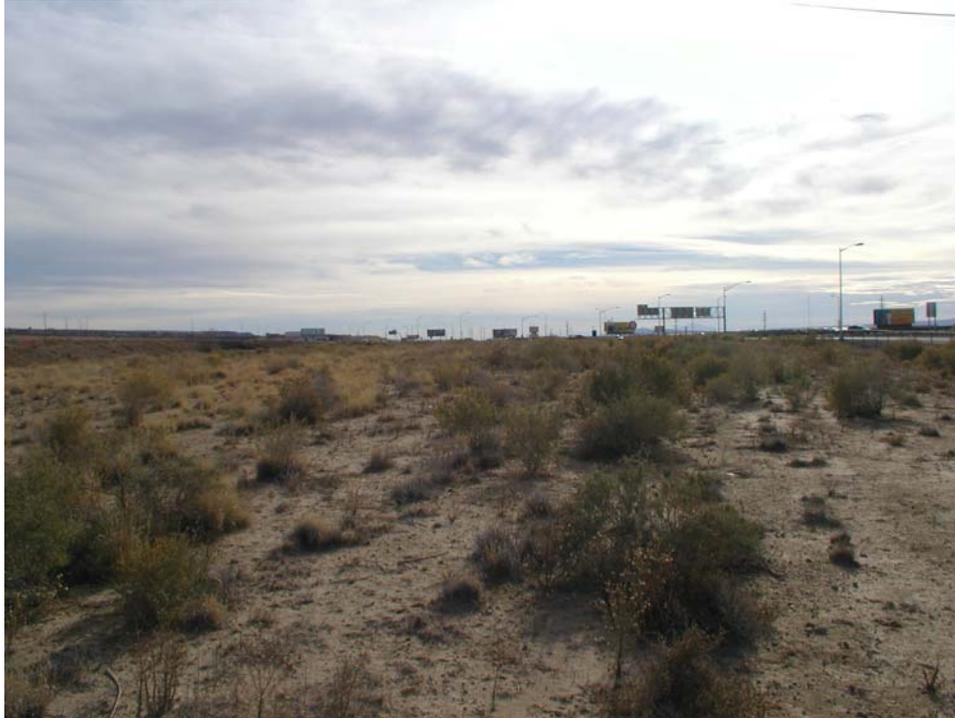
*No. 59 – Photograph of the northeast quadrant of the landfill from its northern tip (looking south).*
