PARCEL 10 ADDITIONAL CHARACTERIZATION REPORT

CITY OF ALBUQUERQUE RAIL YARDS

Albuquerque, Bernalillo County, New Mexico

April 27, 2016

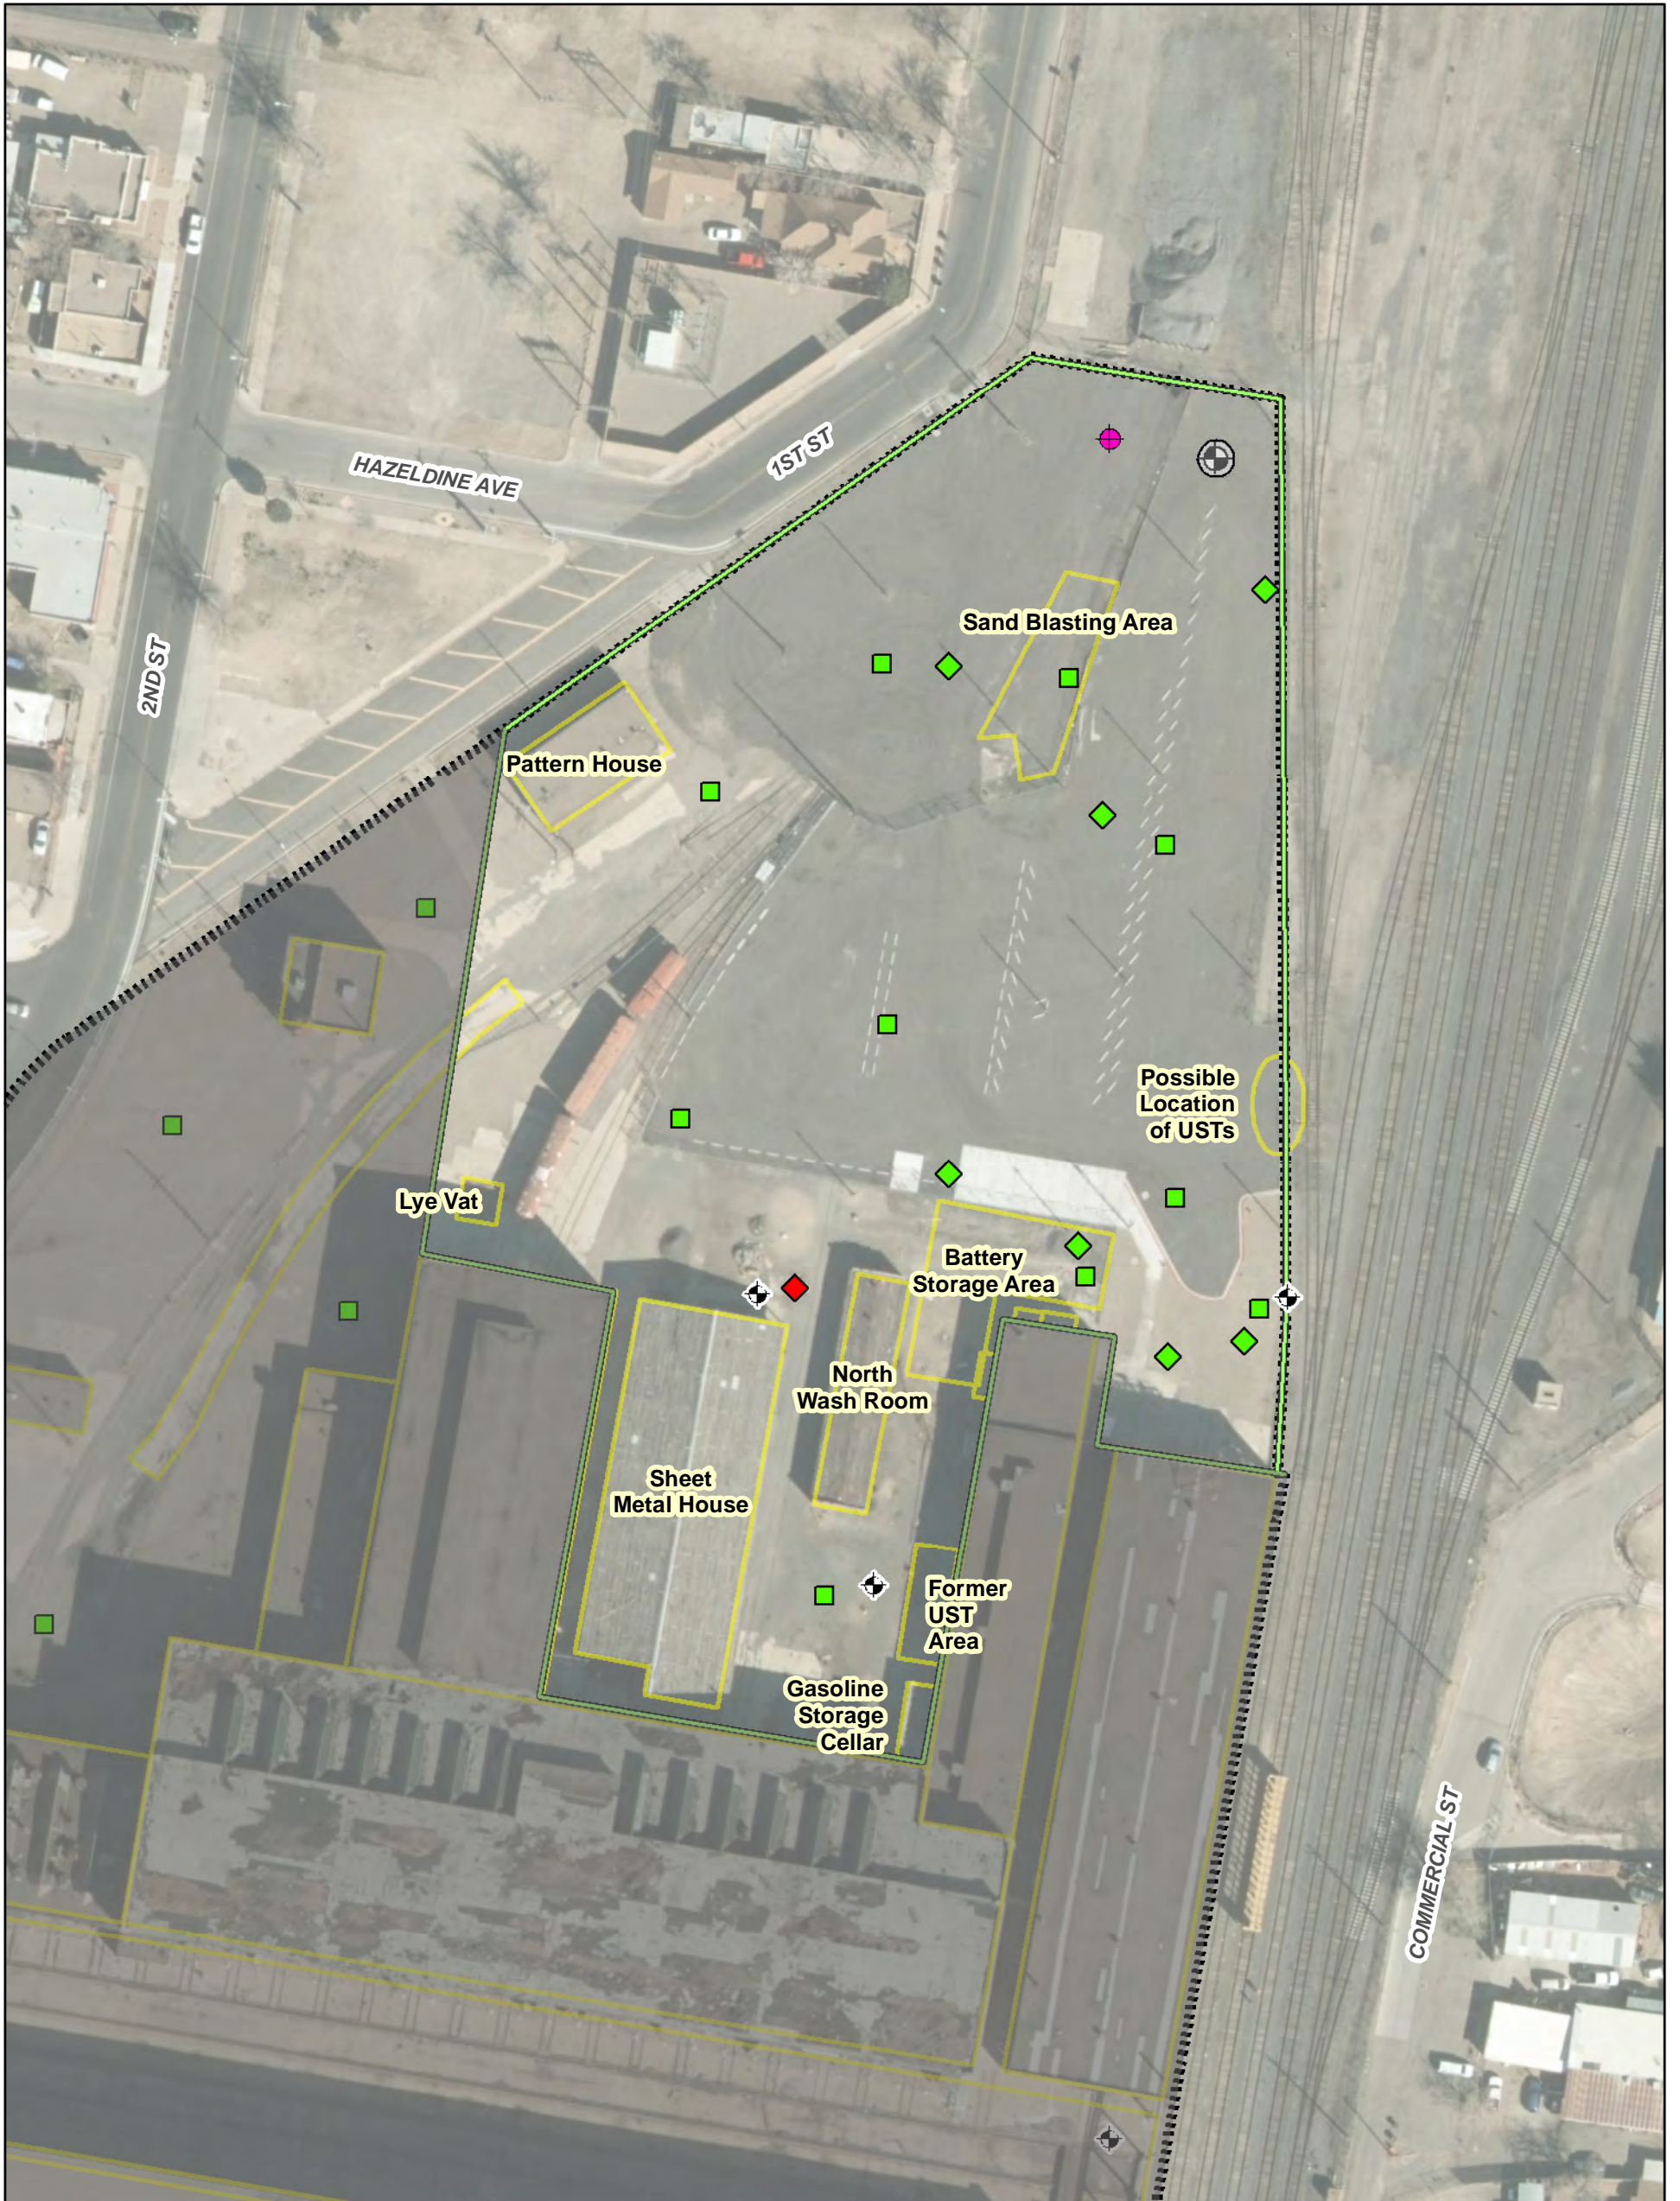
Figure 3d
 Residential SSL Exceedances
 (0-10 ft bgs), Iron
 Additional Characterization,
 Voluntary Remediation Program Activities,
 Albuquerque Rail Yards, Albuquerque,
 Bernalillo County, New Mexico

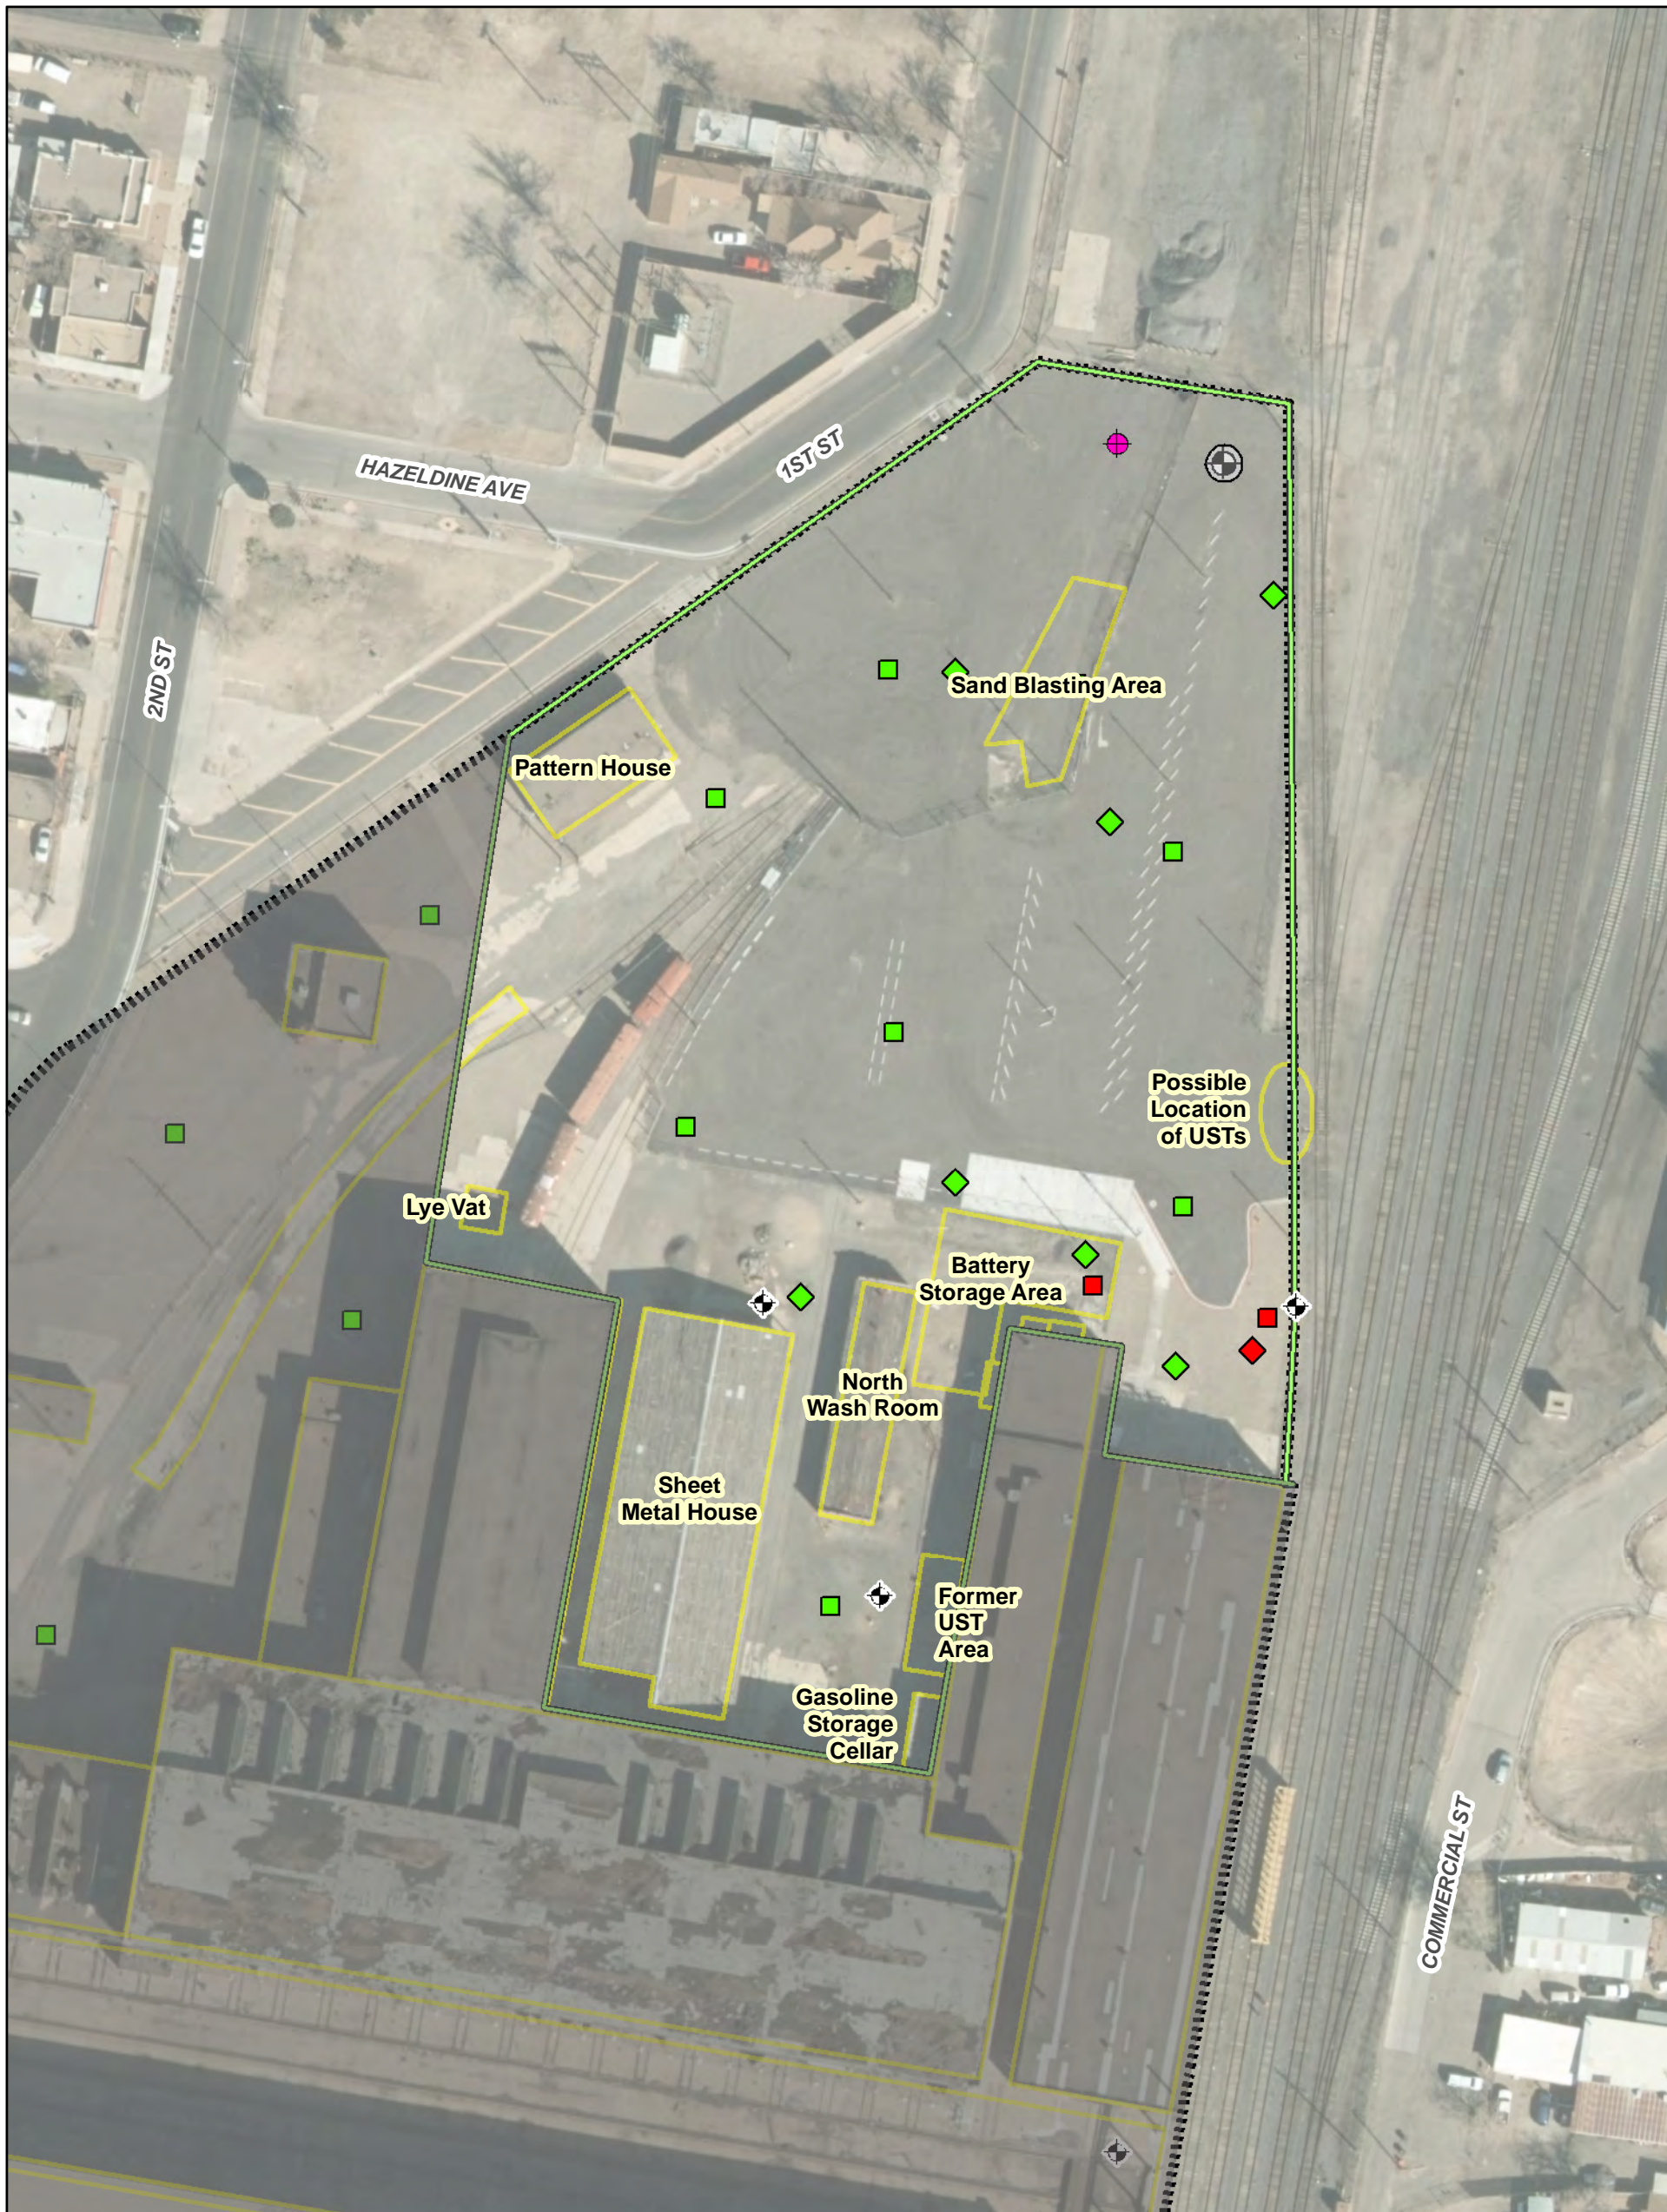
Note: Some sample depths include a portion greater than 10 ft bgs (i.e., sample interval = 8 - 12 ft bgs).
 SSL: Soil Screening Levels (NMED, 2015)

Figure 3f
 Construction Worker SSL Exceedances
 (0-10 ft bgs), Manganese
 Additional Characterization,
 Voluntary Remediation Program Activities,
 Albuquerque Rail Yards, Albuquerque,
 Bernalillo County, New Mexico
