UNIVERSITY AREA DESIGNATION REPORT

METROPOLITAN REDEVELOPMENT AGENCY

3-8-2022

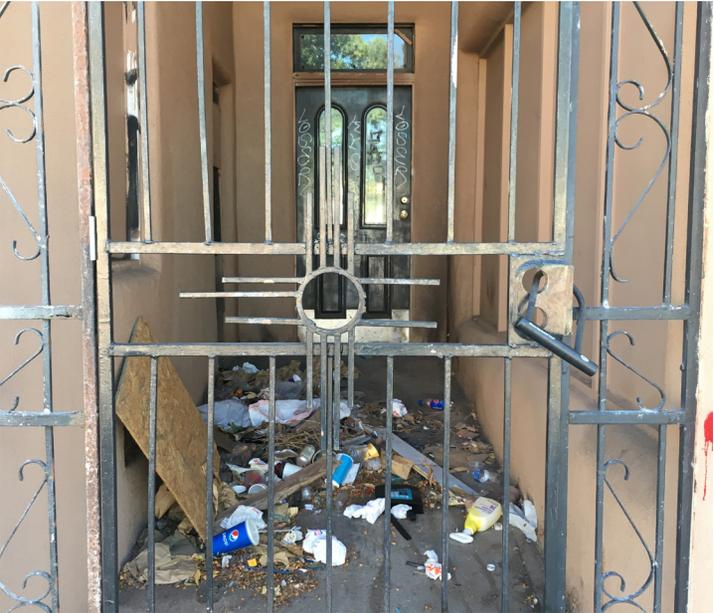
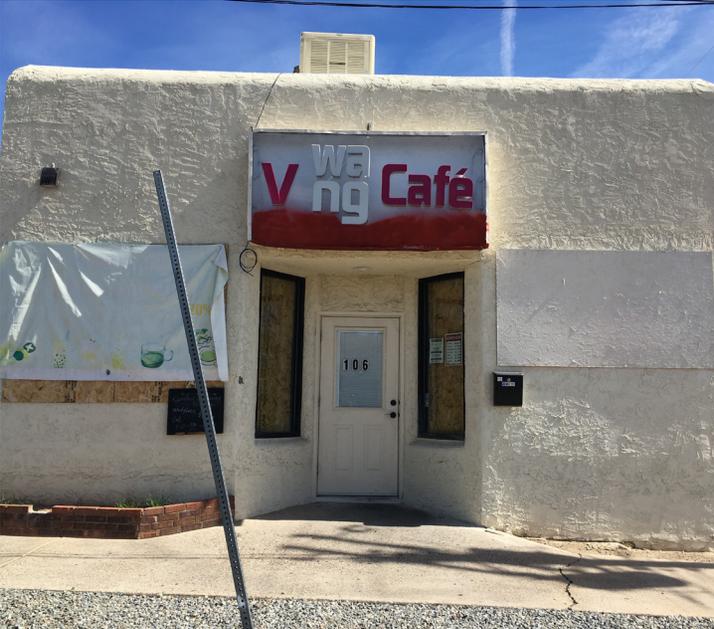
Deteriorated Buildings

Deteriorated buildings are those with chipped or peeling paint or stucco and trim, graffiti, and other signs of neglect. Though many buildings are in good condition, the Study Area has a significant number of buildings that are deteriorated or deteriorating.

Deteriorated Site Conditions

Deteriorated site conditions include weeds, broken asphalt or concrete, and trash. These conditions may exist on private property or in public right of way. In public right of way, deteriorated conditions include broken sidewalks and curbs, broken or missing streetlights, and damaged street furnishings.

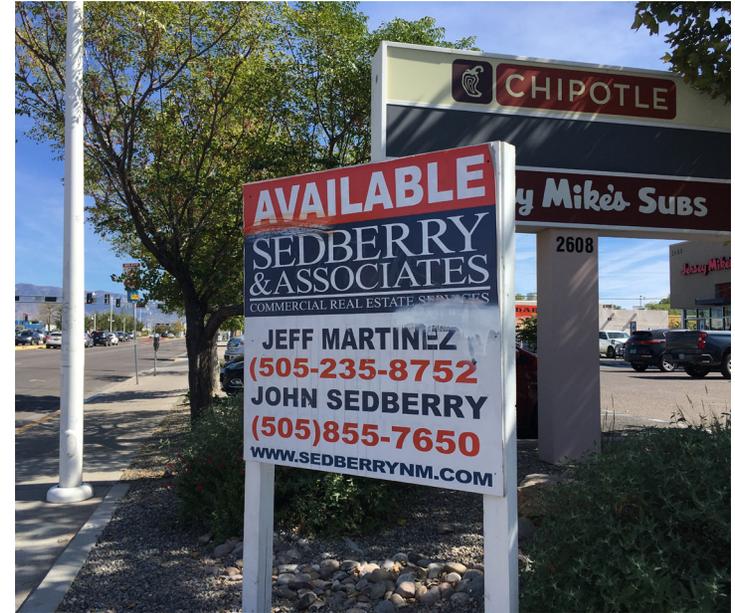
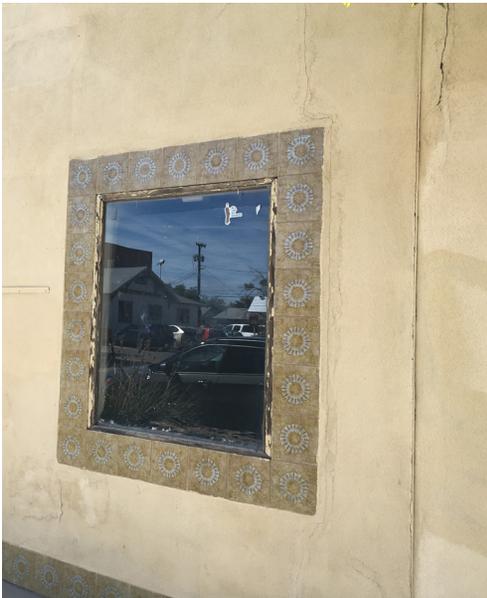
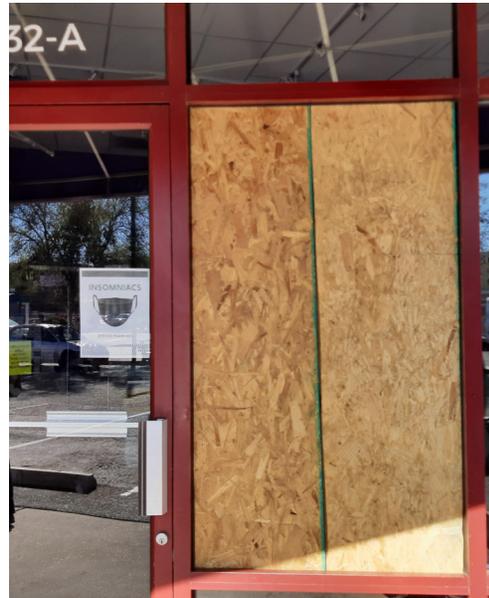
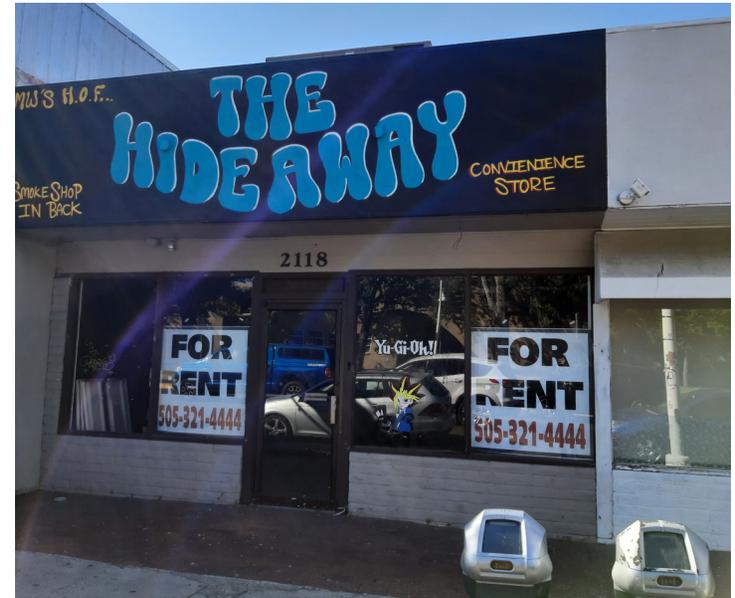
VACANT OR CLOSED BUSINESSES

The high commercial vacancy rate within the Study Area is testimony to the number of vacant buildings and closed businesses. The presence of vacant buildings, especially where windows have been boarded up to protect them from being broken, has an impact on the appearance and “feel” of the entire area. Figure 5 shows the locations of vacant buildings in the Study Area. Along Central Avenue there is a vacant building or vacant space in almost every block. The same is true of Harvard Drive and Cornell Drive, which are predominantly commercial between Central Avenue and Silver Avenue.
