# Annual Report Format

## National Pollutant Discharge Elimination System Stormwater Program MS4 Annual Report Format

NMR04A014 City of Albuquerque

What is the reporting period for this report? (mm/dd/yyyy) From Jul 1, 2022 to Jun 30, 2023

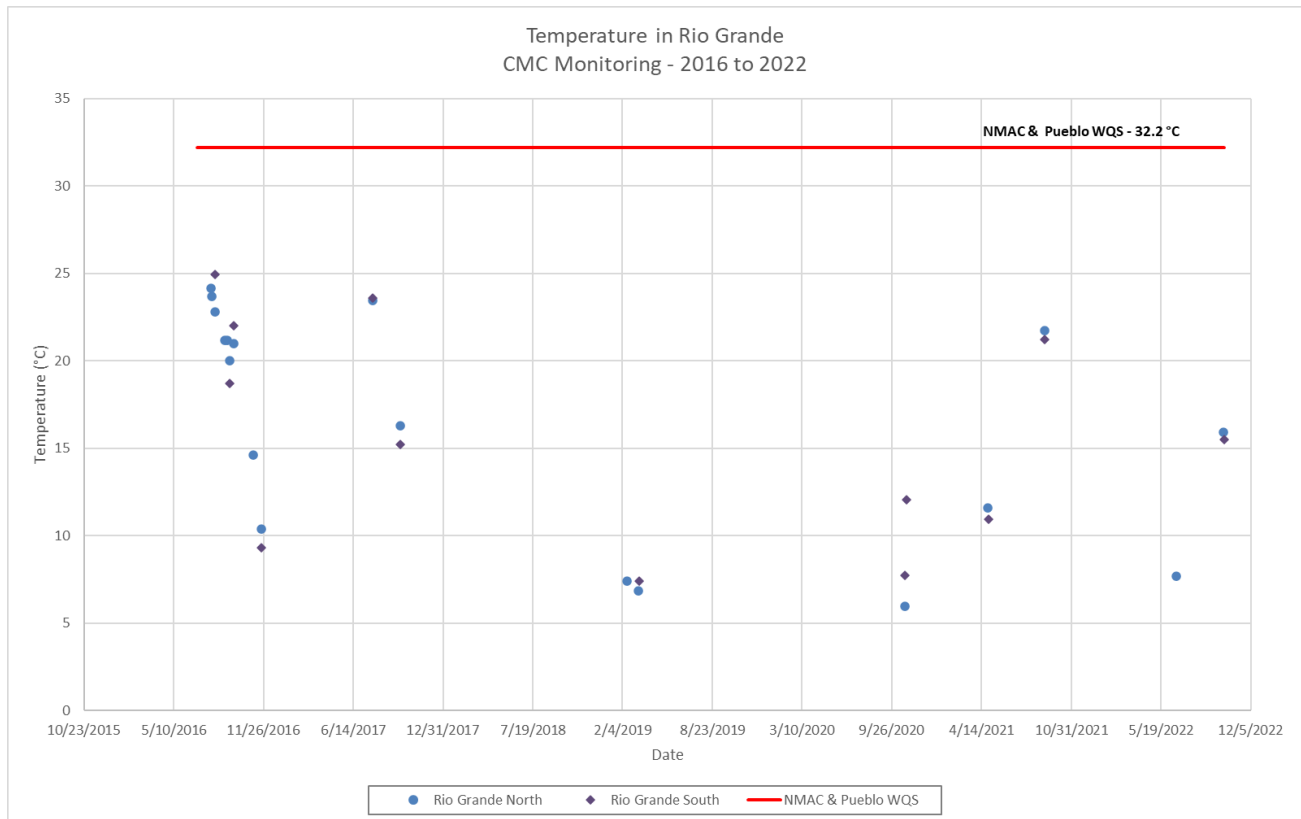
**Figure 5: Temperature Monitoring Results in the Rio Grande CMC Monitoring – 2016 - 2022**

Temperature is listed in the WSB MS4 Permit as a special condition (currently only applicable to the City of Albuquerque and AMAFCA). Past data submitted to EPA and NMED by the MS4 permittees have proven that stormwater discharges into the Rio Grande are not raising the Rio Grande temperature above the WQSs. The data collected during this FY 2023 wet season monitoring also supports this conclusion. All the temperature field readings taken in the Rio Grande during the CMC FY 2023 wet season were below 32.2°C (90°F), which is the WQS for the State of New Mexico and for the Isleta and Sandia Pueblos. Refer to Figure 5 for temperature results and comparison to applicable WQSs for all CMC samples taken upstream and downstream of the MRG MS4 area from 2016 to 2022.

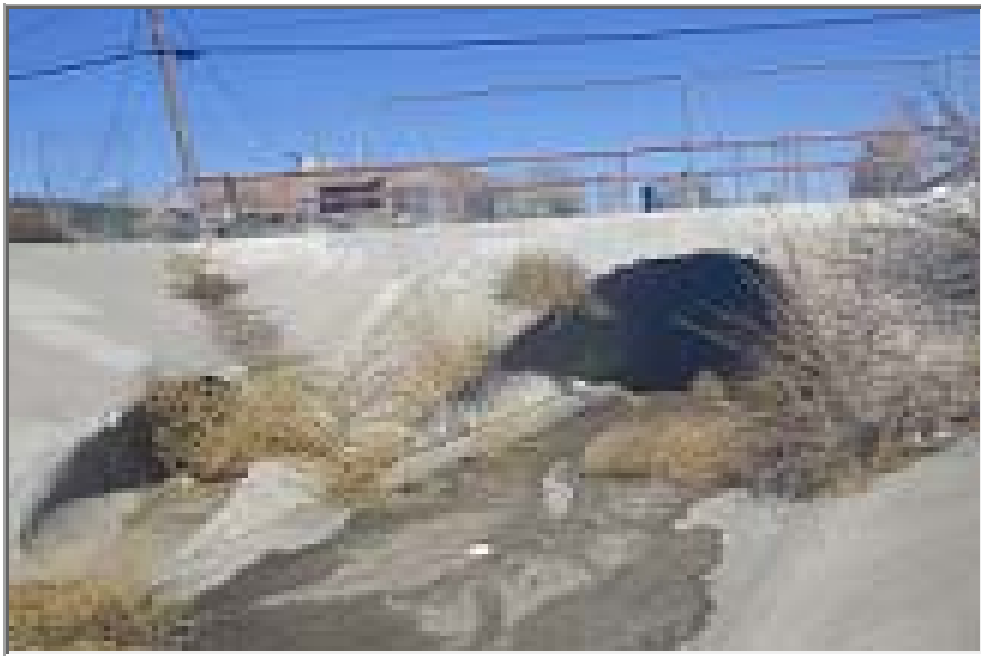
LOCATION **BROADWAY POND INFLOW CHANNEL**

OUTFALL\_NO **2** QUAD **SE** GRID **K-14** SAMPLED

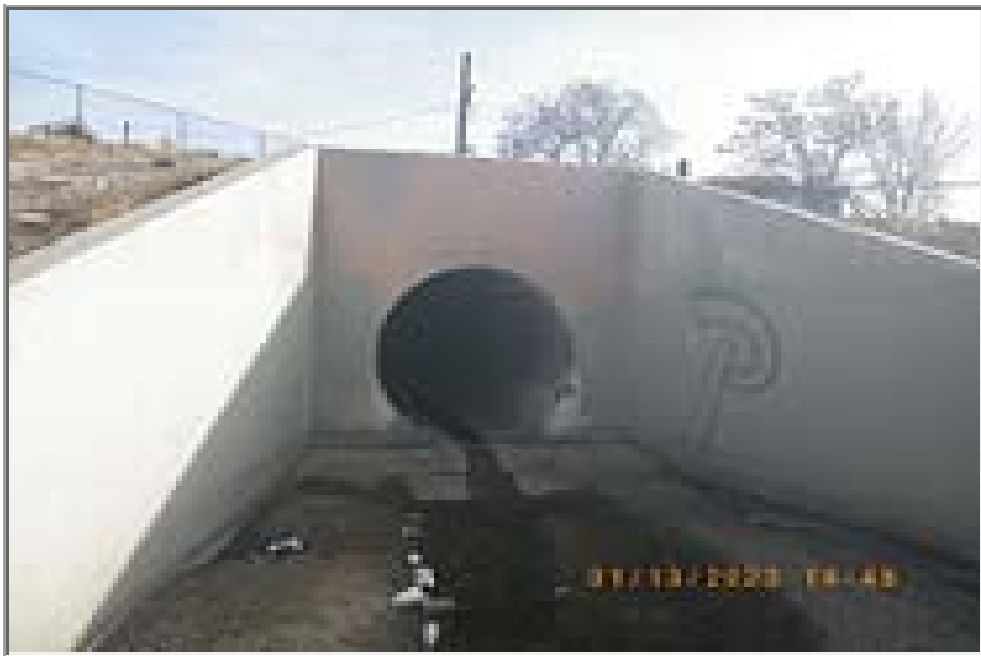
LOCATION **MENAU POND INFLOW CHANNEL**

AIR_TEMP_F	39	Lab	
WATER_TEMP_F	32	Lab_Report	2301537
pH	8.1	E_coli_Coliform_mpn/100ml	>2419.6
CONDUCTIVITY_Umos/cm	510	Ammonia_mg/l	<1
BOD_mg/l	<2	Nitrite_NO2_mg/l	<0.5
COD_mg/l	<20	Nitrate_NO3_mg/l	<0.5
TSS_mg/l	<4	TKN_Tot_Kjeld_N_mg/l	<1
TDS_mg/l	301	Phosphorus_total_mg/l_P	0.39
N-Hexane Extractable-(Oil_Grease)_mg/l	<9.9	Hardness_mg/l_CaCO3	190
Floride_mg/l	0.68	Chlorine_mg/l	<0.05

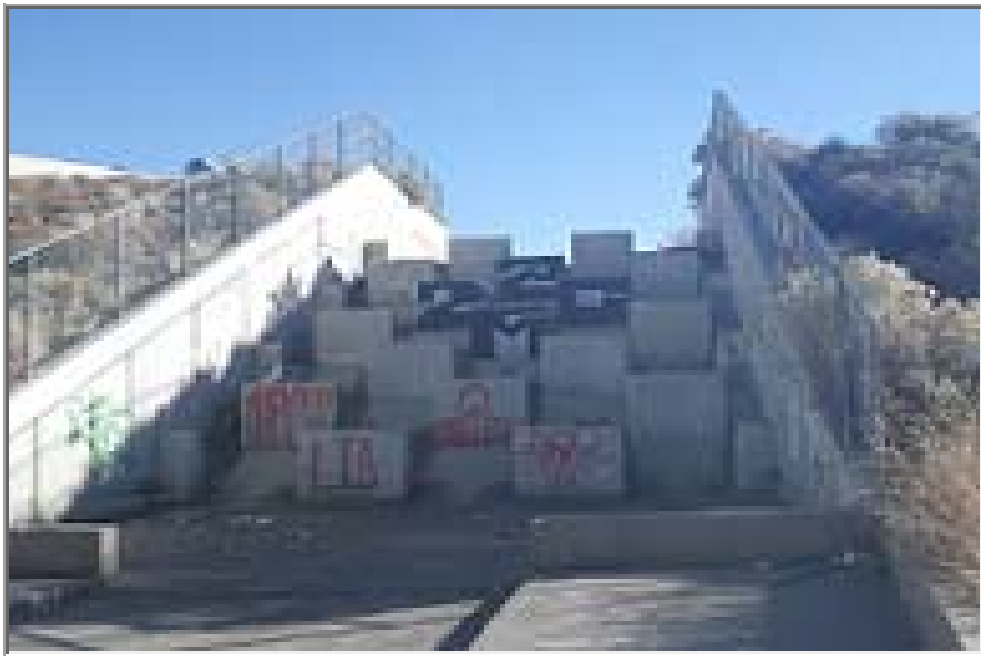
LOCATION **BARELAS PUMPING PLANT INFLOW**

OUTFALL\_NO **4** QUAD **SW** GRID **L-13** SAMPLED

Source of Flow **groundwater infiltration to the storm lines**

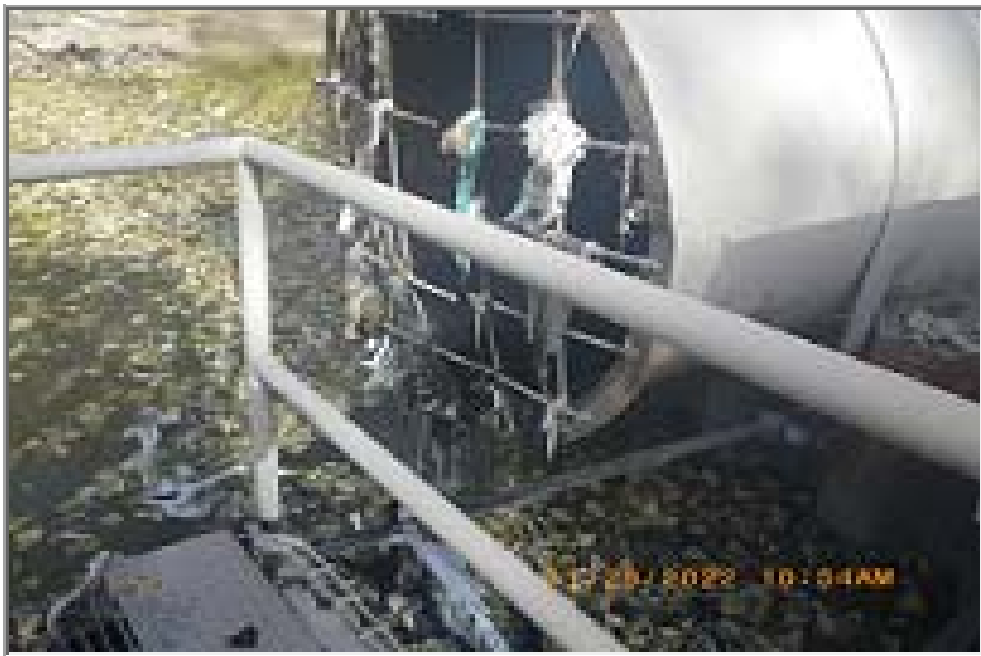
AIR_TEMP_F	50	Lab	HALL ENVIRONMENTAL
WATER_TEMP_F	52	Lab_Report	2211E23
pH	8.23	E_coli_Coliform_mpn/100ml	1011.2
CONDUCTIVITY_Umos/cm	780	Ammonia_mg/l	<2
BOD_mg/l	<2	Nitrite_NO2_mg/l	<0.1
COD_mg/l	nd	Nitrate_NO3_mg/l	0.14
TSS_mg/l	<4	TKN_Tot_Kjeld_N_mg/l	<2
TDS_mg/l	522	Phosphorus_total_mg/l_P	0.23
N-Hexane Extractable-(Oil_Grease)_mg/l	<10	Hardness_mg/l_CaCO3	290
Fluoride_mg/l	0.72	Chlorine_mg/l	<0.05

LOCATION	<b>KIRTLAND CHANNEL AT MULBERRY NE</b>						
OUTFALL_NO	5	QUAD	SE	GRID	M-15	SAMPLED	<input type="checkbox"/>
DATE_INSP	11/21/2022	TIME	11:05	Inspected by	SK		
WEATHER	SUNNY	flow	N	FLOW_GPM	0		
APPEARANCE	na	GROSS POLLUTANT	na				
Source of Flow	na

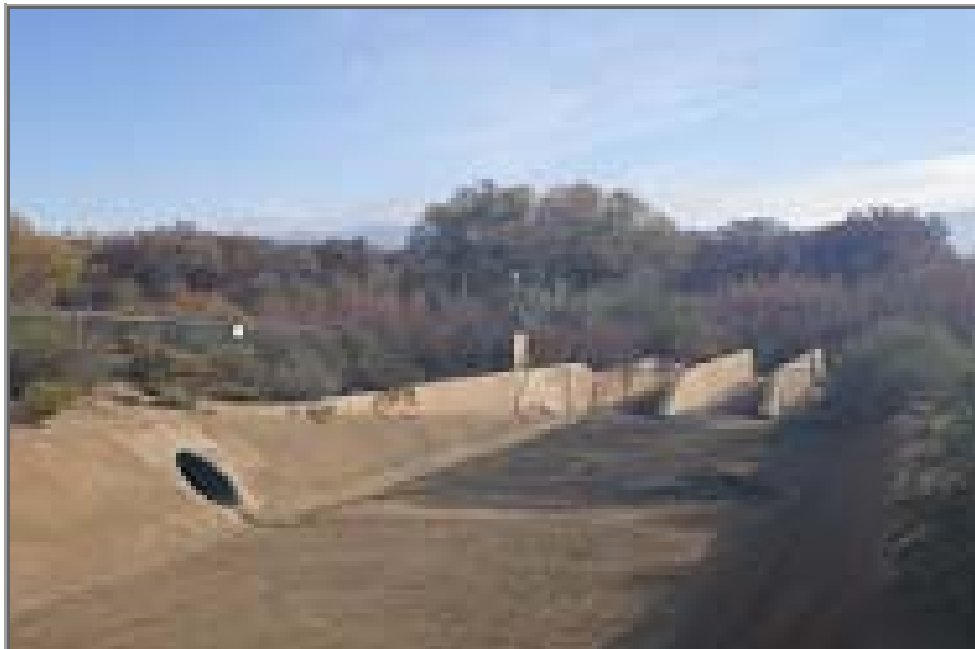
LOCATION **CALABACILLAS ARROYO AT RIO GRANDE**

OUTFALL\_NO **7** QUAD **NW** GRID **C-14** SAMPLED

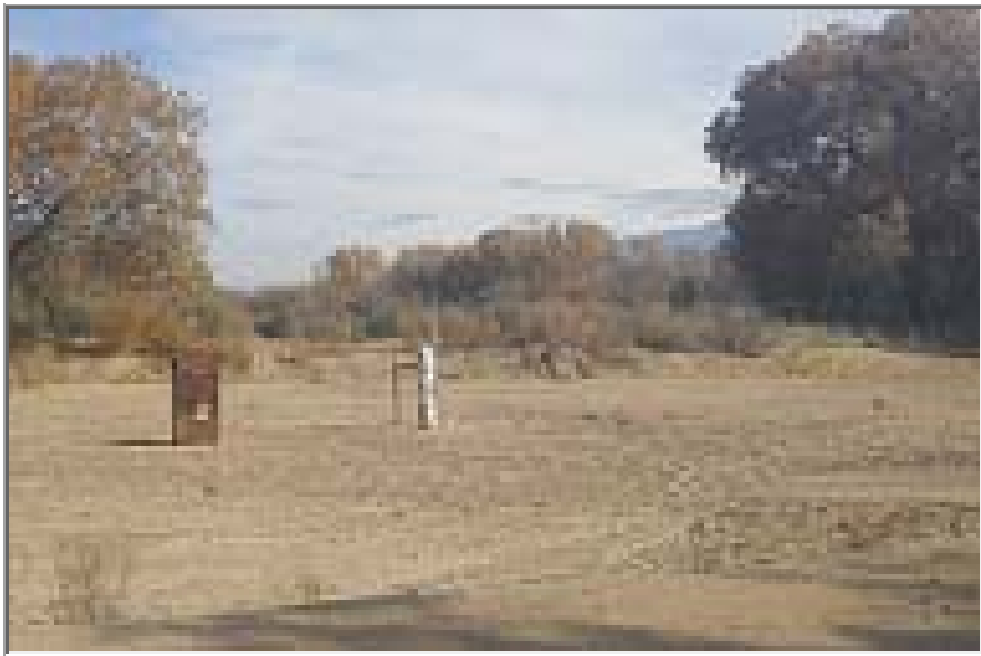
LOCATION **HAHN ARROYO AT CARLISLE NE**

OUTFALL\_NO **8** QUAD **NE** GRID **G-16** SAMPLED

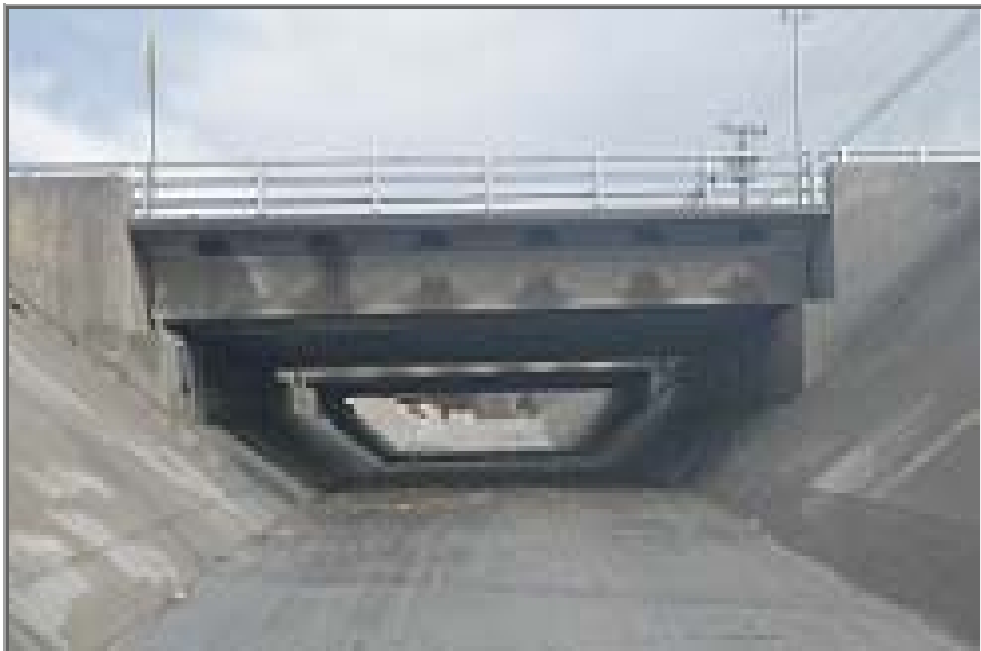
LOCATION **EMBUDO AT PENNSYLVANIA SOUTH OF MENCAL NE**

OUTFALL\_NO **9** QUAD **NE** GRID **J-19** SAMPLED

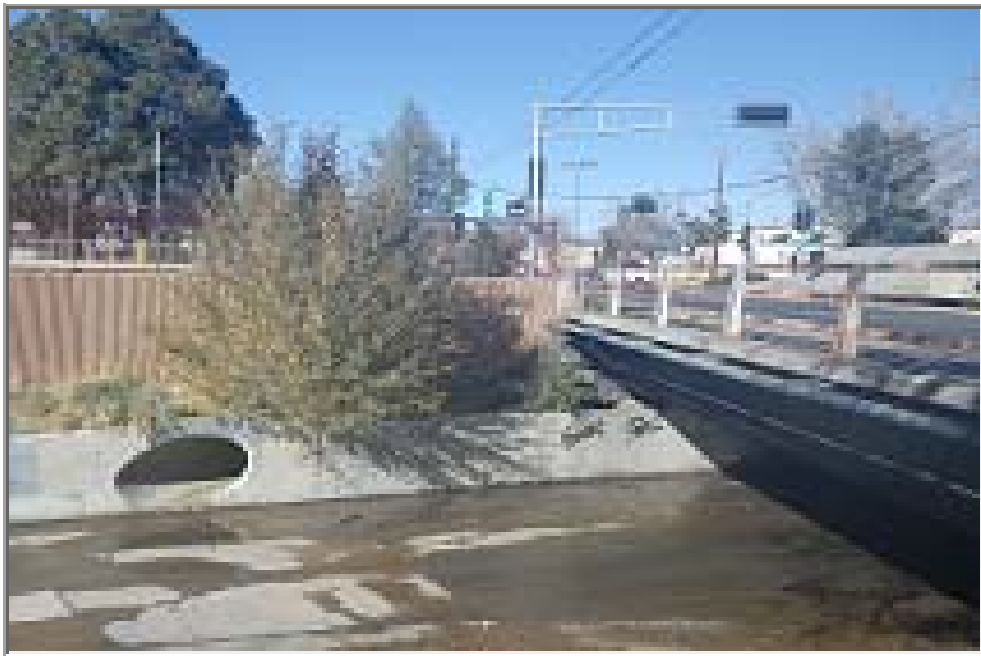
LOCATION **NDC AT TUCKER**

OUTFALL\_NO **10** QUAD **NE** GRID **J-16** SAMPLED

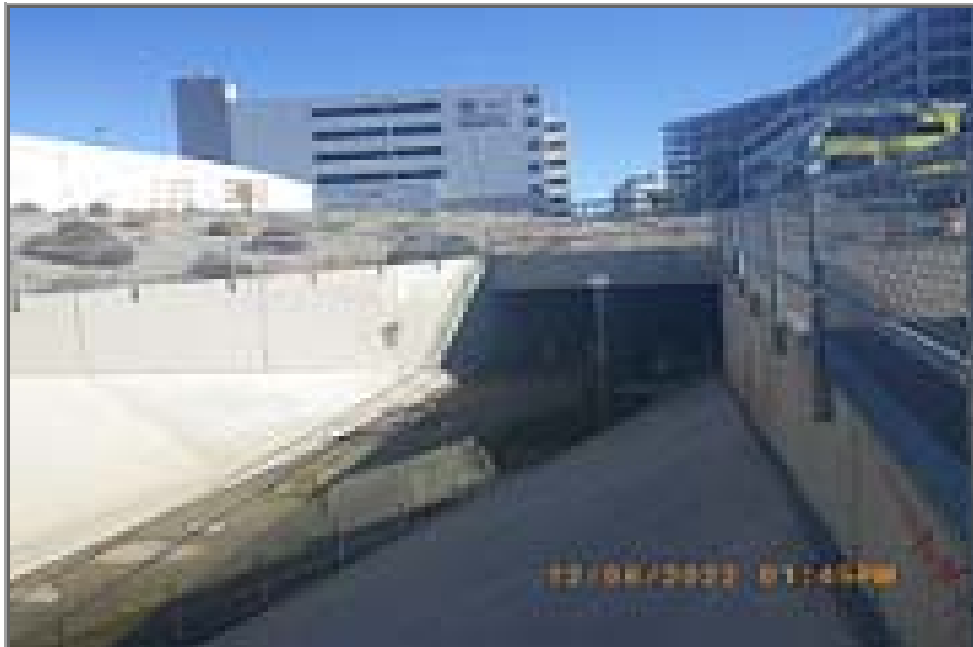
LOCATION **BEAR CANYON ARROYO AT NDC**

AIR_TEMP_F	48	Lab	HALL ENVIRONMENTAL
WATER_TEMP_F	37	Lab_Report	2212536
pH	8.29	E_coli_Coliform_mpn/100ml	1046.2
CONDUCTIVITY_Umos/cm	300	Ammonia_mg/l	<5
BOD_mg/l	<12.	Nitrite_NO2_mg/l	<0.5
COD_mg/l	176	Nitrate_NO3_mg/l	<0.5
TSS_mg/l	16	TKN_Tot_Kjeld_N_mg/l	<5
TDS_mg/l	240	Phosphorus_total_mg/l_P	0.09
N-Hexane Extractable-(Oil_Grease)_mg/l	<9.5	Hardness_mg/l_CaCO3	120
Floride_mg/l	<0.5	Chlorine_mg/l	<0.05

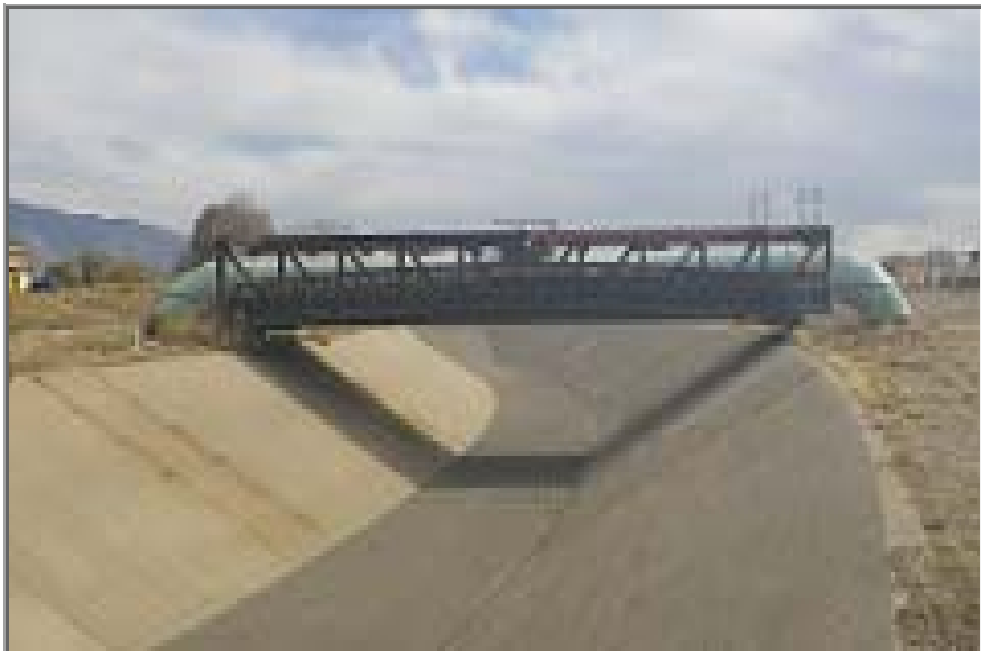
LOCATION **SOUTH PINO ARROYO AT WASHINGTON NE**

OUTFALL\_NO **12** QUAD **NE** GRID **D-17** SAMPLED

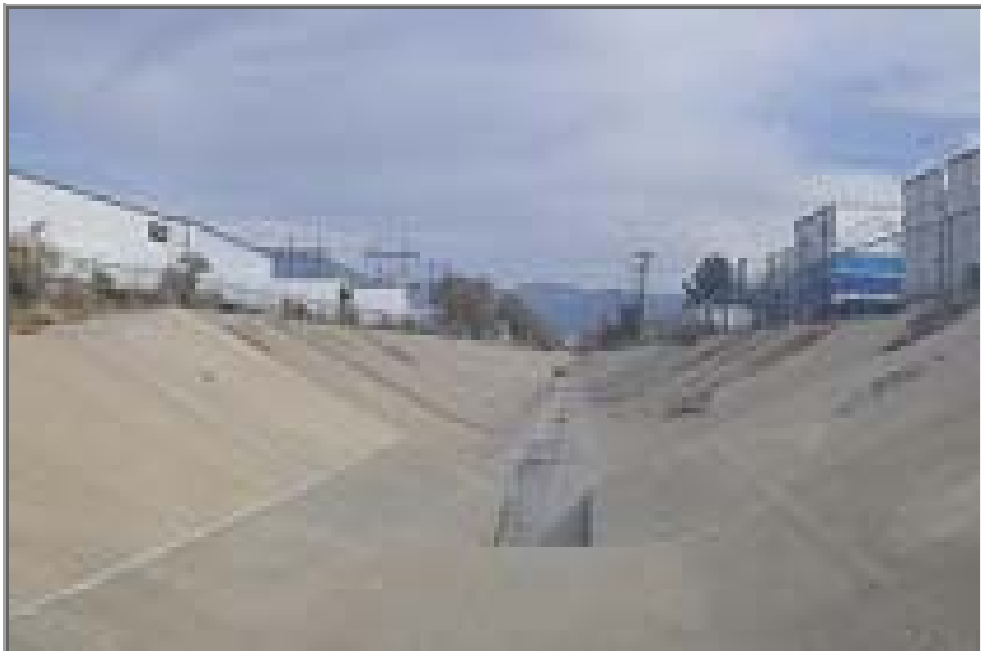
LOCATION **NORTH PINO ARROYO AT TIBURON NE**

OUTFALL\_NO **13** QUAD **NE** GRID **D-17** SAMPLED

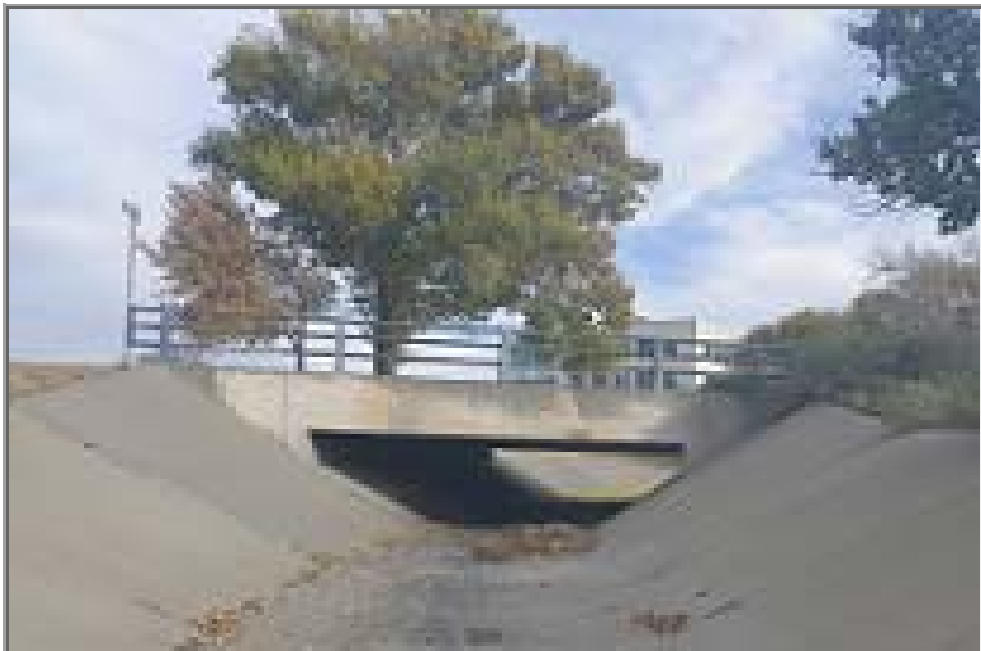
LOCATION **SOUTH DOMINGO BACA ARROYO AT WASHINGTON NE**

OUTFALL\_NO **14** QUAD **NE** GRID **C-17** SAMPLED

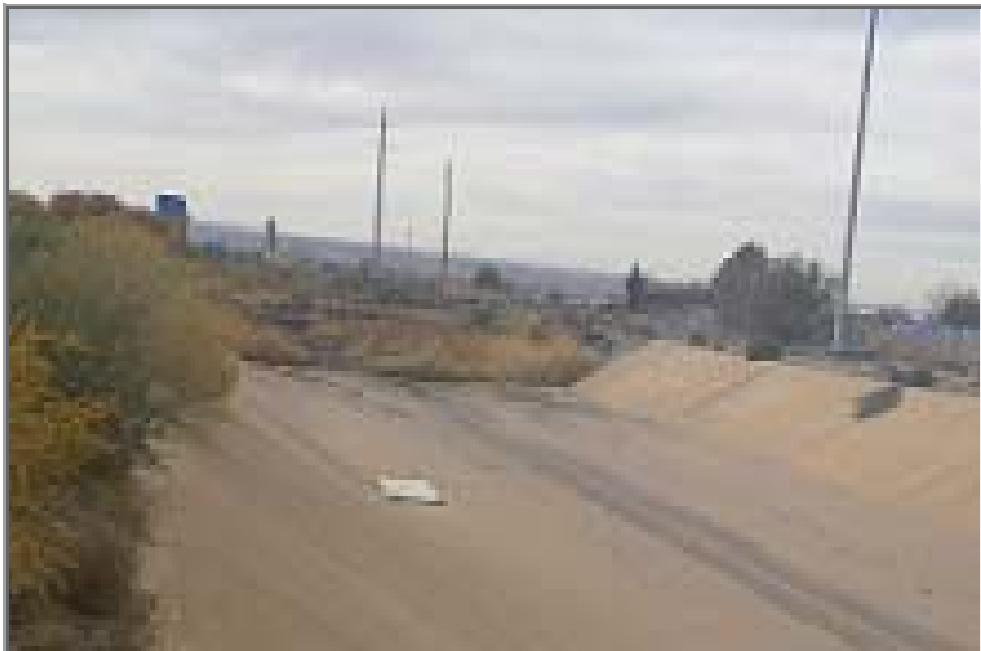
LOCATION **AMOLE DEL NORTE CHANNEL AT BLAKE SW**

OUTFALL\_NO **15** QUAD **SW** GRID **N-10** SAMPLED

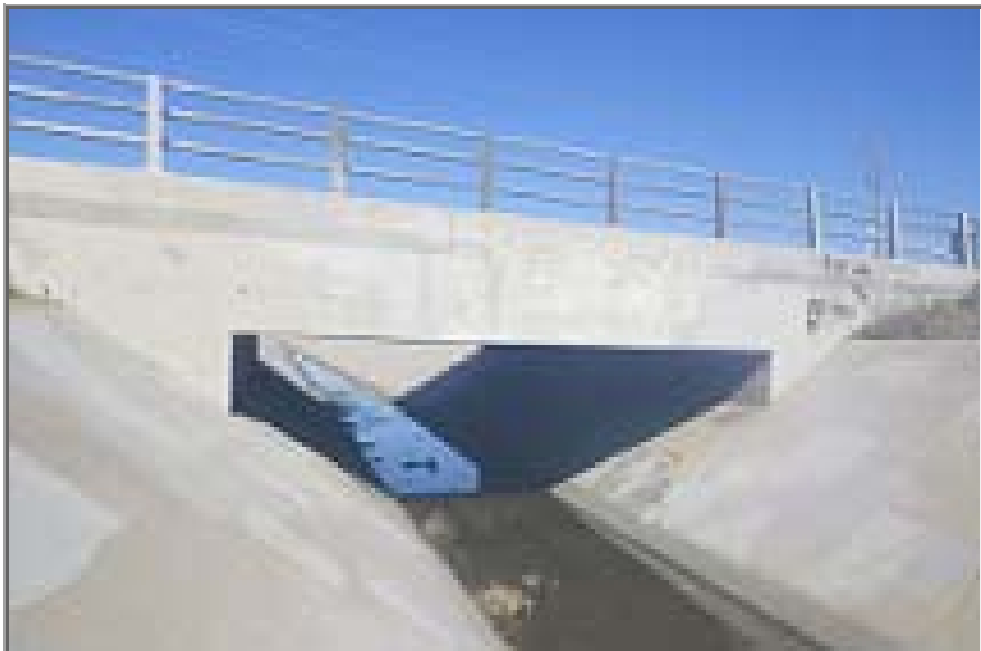
LOCATION **WEST BLUFF NW OUTFALL AT RIO GRANDE AT I-40**  
 OUTFALL\_NO **16** QUAD **NW** GRID **H-11** SAMPLED   
 DATE\_INSP **11/16/2022** TIME **3:20** Inspected by **SK**  
 WEATHER **CLOUDY** flow **NO** FLOW\_GPM **0**  
 APPEARANCE **na** GROSS POLLUTANT **na**  
 Source of Flow **na**

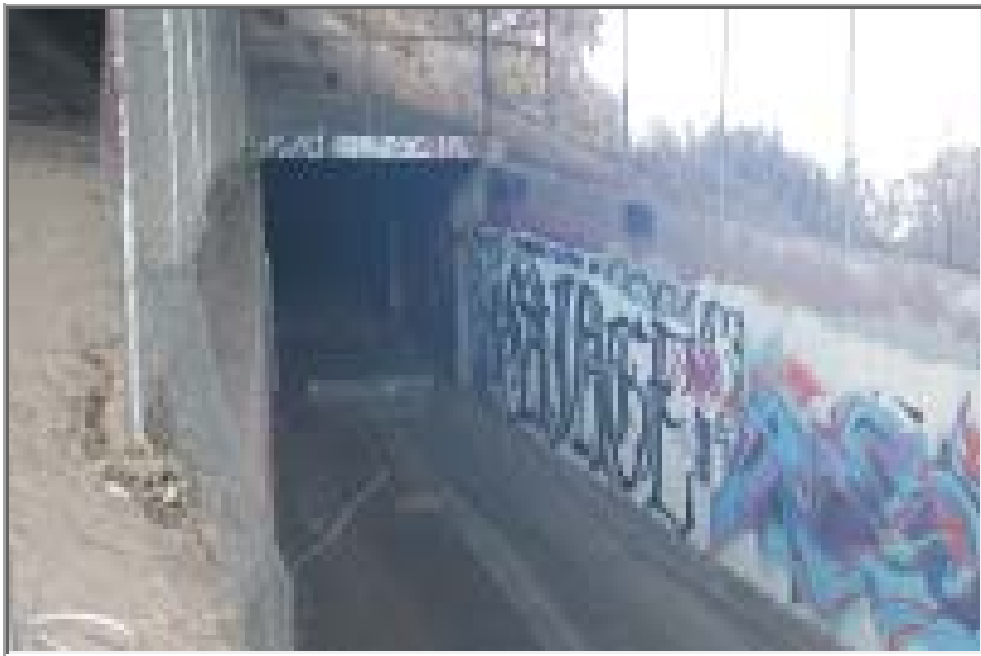
LOCATION **SNOW VISTA ARROYO AT DE VARGAS SW**

OUTFALL\_NO **17** QUAD **SW** GRID **M-09** SAMPLED

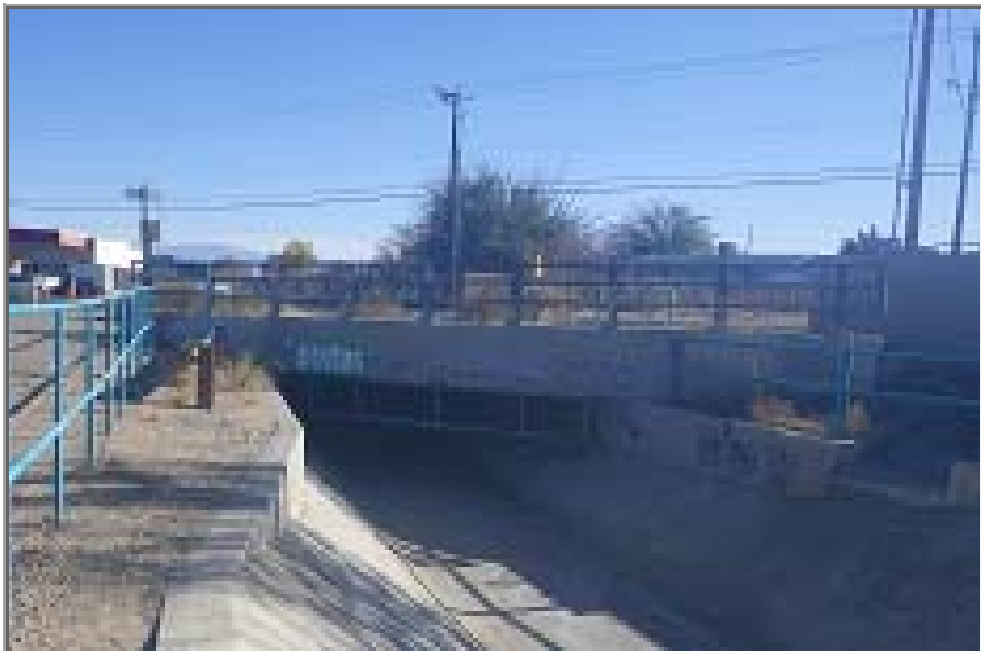
LOCATION **MONTANO EAST OF COORS NW**

OUTFALL\_NO **18** QUAD **NW** GRID **E-12** SAMPLED

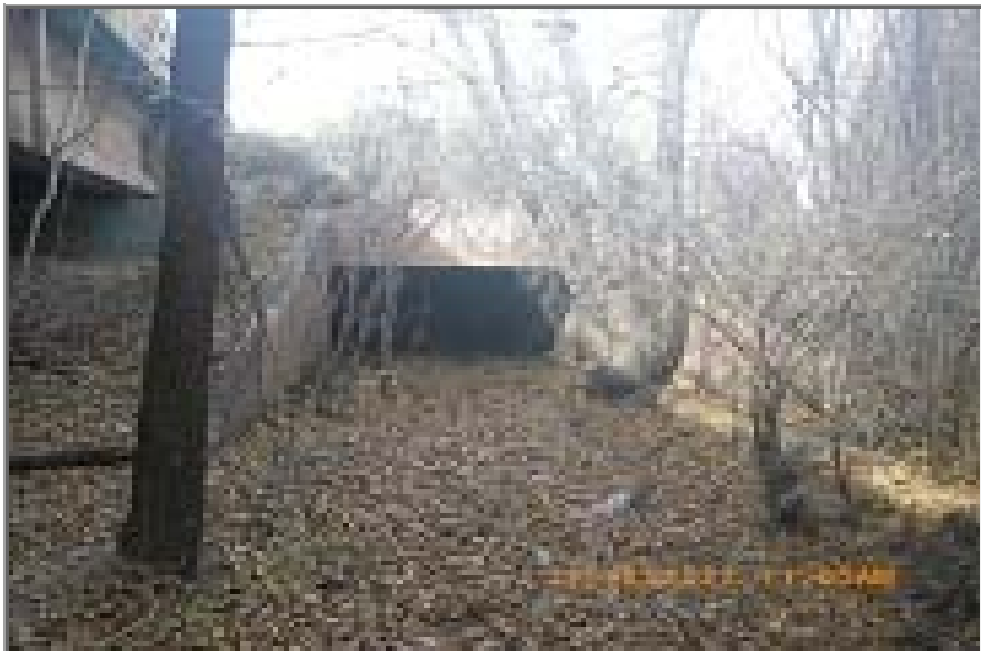
LOCATION **MONTANO NW PS-47 WEST OF RIO GRANDE BLVD**  
 OUTFALL\_NO **19** QUAD **NW** GRID **F-12** SAMPLED   
 DATE\_INSP **11/30/2022** TIME **11:40** Inspected by **SK**  
 WEATHER **SUNNY** flow **NO** FLOW\_GPM **0**  
 APPEARANCE **na** GROSS POLLUTANT **na**  
 Source of Flow **na**

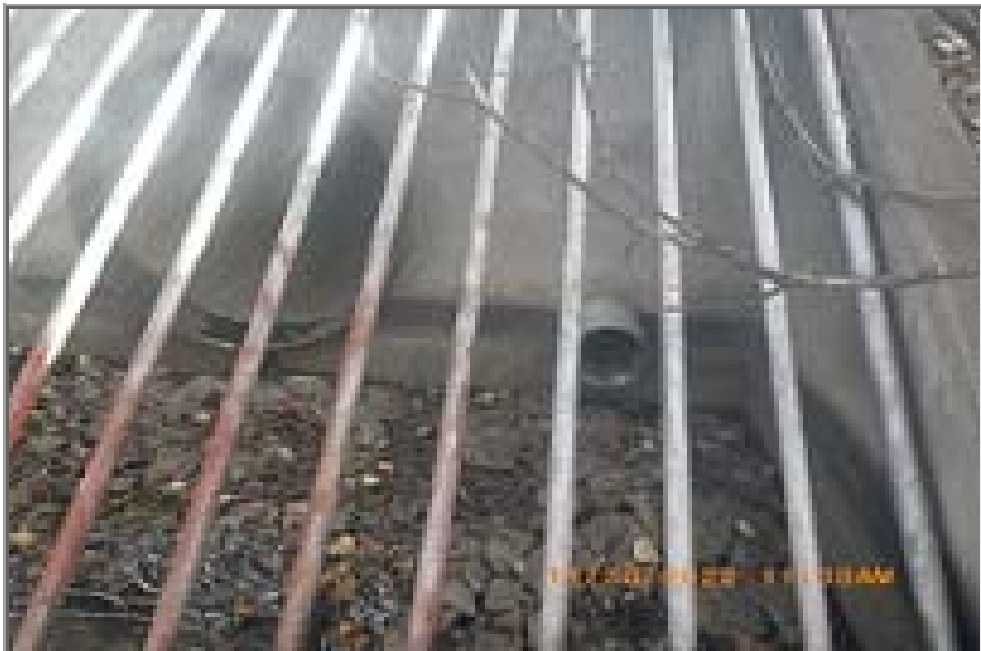
LOCATION **CANDELARIA NW PS-40 AT RIO GRANDE**

OUTFALL\_NO **20** QUAD **NW** GRID **G-12** SAMPLED

Source of Flow **groundwater infiltration**

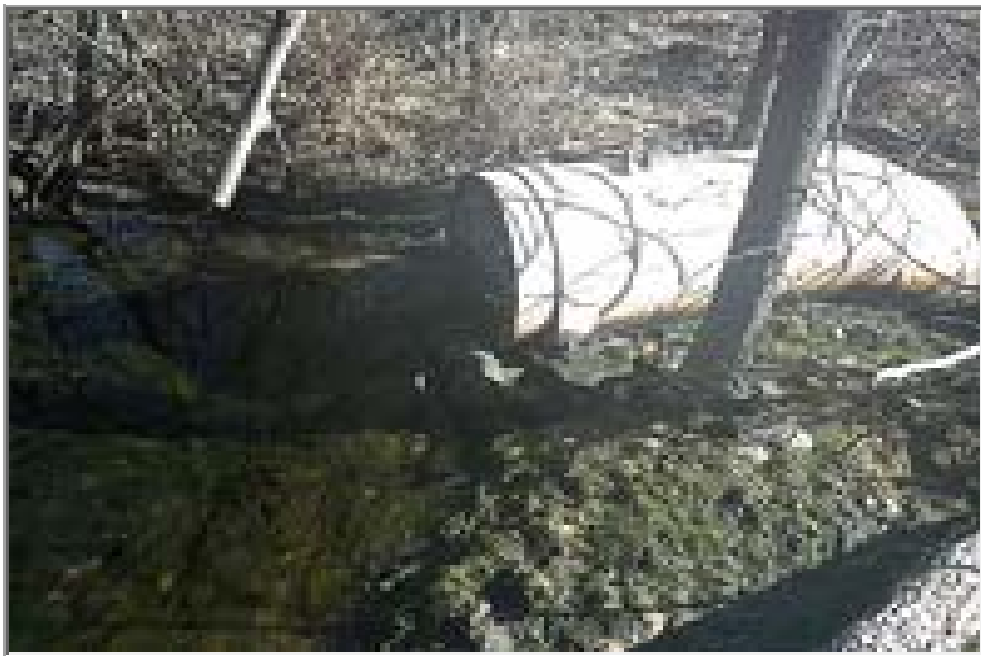
LOCATION **NAMASTE AND COORS NW**

AIR_TEMP_F	38	Lab	HALL ENVIRONMENTAL
WATER_TEMP_F	40	Lab_Report	2301A03
pH	8.16	E_coli_Coliform_mpn/100ml	127.4
CONDUCTIVITY_Umos/cm	470	Ammonia_mg/l	<1
BOD_mg/l	5.0	Nitrite_NO2_mg/l	<0.1
COD_mg/l	<20	Nitrate_NO3_mg/l	<0.1
TSS_mg/l	<4	TKN_Tot_Kjeld_N_mg/l	<1
TDS_mg/l	317	Phosphorus_total_mg/l_P	0.067
N-Hexane Extractable-(Oil_Grease)_mg/l	<10	Hardness_mg/l_CaCO3	170
Fluoride_mg/l	0.36	Chlorine_mg/l	<0.05

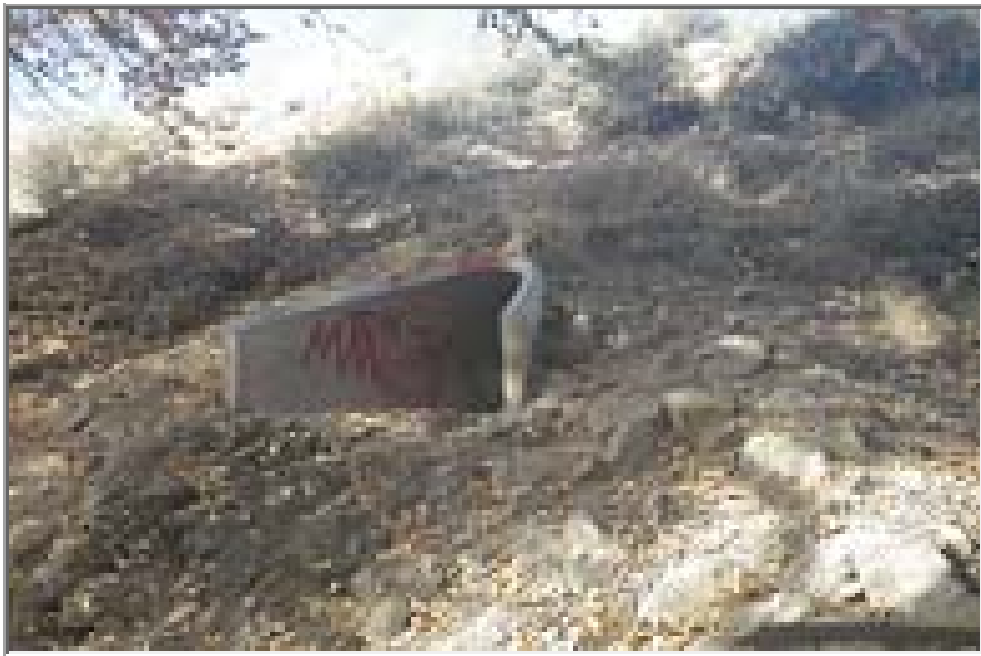
LOCATION **SNOW GOOSE AT OXBOW BLUFF NW**

OUTFALL\_NO **22** QUAD **NW** GRID **G-11** SAMPLED

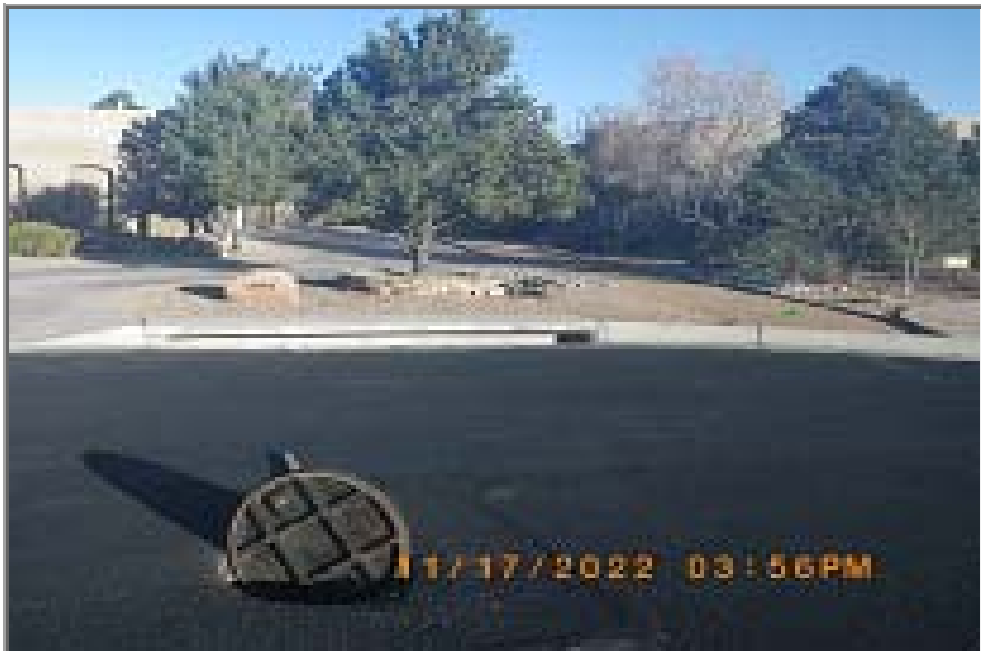
LOCATION **SEQUOIA NW AT RIO GRANDE**

OUTFALL\_NO **23** QUAD **NW** GRID **G-11** SAMPLED

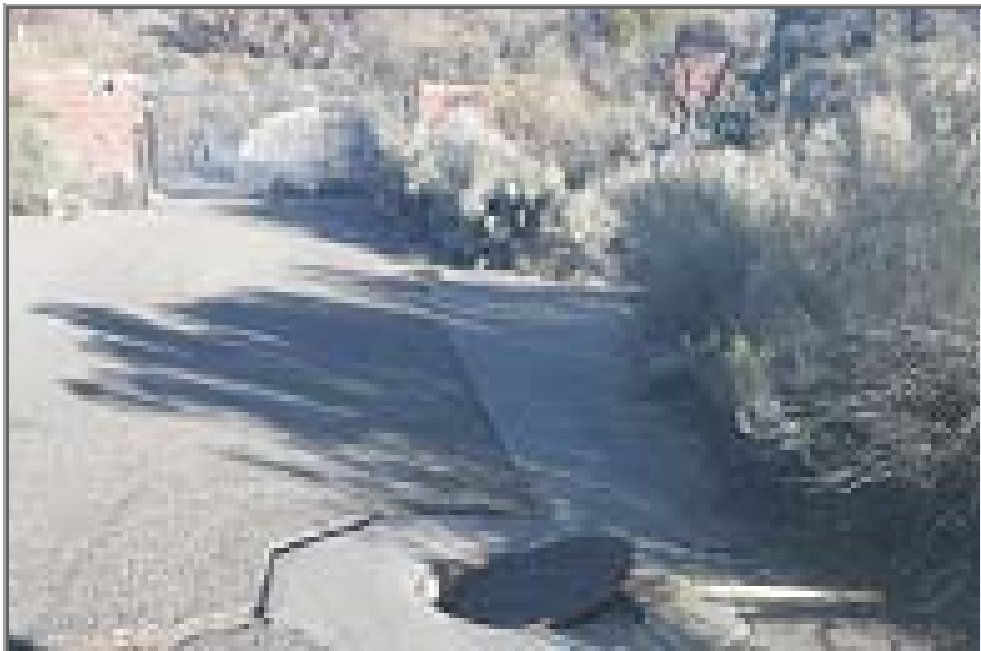
LOCATION **REDLANDS - GRANDE VISTA NW**

OUTFALL\_NO **24** QUAD **NW** GRID **G-12** SAMPLED

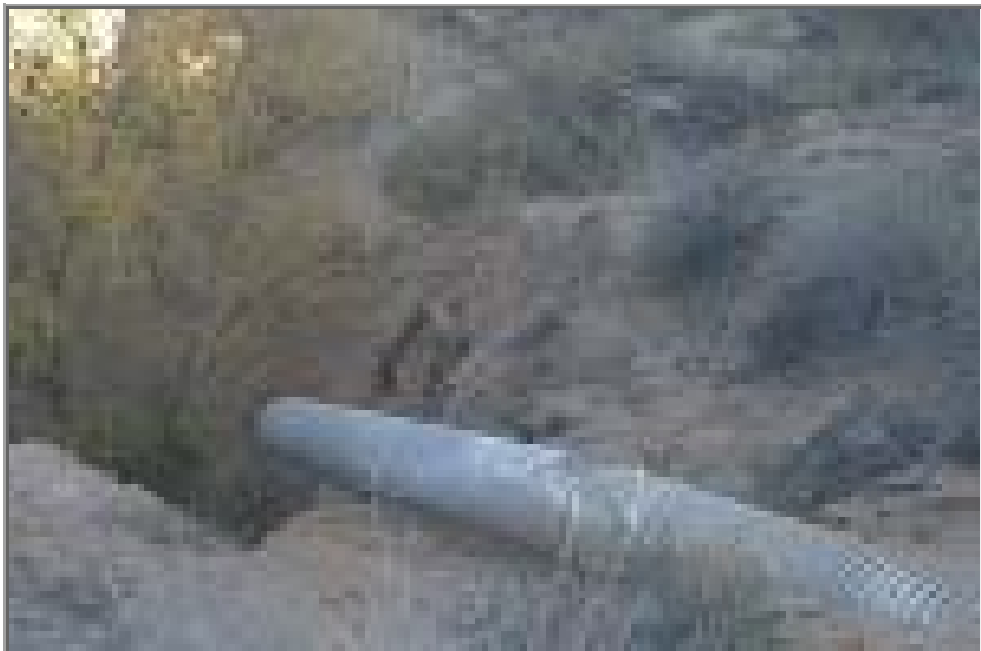
LOCATION	<b>PASEO DEL REY - OURAY - VISTA GRANDE NW</b>						
OUTFALL_NO	25	QUAD	NW	GRID	H-11	SAMPLED	<input type="checkbox"/>
DATE_INSP	11/17/2022	TIME	10:55	Inspected by	SK		
WEATHER	SUNNY	flow	NO	FLOW_GPM	0		
APPEARANCE	na	GROSS POLLUTANT	na				
Source of Flow	na

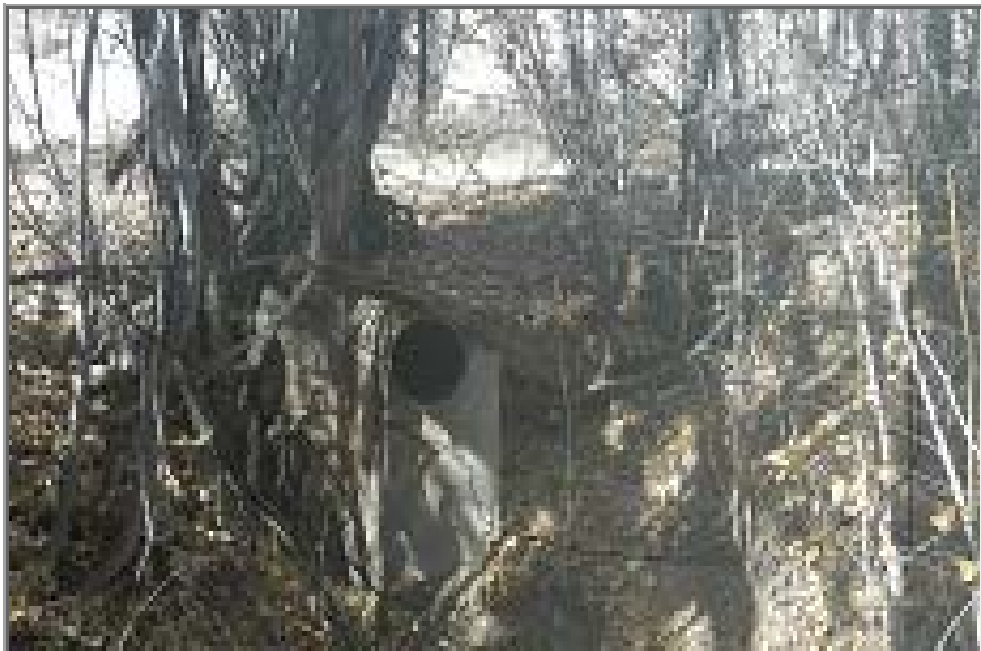
LOCATION **DURANES NW PS AT RIO GRANDE**

OUTFALL\_NO **26** QUAD **NW** GRID **H-12** SAMPLED

Source of Flow **groundwater infiltration and Duranes groundwater pump station at Zickert and Apple N**

AIR_TEMP_F	48	Lab	HALL ENVIRONMENTAL
WATER_TEMP_F	43	Lab_Report	2301542
pH	8.05	E_coli_Coliform_mpn/100ml	238.2
CONDUCTIVITY_Umos/cm	500	Ammonia_mg/l	<1
BOD_mg/l	2.4	Nitrite_NO2_mg/l	<0.5
COD_mg/l	<20	Nitrate_NO3_mg/l	<0.5
TSS_mg/l	18	TKN_Tot_Kjeld_N_mg/l	<1
TDS_mg/l	306	Phosphorus_total_mg/l_P	0.13
N-Hexane Extractable-(Oil_Grease)_mg/l	,9.84	Hardness_mg/l_CaCO3	200
Fluoride_mg/l	0.58	Chlorine_mg/l	<0.05

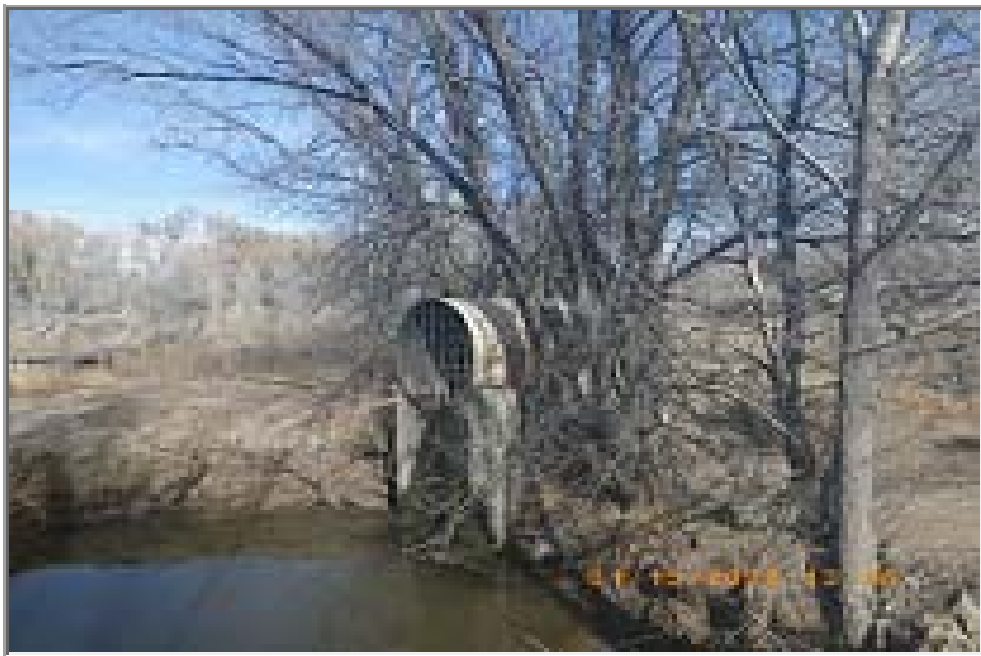
LOCATION **CALLE DEL VISTA-ATRISCO NW**

OUTFALL\_NO **27** QUAD **NW** GRID **H-11** SAMPLED

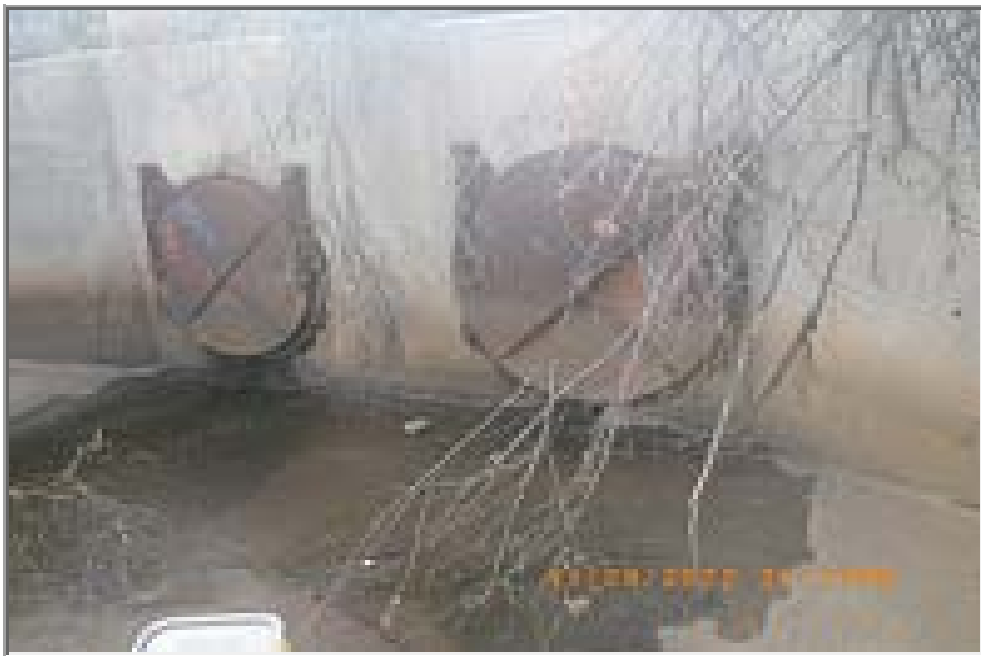
LOCATION **CENTRAL-SUNSET-OSAGE PS-44 THE 36 AND 42 IN PIPES**

AIR_TEMP_F	48	Lab	HALL ENVIRONMENTAL
WATER_TEMP_F	46	Lab_Report	2211D77
pH	8.24	E_coli_Coliform_mpn/100ml	111.8
CONDUCTIVITY_Umos/cm	670	Ammonia_mg/l	<1
BOD_mg/l	<2	Nitrite_NO2_mg/l	<0.1
COD_mg/l	nd	Nitrate_NO3_mg/l	0.2
TSS_mg/l	<4	TKN_Tot_Kjeld_N_mg/l	<1
TDS_mg/l	439	Phosphorus_total_mg/l_P	0.1
N-Hexane Extractable-(Oil_Grease)_mg/l	<9.7	Hardness_mg/l_CaCO3	230
Fluoride_mg/l	0.55	Chlorine_mg/l	<0.05

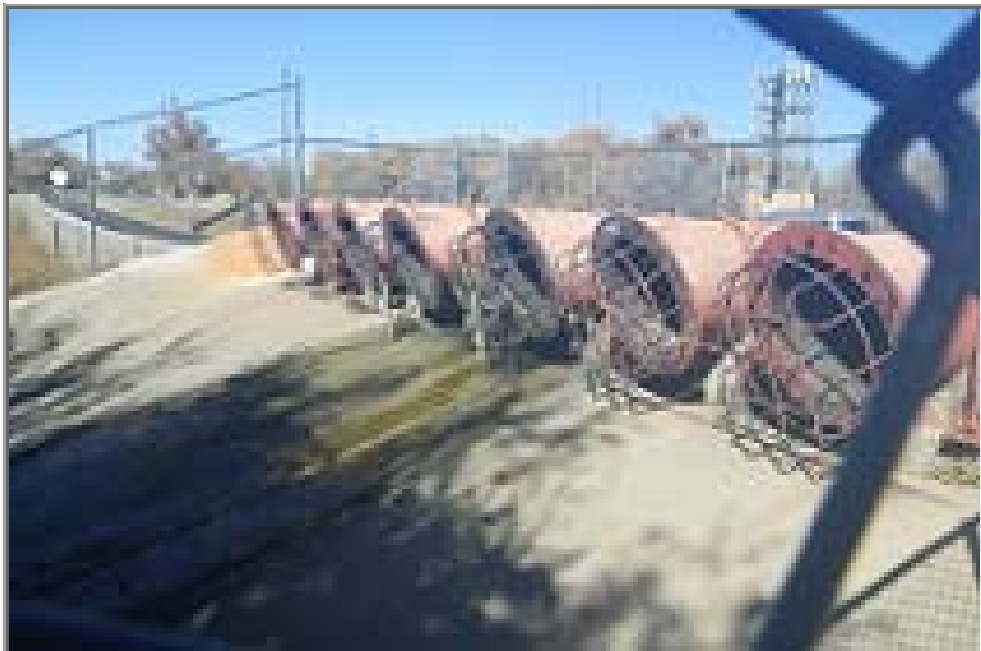
## NDC AT ALAMEDA NE

LOCATION	<b>NDC AT ALAMEDA NE</b>						
OUTFALL_NO	36	QUAD	NE	GRID	C-17	SAMPLED	<input checked="" type="checkbox"/>
DATE_INSP	11/29/2022	TIME	2:00		Inspected by	SK	
WEATHER	SUNNY	flow	YES		FLOW_GPM	15	
APPEARANCE	clear		GROSS POLLUTANT	leaves, papers, plastics			
Source of Flow	Irrigation water and well wash water at Love wells #4 and 8 and Ridge Crest #3 and 4.

AIR_TEMP_F	54	Lab	HALL ENVIRONMENTAL	
WATER_TEMP_F	52	Lab_Report	2211E40	
pH	8.11	E_coli_Coliform_mpn/100ml	21.6	
CONDUCTIVITY_Umos/cm	520	Ammonia_mg/l	<5	
BOD_mg/l	9	Nitrite_NO2_mg/l	<0.5	
COD_mg/l	45.4	Nitrate_NO3_mg/l	<0.5	
TSS_mg/l	<4	TKN_Tot_Kjeld_N_mg/l	<5	
TDS_mg/l	354	Phosphorus_total_mg/l_P	0.07	
N-Hexane Extractable-(Oil_Grease)_mg/l	<9.8	Hardness_mg/l_CaCO3	180	
Fluoride_mg/l	0.67	Chlorine_mg/l	<0.05

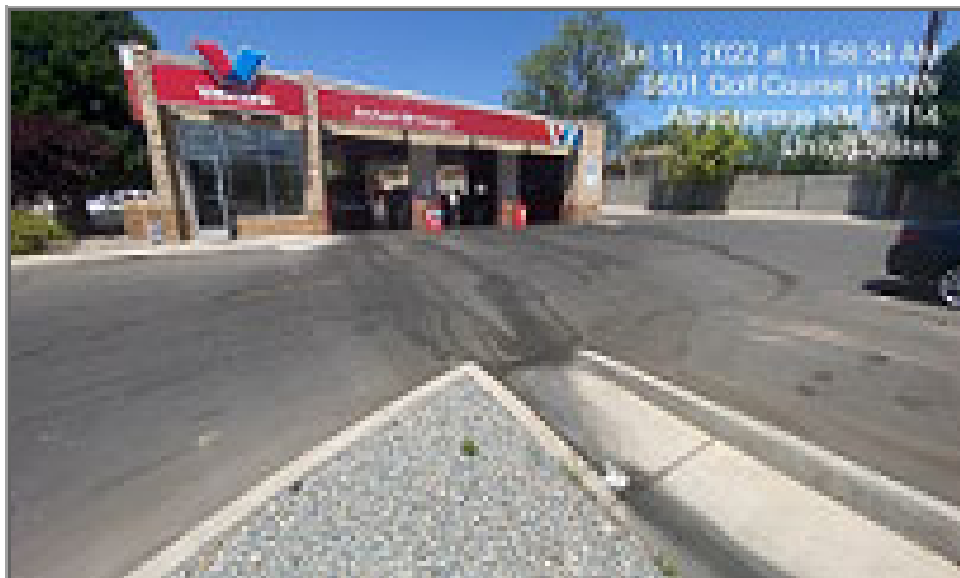
THE DRY BROWN RESIDUE WAS VISIBLE ALONG THE GUTTER. THE OWNER STATED THAT THE BROWN STAIN IS THE CHEMICAL THAT A CLEANING COMPANY USED TO CLEAN UP THE OIL ON THE DRIVE PAD.

INSPECTOR GAVE HIM POLLUTION PREVENTION BROCHURES AND ASKED THEM TO STOP DISCHARGING ANY LIQUID TO THE STREET.

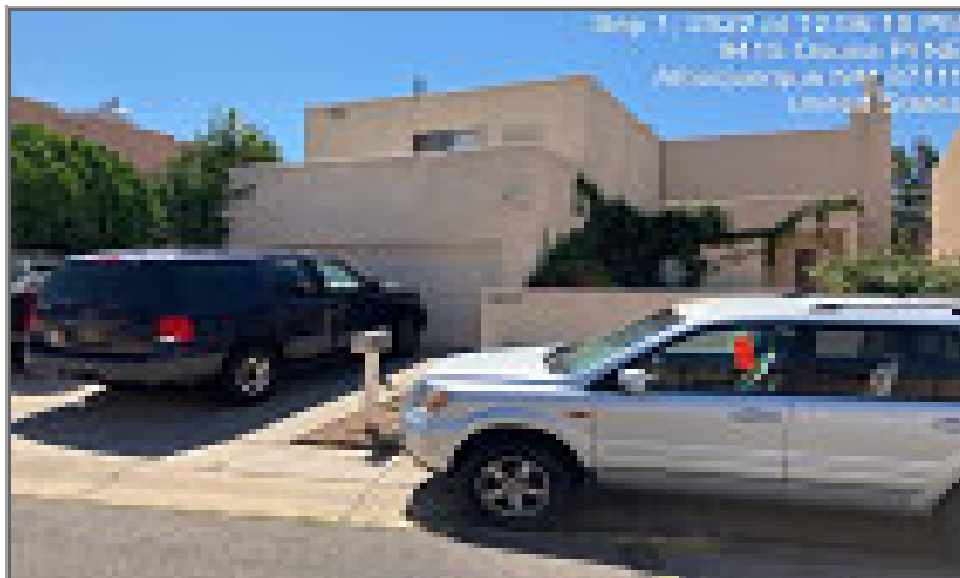
ABANDONED CAR LEAKING BRAKE FLUID

APD RED TAGGED THE CAR. INSPECTOR COVERED THE OIL SPOTS WITH ABSORBENT

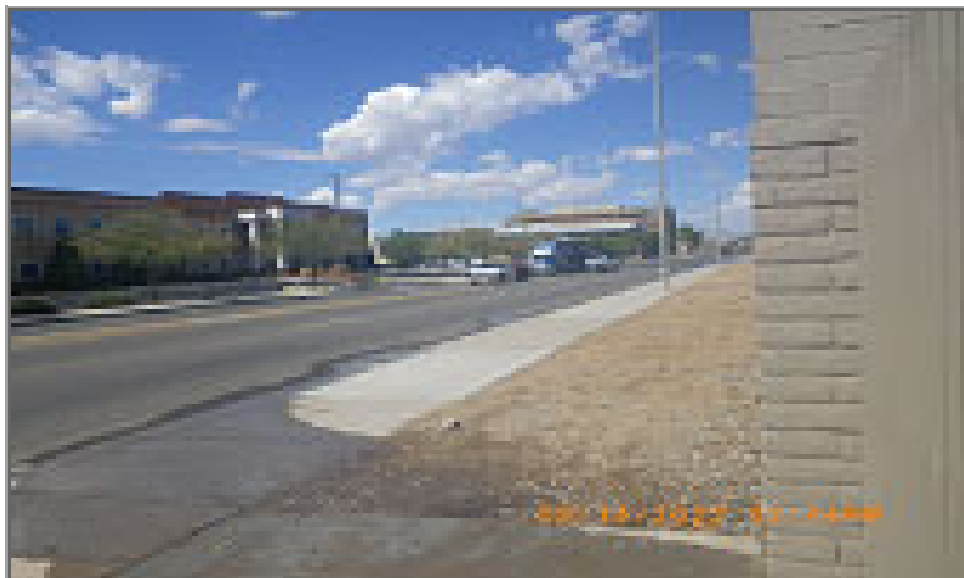
IT WAS A BROKEN WATER PIPES

THE MANAGER IS IN THE PROCESS OF REPAIRING THE BROKEN WATER LINE

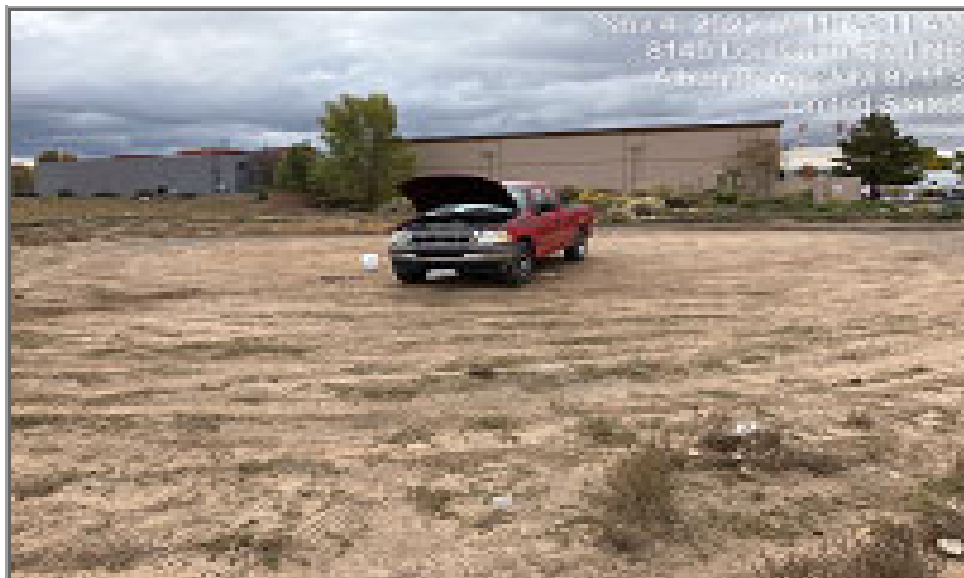
THERE WAS A BROKEN DOWN TRUCK IN THE MIDDLE OF THE VACANT LOT WITH THE TRANSMISSION AND DRIVE TRAIN LAYING ON THE GROUND.

INSPECTOR GAVE THE TRUCK OWNER SOME POLLUTION PREVENTION BROCHURES.
