# Annual Report Format

## National Pollutant Discharge Elimination System Stormwater Program MS4 Annual Report Format

NMR04A014 City of Albuquerque

What is the reporting period for this report? (mm/dd/yyyy) From Jul 1, 2022 to Jun 30, 2023

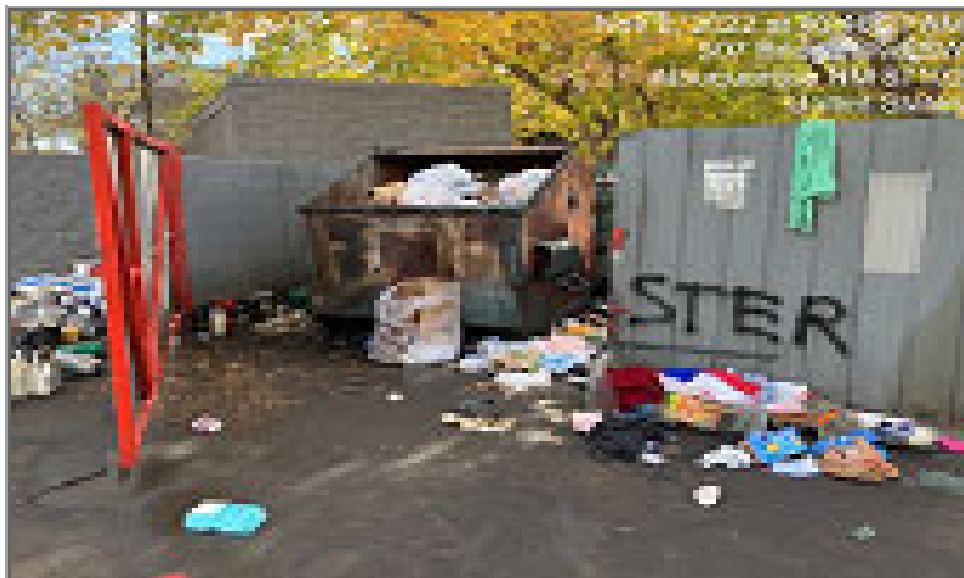
AT THE TRASH BIN SIDE OF THE TRSH BIN APPROXIMATELY 30 CONTAINERS OF USED ANTIFREEZE AND USED OIL GALLON CONTAINERS THAT ARE LEAKING

THE MANAGER SAID THAT THEY WILL CLEAN IT UP.

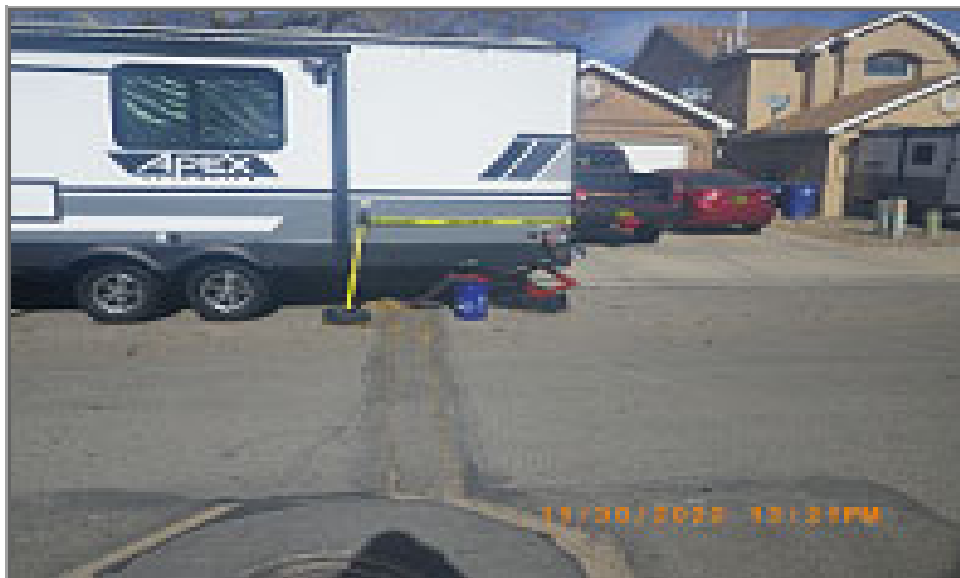
9004 SUNFISH SW

THERE WAS A PIPE COMING OUT FROM RV TO STORM INLET.NO DISCHARGE OBSERVED

I SPOKE TO THE RESIDENT AND HE TOLD ME THAT HE PUT THE PIPE TO PROTECT FROM FREEZING AND HE NEVER DUMPED ANY THING TO STORM DRAIN. HE DID REMOVE THE PIPE

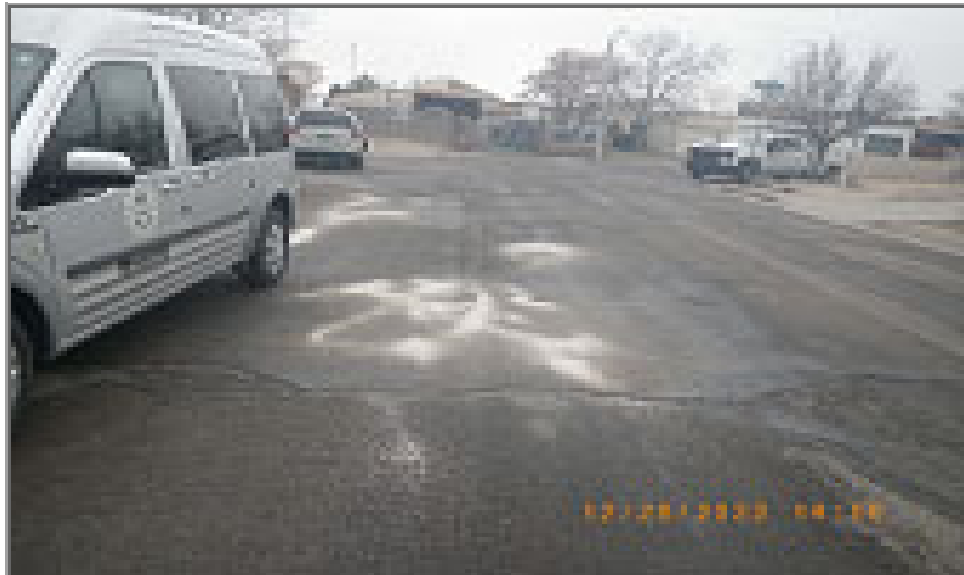
10212 MCKNIGHT NE

THERE WAS A BROKEN CAR CAUSED OIL SPILL AROUND THIS AREA

I COVERED THE SPOTS WITH ABSORBENT AND DISTRIBUTED POLLUTION PREVENTION BROCHURES

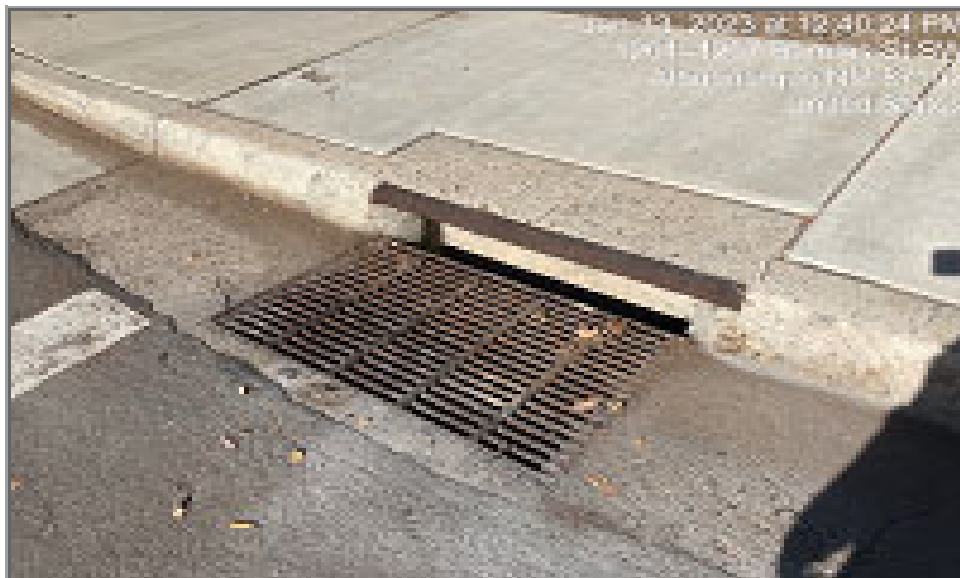
**CEDAR BETWEEN COAL AND HAZELDINE SE**

THERE WAS EVIDENCE OF BURNT LEAVES BEING THROWN INTO THE SW INLET

THE RESIDENT DENIED THROWING THE ASHES INTO THE INLET, BUT HE CLEANRD UP THE REMAINING ASHES. INSPECTOR DISTRIBUTED EDUCATIONAL MATERIAL AT THIS AREA.

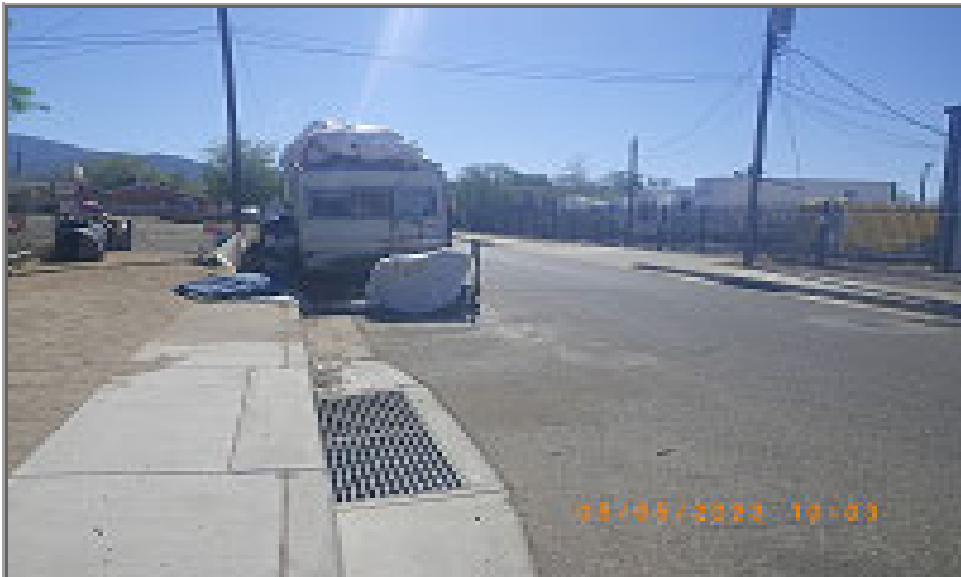
CLAREMONT AND BROADWAY POND

IT WAS A BROKEN RV, NO SEWAGE HAS BEEN DUMPED

COVERD THE AREA AROUND STORM INLET WITH OIL ABSORBENT AND GLUED NO DUMP SIGN ON THE ILETS NEAR BY. ALSO LEFT EDUCATIONAL MATERIAL WITH RV OWNER.

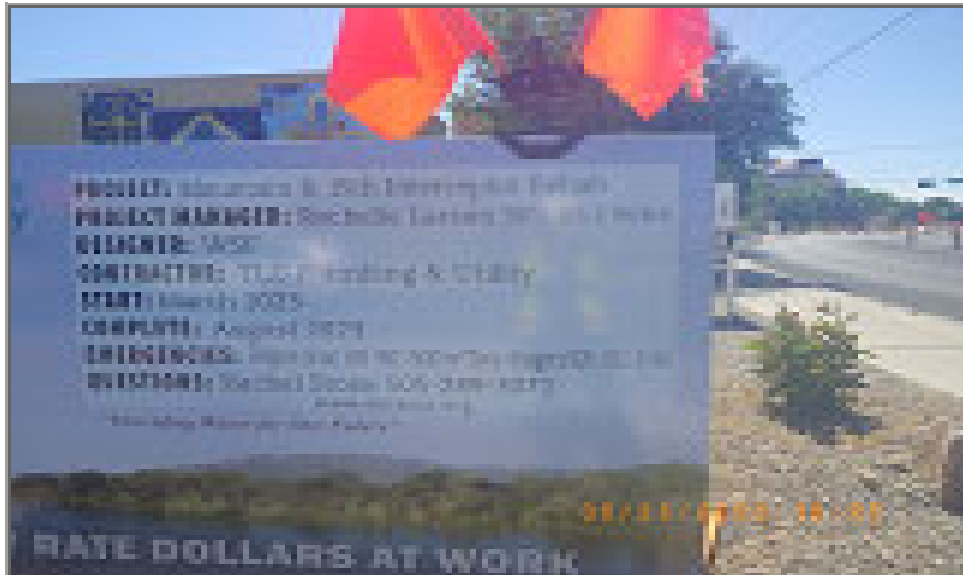
RELEASE OF RAW SEWAGE FROM THE CITY SEWER PIPELINE. THE CAUSE OF RELEASE IS DUE TO WORK THAT IS BEING DONE

THERE WAS A BIG PROJECT FOR REPLACEMENT OF SANITARY SEWER ALONG THIS STREET CAUSING STRONG SMELL. THERE WAS NO SEWAGE SPILL TO THE STREET.

ASKED THE CONTRACTOR TO PROTECT STORM INLETS CLOSE TO THE TRENCH.
