City of Albuquerque Elementary & Middle School Crossing Evaluation

Executive Summary

The Department of Municipal Development (DMD) studied over 350 crossing locations for elementary and middle schools within the City limits. Twenty-four data points were collected for each location, and then a two-step process was used to calculate a crossing score and a crossing rating for each. The first step used a graph to determine if the crossing had sufficient traffic operations infrastructure, such as signs and striping, flashing beacons, or a traffic signal. That determination, combined with an assessment of other factors, such as the quality of the pedestrian facilities and the presence of traffic calming, resulted in the rating. The rating was divided into six (6) categories:

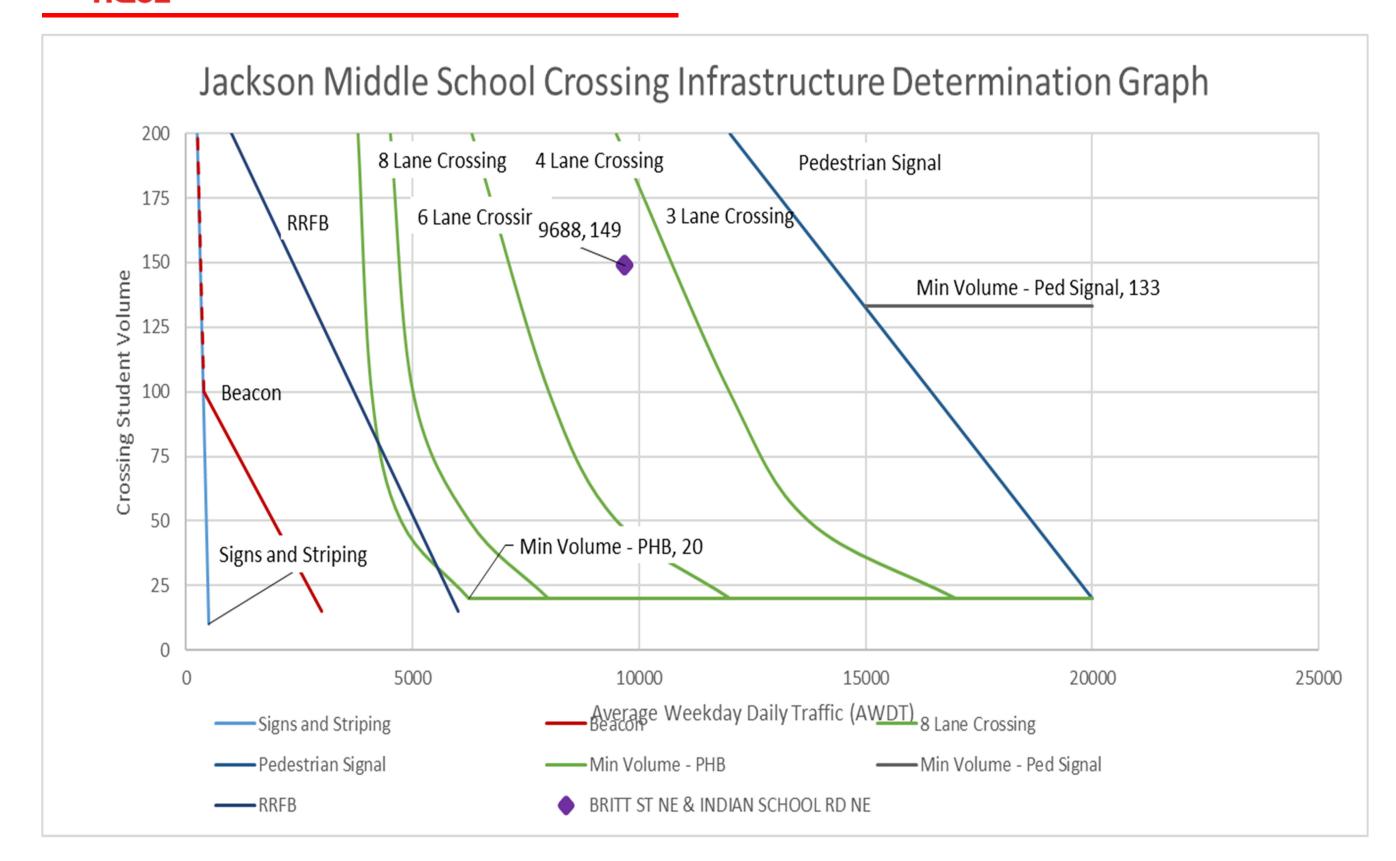
This graph shows the one crossing for Jackson Middle School. It is located at the intersection of Indian School Rd NE and Britt St NE. Indian School carries 9688 vehicles per day, and 149 students used it on the count day. The point is plotted on the graph using the traffic volume as the x-value (9688 vehicles per day) and the pedestrian volume (149 students) as the y-value.

There are eight lines on the graph, representing five types of infrastructure: signs and striping, flashing beacons, RRFBs, PHBs, and traffic signals. There are four lines for the PHBs for different length crossings. A longer crossing requires fewer motor vehicles and pedestrians to meet the warrant for installation. The warrant lines for the PHBs and traffic signals are taken from the graphs presented in the MUTCD.

Any equipment lines to the left of the crossing point indicate the desired infrastructure for the crossing. In this case, lines for signs and striping, flashing beacons, and RRFBs lie to the left of the point, as do warrant lines for a PHB for an eight-lane crossing, a six-lane crossing, and a four-lane crossing. Indian School is a three-lane road in this section, and the warrant line for a PHB on a three-lane road lies to the right of the point, so the crossing does not warrant a PHB.

Jackson Middle School – Indian School Rd NE and Britt St NE

- Primary deficiency: Additional infrastructure desired.
- Other deficiencies identified: None.
- Recommended remedy: Install RRFBs (\$30K).
