***BERNALILLO COUNTY SAFETY
STUDY FOR CENTRAL AVE***
Eubank Blvd to Juan Tabo Blvd

Bernalillo County Safety for East Central Ave Safety Study: Eubank Blvd to Juan Tabo Blvd

February 2021

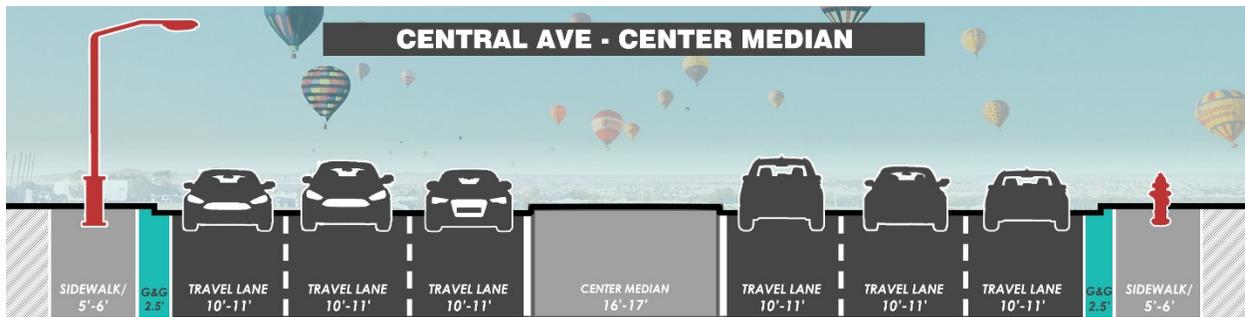
Figure 1: Typical Section from Eubank Blvd to Juan Tabo Blvd with Center Median

Central Ave through the study area features three lanes in each direction plus a median/center turn lane. Lane widths vary slightly but are generally 10-11 feet. The roadway was resurfaced in 2020 and is in excellent condition, as of this writing.

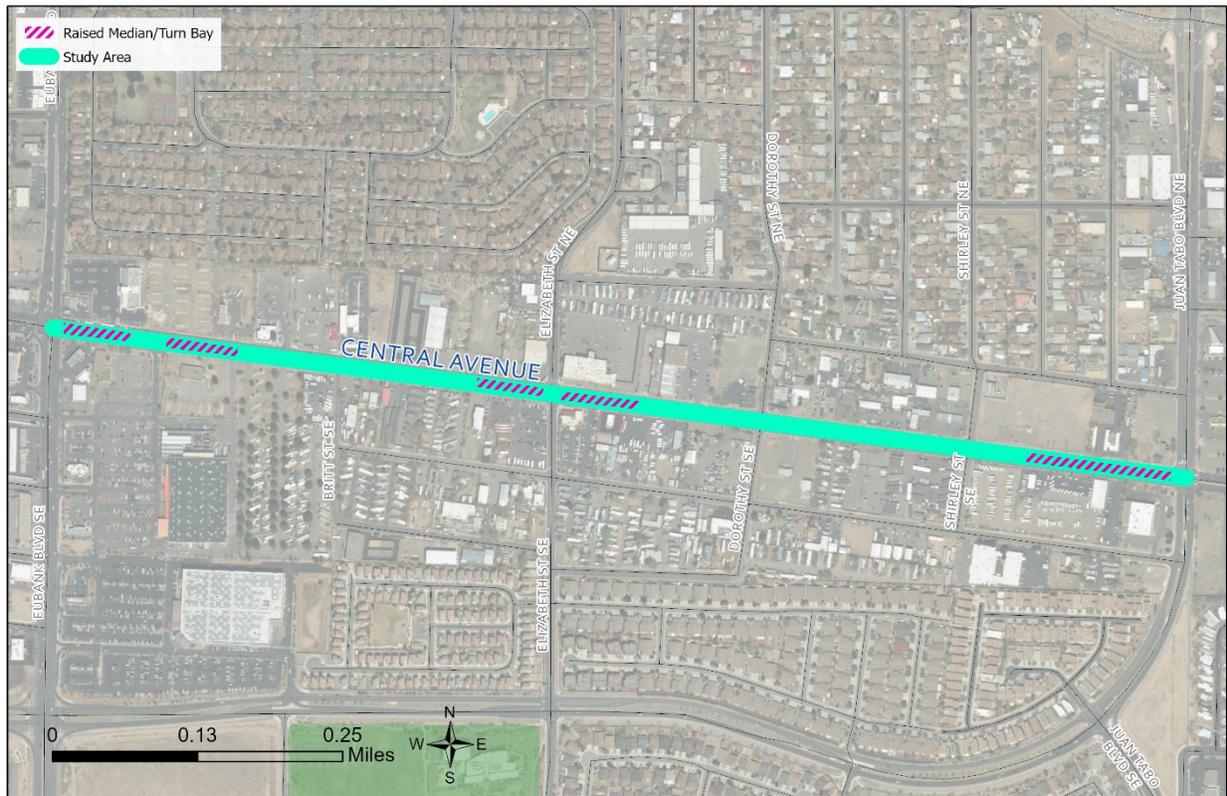
Figure 3: Raised Medians/Turn Bays

Central Ave through the study area features a combination of two-way left turn lanes and raised medians/turn bays, which are primarily concentrated around signalized intersections. An additional median and left turn bay is present east of Eubank Blvd that allows vehicles traveling westbound on Central Ave to access the Home Depot and Costco shopping center. Overall, areas with raised medians/turn bays comprise about 0.38 miles of the study area while two-way left turn lanes are present for 0.62 miles. Raised medians that manage access are a proven safety countermeasure along major roadways and are strongly preferred over two-way left turn lanes along principal arterials in the DPM (see Section 7-4(I)(7)).

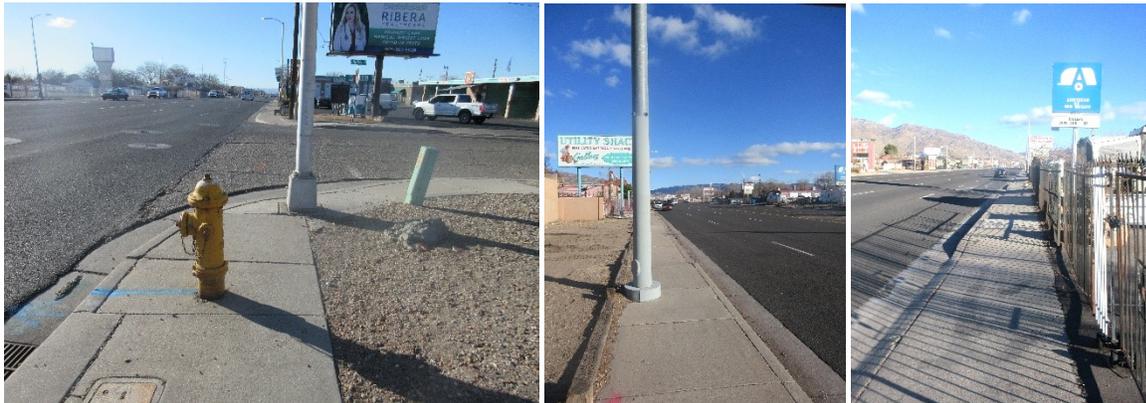
Obstructions and uneven sidewalk surfaces along East Central Ave. Fencing on the outside edge the sidewalk limits the usable area and forces pedestrians to walk closer to the roadway edge.

In addition to the lack of separation between motorists and pedestrians, light poles and fire hydrants create regular sidewalk obstructions along the entirety of the corridor. These obstructions reduce the usable sidewalk width available and can create unsafe conditions for users. Obstructions would need to be addressed with passing spaces, sidewalk expansion, or relocation. Other less frequent obstructions along the corridor include bus stop benches and signs. Figure 5 indicates obstructions along Central Ave.

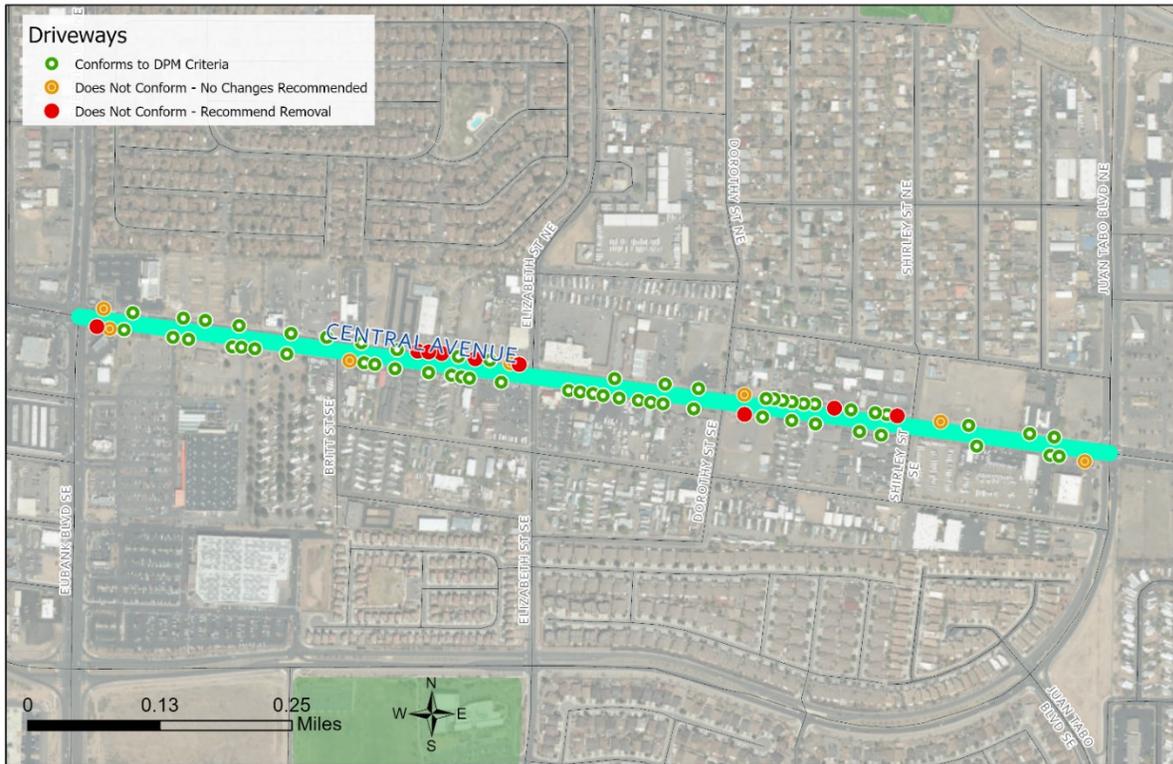
Figure 4: Driveways through the Study Area

Another major impediment to pedestrian travel along the corridor is the presence of driveways and curb cuts that enable vehicle turning movements and create uneven sidewalk conditions. Preliminary analysis identified 74 driveways along the study area, including multiple driveway access points for many individual properties (see Figure 4). Of the identified driveways, approximately 23.0% would be in violation of the location criteria established in the DPM for minimum distances from intersections if the owners of these properties were to apply for a permit for site and building improvements. In some cases, driveways have been closed off through gates or other barriers. While these driveways are no longer an issue for pedestrians in terms of conflicts with motor vehicles, the fences create uncomfortable walking conditions by creating a physical barrier on one side of the sidewalk while vehicles travel at high speeds on the opposite side of the sidewalk.

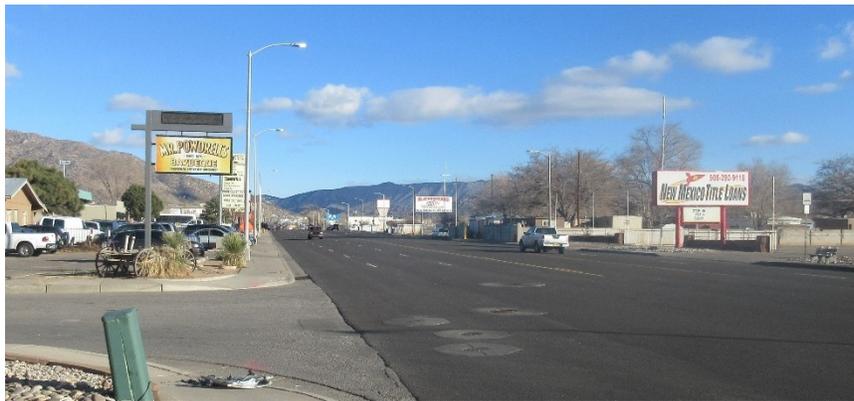
Lighting throughout the corridor has an average maintained illuminance greater than the minimum design value outlined in the AASHTO Roadway Lighting Design Guide and has recently been updated to LED to meet the new City standard. However, current lighting patterns, featuring luminaires located on the outside edge of the sidewalk in each direction, are focused on creating visibility for moving traffic and lack pedestrian scale lighting at locations where pedestrians are often present. Light poles are generally spaced about 130-180 feet apart.

Roadway lighting near Central Ave and Dorothy St

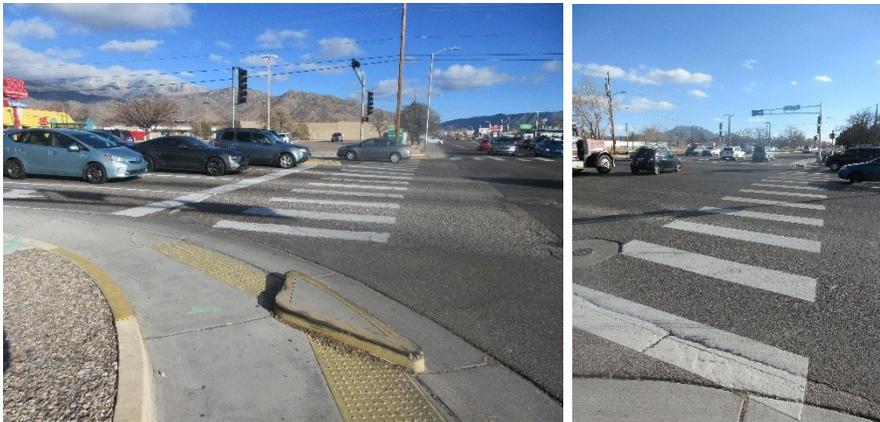
Figure 7: Crosswalk Design at Juan Tabo Blvd and Central Ave

Crosswalks are push-button activated, and the pedestrian walk signal is not automatically triggered with each light cycle. The pedestrian crossing times meet MUTCD requirements.

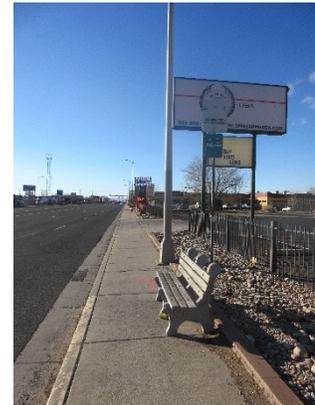
Central Ave is served by two high frequency transit lines; Route 66 provides local service and stops every two blocks, while the ART Green Line (Route 777) is a bus rapid transit service with stops at Eubank Blvd and Juan Tabo Blvd. Both routes operate with a frequency of every 15-minutes (pre-COVID) and serve the extent of Central Ave from Tramway Blvd to Unser Blvd. Service for both routes spans from around 6 AM to around 11 or 12 PM depending on the day of the week. In addition to the service along Central Ave, all-day local routes operate north-south along Eubank Blvd (Route 2) and Juan Tabo Blvd (Route 1).

Transit activity along the corridor is concentrated heavily around Juan Tabo Blvd and Eubank Blvd, with about 5,000 and 8,000 combined trips associated with both Central Ave transit routes at those intersections, respectively. In addition to ART stops, these intersections also serve as transfer points for north-south routes.

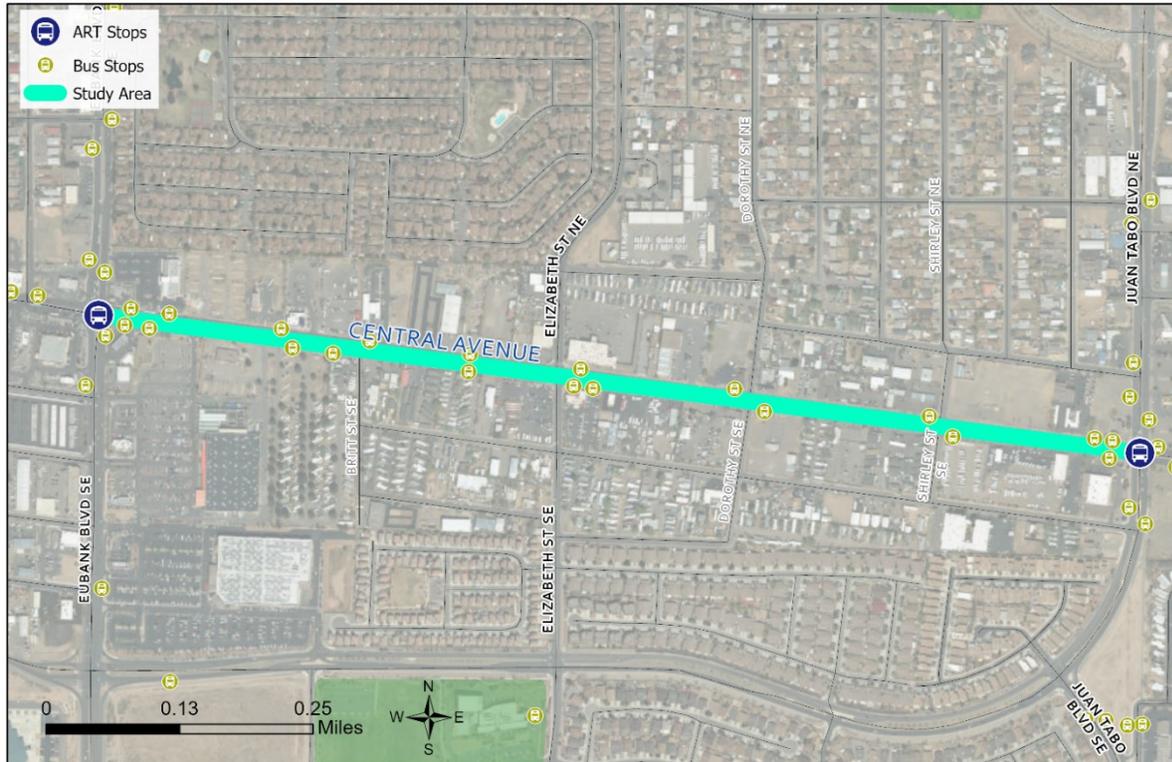
Figure 8: Transit Stops through Study Area

Most transit stops along the corridor feature signs and benches only. Shelters are present at in the westbound direction to the east of Eubank Blvd, near Elizabeth St, near Britt St, and west of Juan Tabo Blvd. The only shelter provided in the eastbound direction is located near Elizabeth St. Guidance from the DPM calls for shelters to be present at all stops along Major Transit Corridors and Premium Transit Corridors.

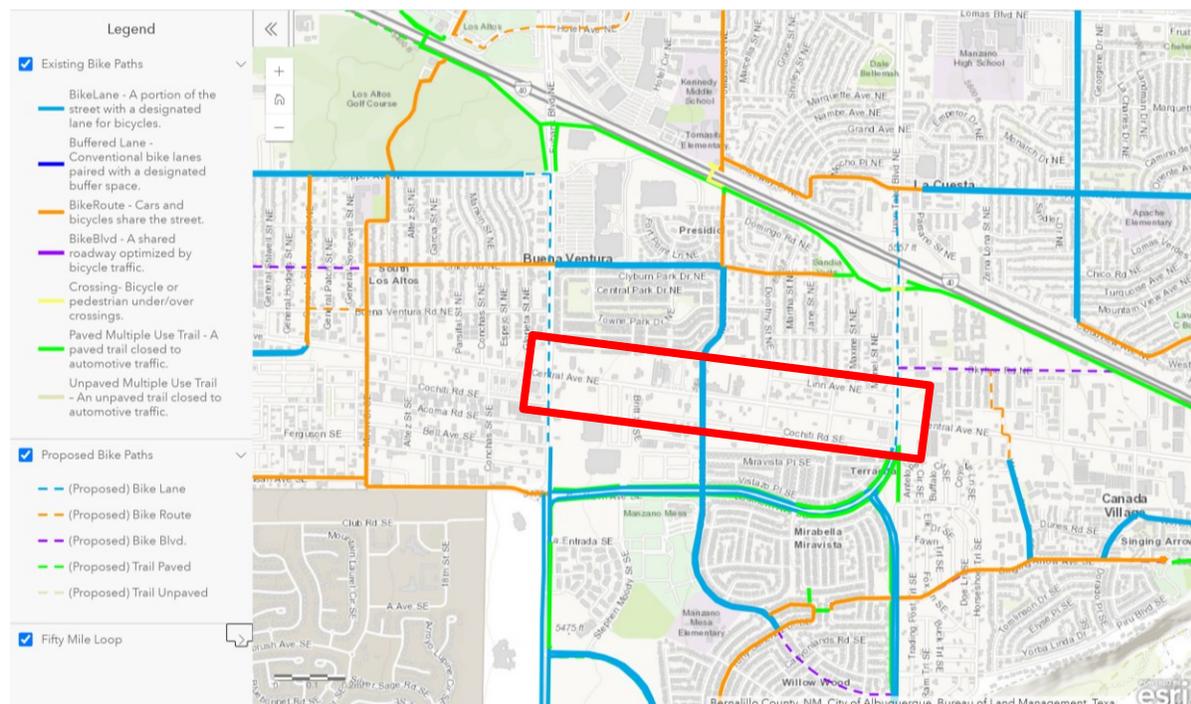
Figure 9: Existing and Proposed Bicycle Facilities near Study Area

Bikeway facilities are present on parallel roadways, though connections across the study area are generally limited. Chico Rd to the north of Central Ave is a designated bike route where cars and bicyclists share the roadway. The bike route connects with the I-40 Trail East and provides access to the greater Albuquerque area. Bike lanes and a paved multi-use trail are present along Southern Rd to the south of Central Ave between Eubank Blvd and Juan Tabo Blvd. Elizabeth Rd/Morris Rd is a key connection to both sets of parallel bikeways. However, longer distance connections are limited, and options are generally limited for bicyclists and pedestrians to use alternative routes adjacent to Central Ave to travel east-west and access nearby destinations. Where options do exist, such as Cochiti Rd to the south of Central Ave, connectivity is limited by the major shopping plaza to the southeast of Eubank Blvd and Central Ave.

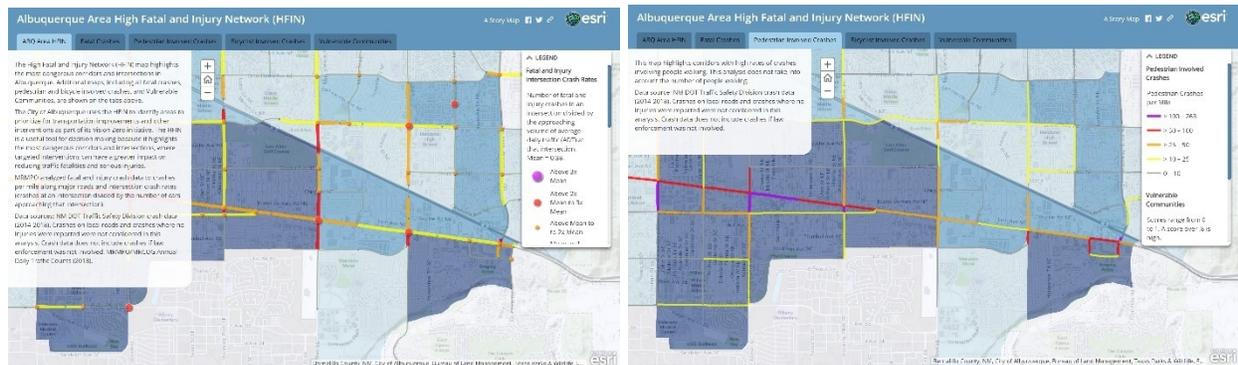
Figure 10: High Fatality and Injury Network and High Crash Rate Network (MRCOG)

The individual intersections along Central Ave with the highest number of crashes from 2013 to 2017 are Eubank Blvd and Juan Tabo Blvd; about 83% of all crashes in the study area took place at these two intersections. The concentration of crashes at these locations are due to high number of conflict points when high volume multi-lane arterials intersect. More pedestrians are also present at these intersections due to the presence of high-volume transit stops and signalized pedestrian crossings.

The intersection at Eubank Blvd is of particular concern as it has a high number of severe crashes (n=86) and overall crashes (n=307). Between 2013 and 2017 there were also eight pedestrian-involved crashes. The primary causes of crashes at Eubank Blvd include driver inattention, driver error, and failure to yield, reflecting the conflicts associated with turning movements. Though fewer overall crashes took place at Juan Tabo Blvd compared to Eubank Blvd, Juan Tabo Blvd experienced a significant number of severe crashes (n=64) and had equal or higher numbers of pedestrian (n=8) and bicycle-involved crashes (n=3) than Eubank Blvd. Among fatal crashes, one occurred at Britt St and one occurred at Juan Tabo Blvd.

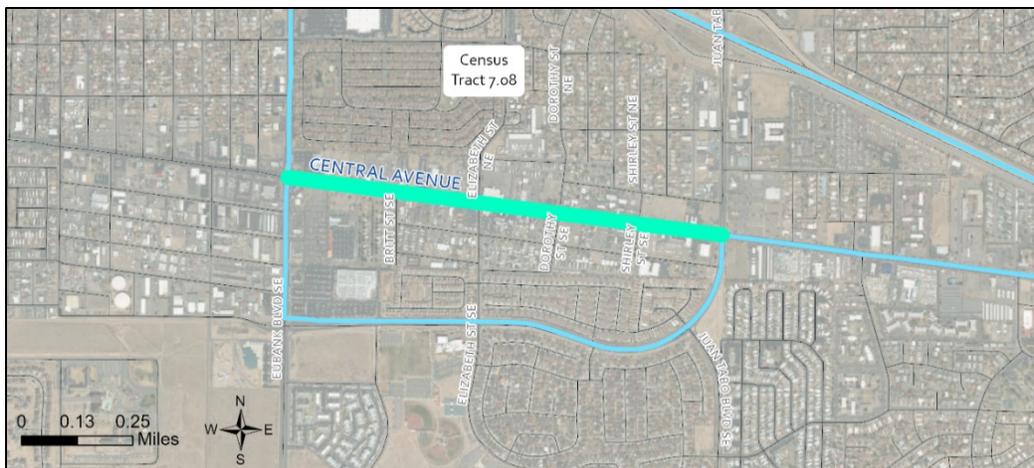
Figure 13: Location of Census Tract 7.08

Demographic and socioeconomic analysis for the study area is based on data from the American Community Survey (2014-2018 5-year estimates) for Census Tract 7.08, which encompasses neighborhoods north and south of Central Ave to the east of Eubank Blvd. The tables below compare conditions in the study area to the City of Albuquerque and Bernalillo County overall.

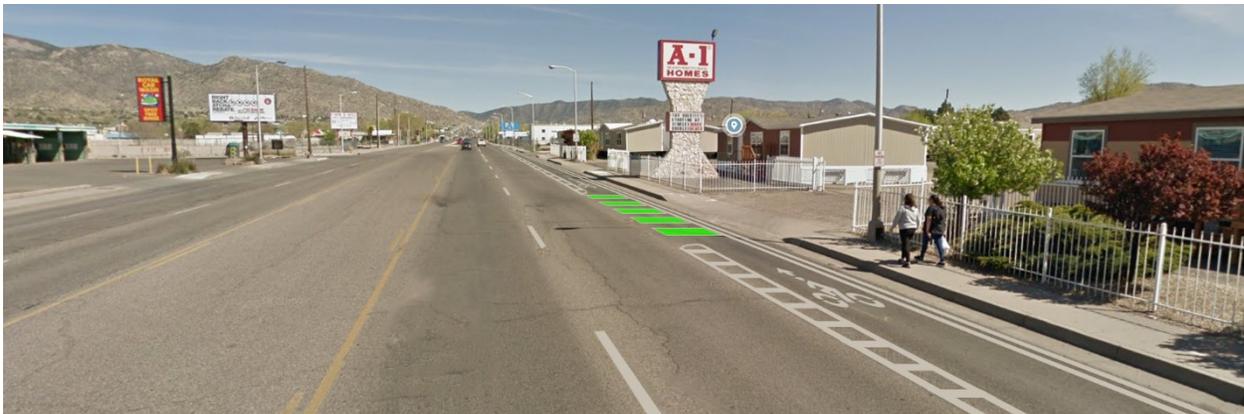
Figure 19: Road Diet Concept Through Re-Striping

Overall, removal of the outside travel lane and narrowing of the two way left turn lane could result in 10-12' of space for bicycle and pedestrian facilities in each direction. A road diet through restriping could also be complemented with raised medians with turn bays in place of the two-way left turn lane. Median refuges with vertical barriers should be installed at regular intervals to create additional pedestrian crossing opportunities. A concept for a road diet through restriping can be found in Figure 19.

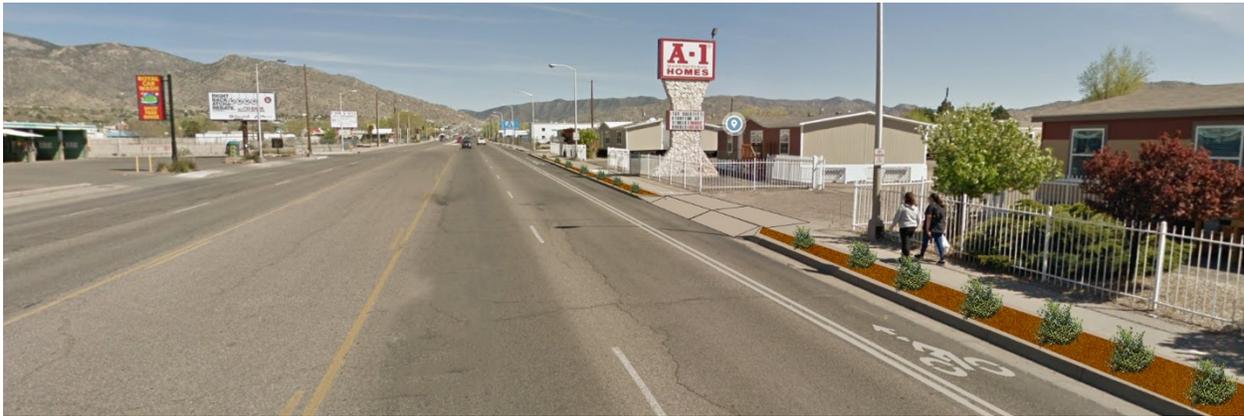
Figure 20: Road Diet with Reconstructed Sidewalks

A far more costly, though more permanent and comprehensive approach would be to install a road diet as part of a corridor rehabilitation and reconfiguration project. Such a project would permanently remove one travel lane in each direction and would provide an opportunity to reconstruct sidewalks, address uneven surfaces, and remove obstructions.

The reconfiguration of the corridor as part of a road diet also creates a meaningful opportunity to introduce landscaping along the corridor. In addition to community aesthetics – some stakeholders cited a need for landscaping due to the lack of green space along the corridor – landscaping trees can provide shade along the sidewalk and enhance pedestrian comfort levels by creating physical barriers from motor vehicle traffic. Landscaping has also been proven to have traffic calming effects on a roadway.

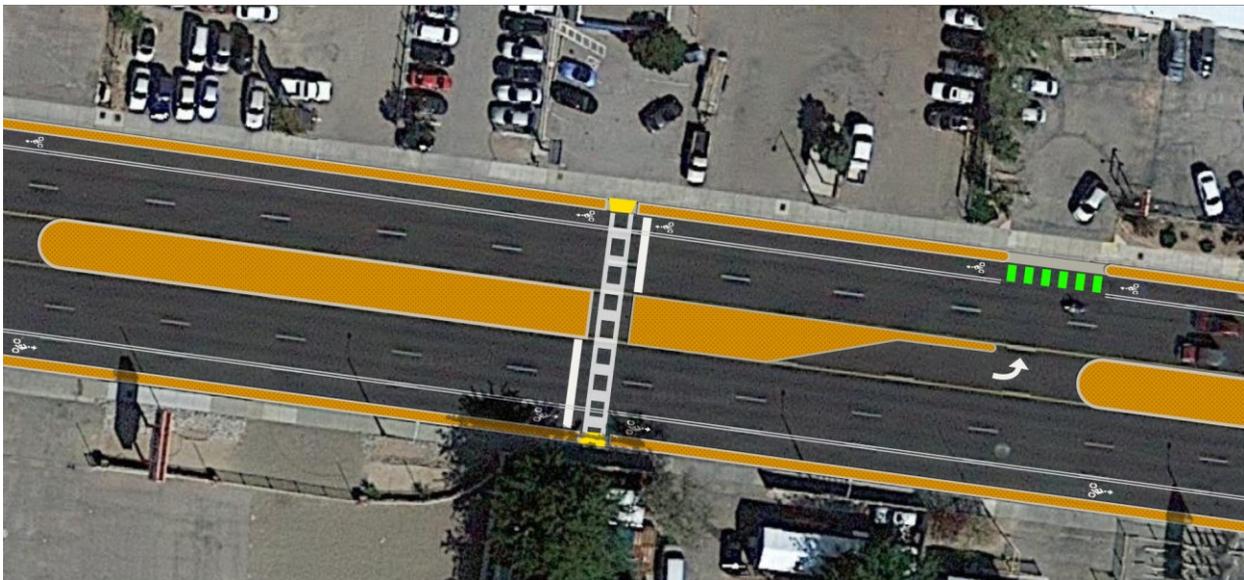
Figure 21: Raised Median Concept with Pedestrian Refuge

Most of the corridor features two-way left-turn lanes in the center of the roadway. As such, there is an opportunity to install medians with appropriate turn bays along the corridor. Such countermeasures are a form of access management that create physical barriers between traffic traveling in opposite directions. In addition to access management, medians with landscaping enhance community aesthetics, as requested by stakeholders during the outreach process for this study. The installation of raised medians would also reduce the number of lanes that individuals must cross at a time and could serve as refuge islands. Per the DPM, raised medians should be a total 14' in width, with 2-4' of raised median used to separate traffic as part of a turn bay. Median refuges should be at least 6' in width.

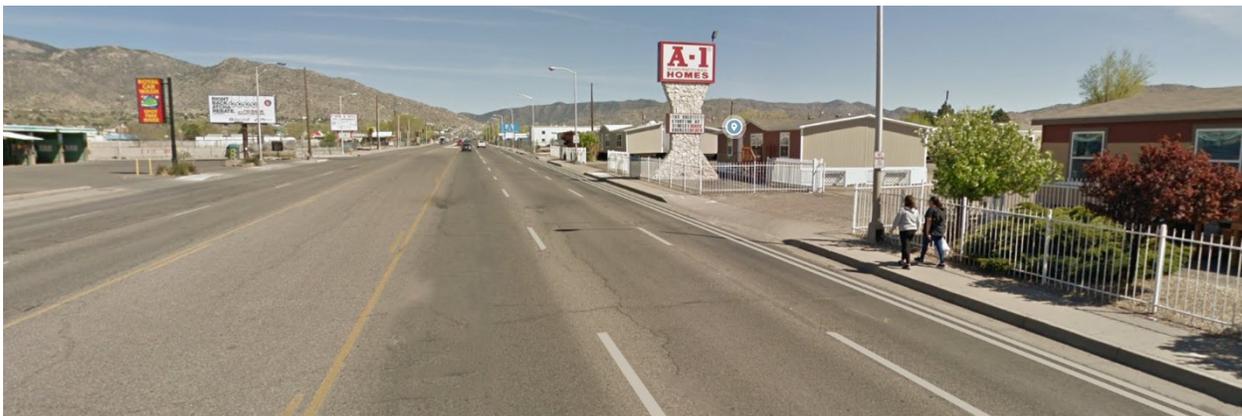
Figure 22: Restriping Concept with Buffer/Shy Lane

The most feasible means of installing a buffer/shy lane is to reallocate space from the two-way left turn lanes to the buffer/shy lane since the turn lanes are excessively wide through the study area (17-18'). It is important to note that two-way left turn lanes are not considered to be appropriate in the DPM for arterials with more than two travel lanes in each direction. (Raised medians are preferred.) However, if existing two-way left turn lanes are to be maintained, the width should be reduced from the current design of 17-18' to a width of 12-14', as indicated in the City's DPM.

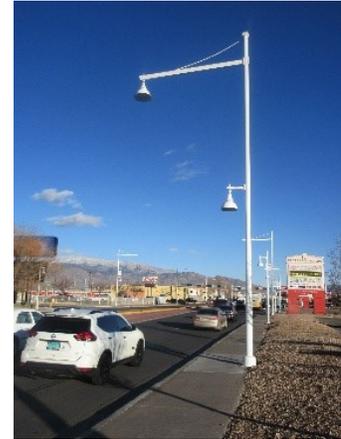
Though the current lighting meets City minimum standards, illumination is designed for roadway users rather than pedestrians. Per the FHWA Toolbox of Countermeasures, enhanced lighting can reduce pedestrian fatality rates and is especially important along corridors with significant pedestrian activity as well as high speeds, which requires greater stopping distance. This study recommends that installation of pedestrian-scale be applied along the length of the corridor. Areas where lighting is particularly critical include areas around transit stops.

Lighting should follow similar design patterns to other portions of Central Ave where pedestrian-scale lighting is present, including the portion of Central Ave to the west of Eubank Blvd where lighting is under design. Pedestrian-scale lighting received a high level of support among business owners and community stakeholders during the outreach efforts for this study and should be considered a high priority.
