Rio Grande Valley State Park,  
Central to Montañó Project:  
Environmental Monitoring Plan and  
Baseline Data Report

Prepared for  
City of Albuquerque

Prepared by  
SWCA Environmental Consultants

October 29, 2014

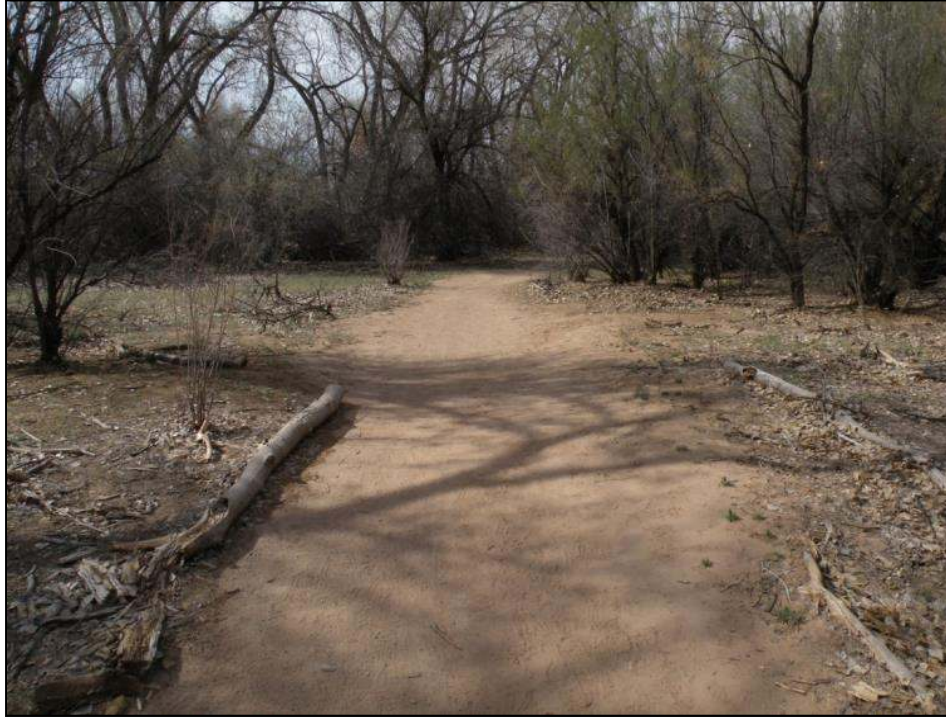
**Figure 1.5. Example of an existing soil-based trail at the Rio Grande Nature Center State Park.**

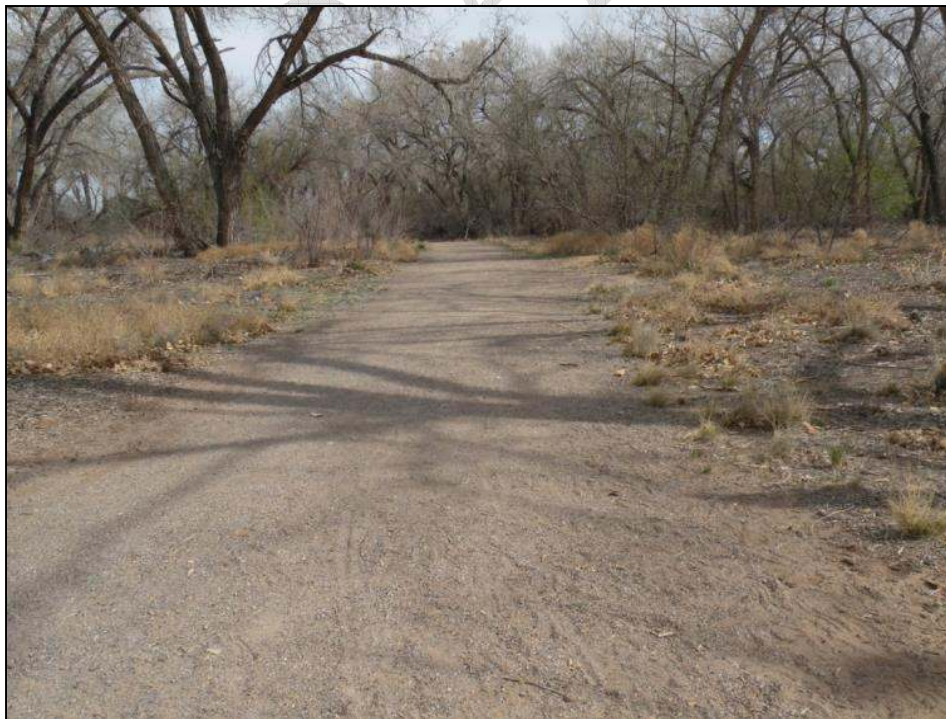
**Figure 1.6. An example of the existing trail with fine-crush rock at the Rio Grande Nature Center State Park.**

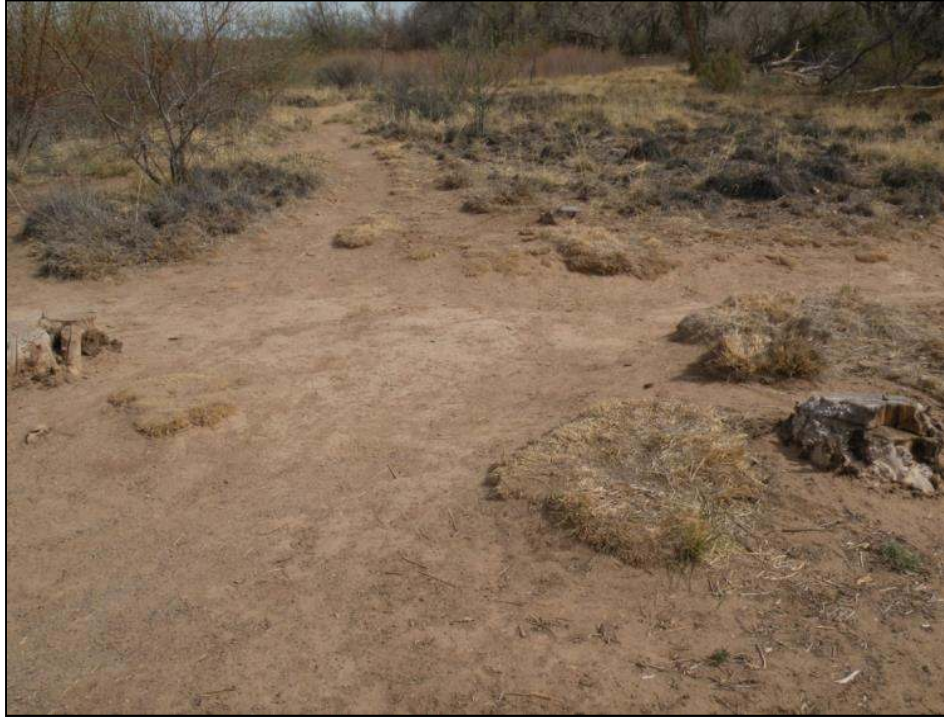
**Figure 1.7. Example of unofficial side trail at the Rio Grande Nature Center State Park, showing soil erosion and damage to vegetation.**

remain for retention of bosque experience. User-made side trails may cause damage to soils and vegetation (Figure 1.7) and permit unsanctioned access for users to wander throughout the bosque, with an increased potential to disturb wildlife and resources. If any unofficial trails are selected for closure, restoration work will be done to promote soil health and for native vegetation to become re-established. Some user-made side-trails may be left in place to provide for a broader range of visitor experiences. Decisions on the design of a future trail system, the range of visitors and experiences, and whether to designate some segments as limited use or multiple use will be based on ecological and existing physical conditions. Alternative designs based on existing conditions will be developed after this baseline monitoring plan has been finalized and evaluated. Construction of any proposed amenities or of improvements to the main trail would not occur until late 2014 or early 2015, depending upon results of public review and any needed approvals.

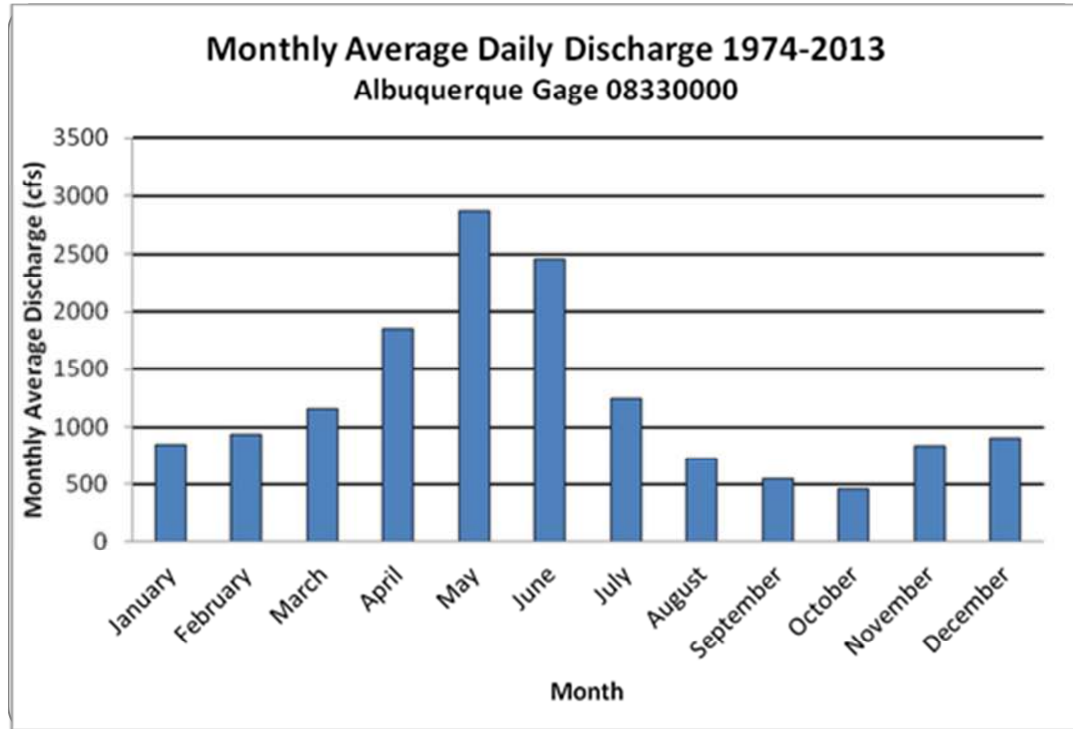
**Figure 3.1. Monthly average annual flows recorded from the USGS Albuquerque gage (08330000), 1974–2013 (USGS 2014).**

of the Rio Grande at Albuquerque averaged over the years 1974 through 2013 are presented in Figure 3.1.

The post-Cochiti spring hydrograph maintains the shape of the pre-Cochiti hydrograph, although it is attenuated and may be occurring earlier in the year. Flow rates vary from year to year depending on winter snowpack and seasonal temperatures but overall, peaks tend to occur during the late spring and early summer.

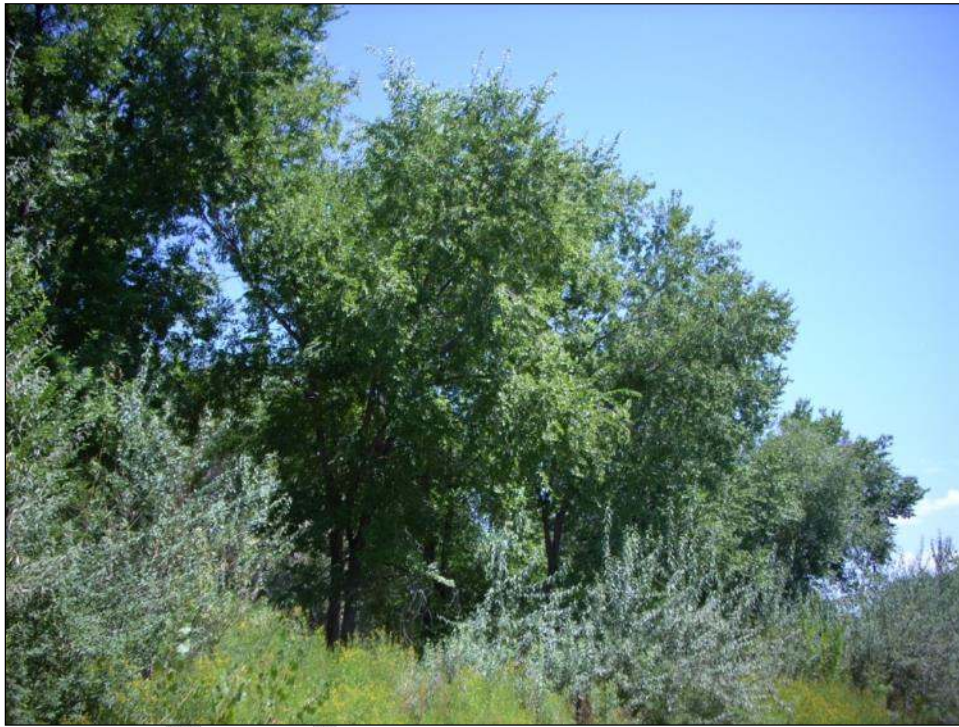
**Figure 3.3. Cottonwood/Russian olive, Hink and Ohmart (1984) structural type I classification, Albuquerque Reach bosque.**

Hink and Ohmart (1984) reported cottonwood forest of structure Type I to be the most abundant vegetation in their intensive study area (Figure 3.3). Russian olive was the most common understory species, often found in association with saltcedar. Much of the Albuquerque Reach bosque was characterized by thick, mixed native and non-native shrubs and trees. The midstory vegetation was dominated by Russian olive, scattered saltcedar, and fourwing saltbush (*Atriplex canescens*). Canopy vegetation, where present, was dominated by scattered Rio Grande cottonwood with occasional Siberian elm. Understory herbaceous vegetation was sparse in areas that have thick woody growth; however, in areas that were more open, alkali sacaton (*Sporobolus airoides*) and giant sacaton (*S. wrightii*) dominated. Sample images of Hink and Ohmart structural classes are in Figure 3.4 (USACE et al. 2007).

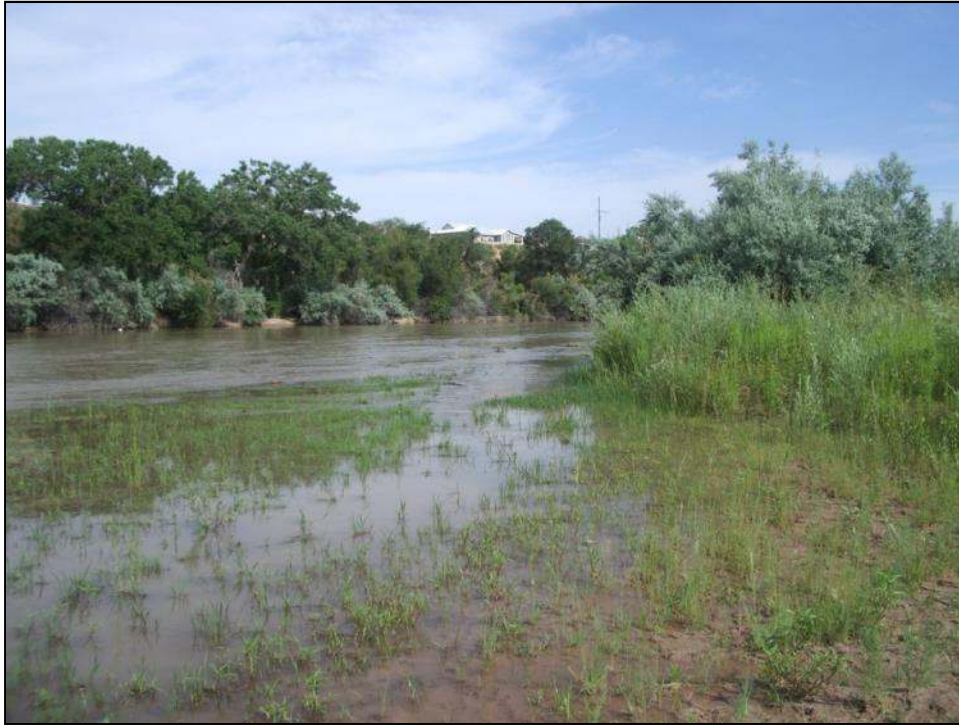
**Figure 3.8. Inundated river bar and vegetation growth in the Albuquerque Reach.**

Despite considerable attention devoted to the ecology and biodiversity of the riparian bosque (Hink and Ohmart 1984; Crawford et al. 1993), until recently little was known about the in-channel sandbars and islands. These dynamic environments support young wetland and riparian vegetation (Figure 3.8) and most of the natural regeneration of Rio Grande cottonwoods in the river corridor (Milford and Muldavin 2004). Perhaps due in part to the lack of flood peaks during the current drought, vegetated islands and sidebars currently support approximately 13% of the vegetated floodplain throughout the Albuquerque Reach (Milford et al. 2003).

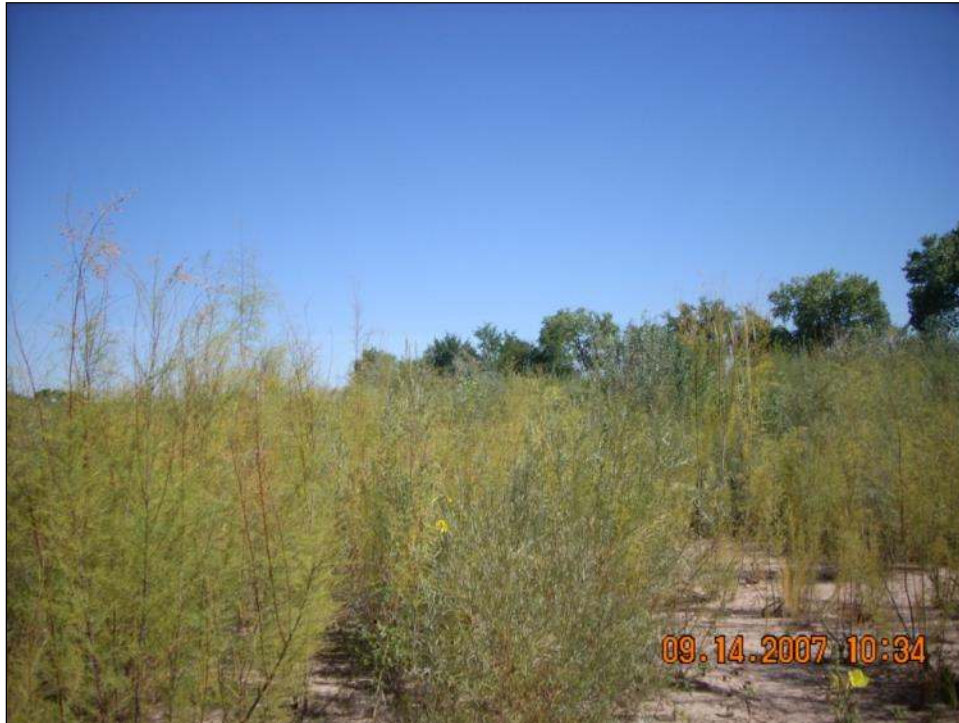
**Figure 3.9. Coyote willow and saltcedar on the interior section of an Albuquerque Reach point bar.**

The establishment of non-native riparian trees along the riparian zone of the MRG has become a significant environmental and natural resource management concern (Parker et al. 2005). Saltcedar (Figure 3.9) is a non-native tree introduced from central Asia that has become an ever-increasing component of the Rio Grande bosque since the mid 1930s (Crawford et al. 1993). Two species of saltcedar, *Tamarix ramosissima* and *T. chinensis*, were apparently introduced to the MRG in the early twentieth century, and both species now occur throughout the region. The two species are difficult to tell apart, and they are known to hybridize. Our references to saltcedar are inclusive for both species and for hybrids. In many areas, saltcedar has replaced native riparian understory plant communities, decreasing habitat quality for the flycatcher and many neotropical birds (Anderson et al. 1977; Smith et al. 2006). Moore and Ahlers (2008) find that productivity of flycatcher nests in the MRG is significantly greater in native willow-dominated habitats than in saltcedar habitats, and the authors conclude that flycatchers prefer native willow-dominated habitat when available over saltcedar habitats. Saltcedar seeds germinate readily in most areas that are frequently disturbed (Stromberg 1997), and the plant commonly forms impenetrable thickets, making it highly competitive. Furthermore, the ability of saltcedar to stabilize banks has supplemented human-made channelization of the river (Dahm et al. 2002), a feature of MRG morphology that has reduced habitat quality for the silvery minnow.

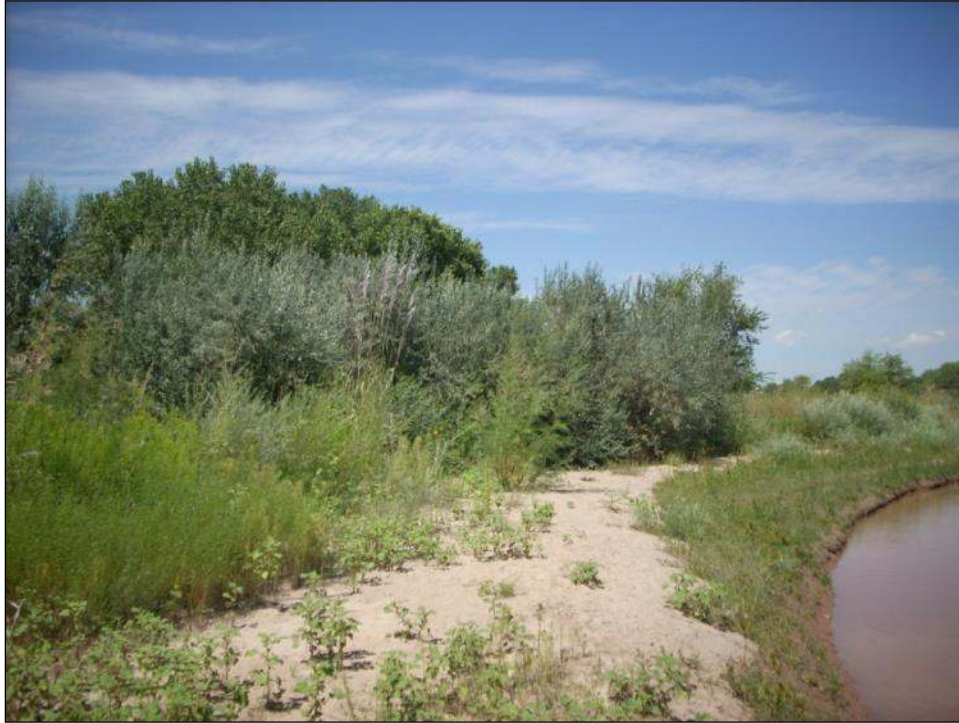
**Figure 3.10. Russian olive in the Albuquerque Reach colonizing channel margin (background) with cottonwood behind.**

Russian olive (Figure 3.10) was introduced to the MRG between 1900 and 1915 (Hink and Ohmart 1984) and spread throughout the MRG to become a dominant component of riparian vegetation by 1960 (Campbell and Dick-Peddie 1964). Like saltcedar, Russian olive is highly competitive due largely to its ability to survive environmental stresses such as low light and drought conditions. Russian olive also contributes to channel stabilization (Waring and Tremble 1993), reducing river sinuosity and overbank flooding. Hink and Ohmart (1984) recognize that the widespread establishment of saltcedar and Russian olive coincided with the period of significant disturbance associated with the Middle Rio Grande Project (1925–1935). Hink and Ohmart (1984) and Dick-Peddie (1993) note that Russian olive is the dominant invasive tree found along riparian reaches north of Albuquerque, while saltcedar tends to proliferate along more southern reaches.

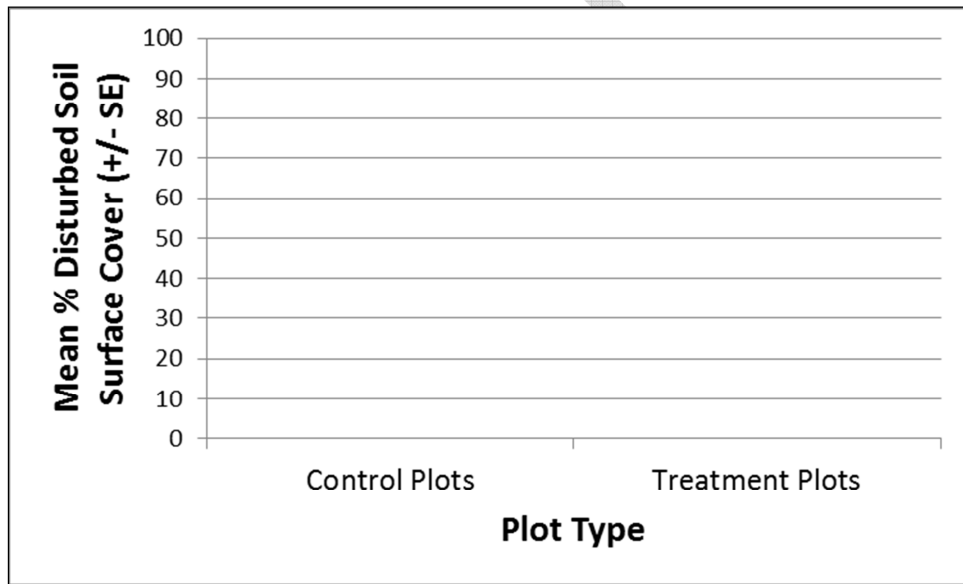
**Figure 7.5. Mean percent canopy cover of human-caused soil surface disturbance measured from control and treatment vegetation and soils plots.**

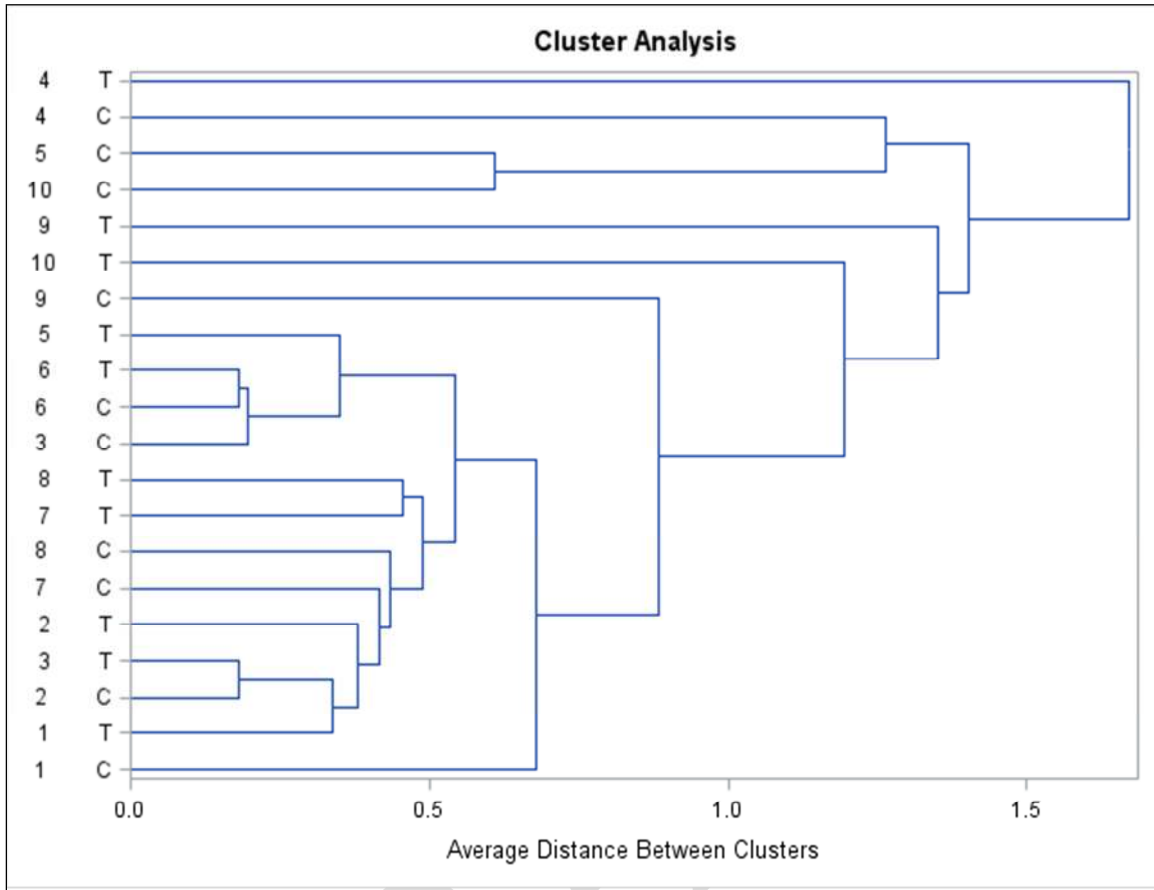
**Figure 7.6.** Dendrogram resulting from cluster analysis of all 20 control and treatment vegetation and soils plots based on similarities in species composition. Numeric values on the vertical axis represent site locations, C and T values represent control or treatment plots. Similarity distance is Euclidean distance.

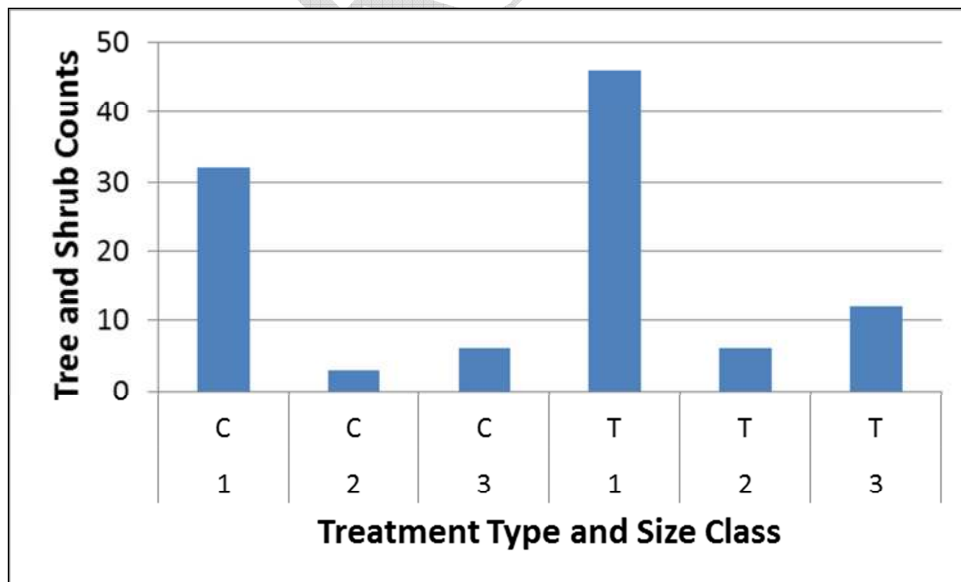
**Figure 7.7. Sum counts of woody trees and shrubs across all control and treatment vegetation plots by size class. Size class DBH: 1) <10 cm, 2) 10-20 cm, 3) >20 cm.**

The dominant trees across all 20 vegetation and soils plots were Rio Grande cottonwood, saltcedar, Russian Olive, and Siberian elm. The total counts and heights of all woody trees and shrubs by three size classes were similar across control and treatment vegetation and soils BEMP plots (Figure 7.7 and Figure 7.8).

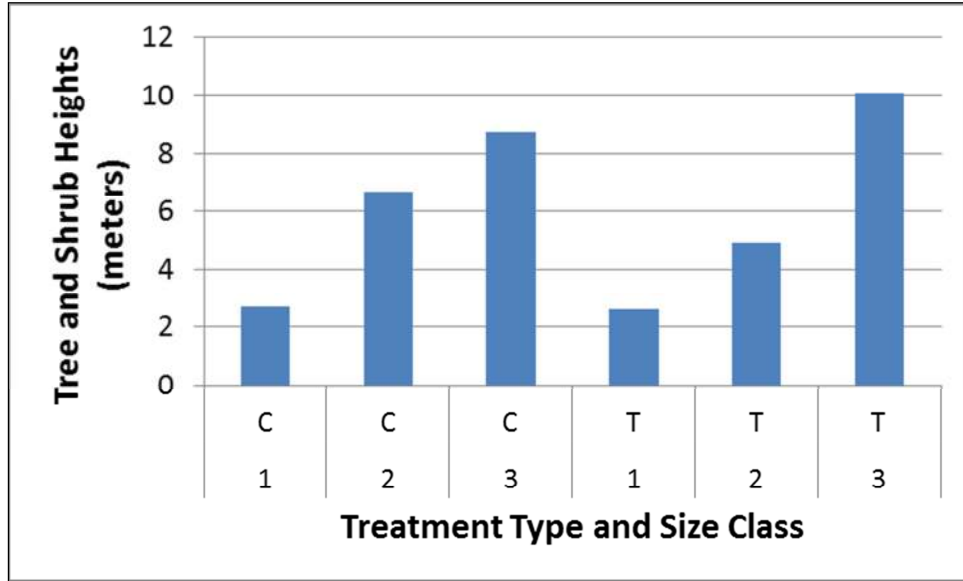
Figure 7.8. Average heights of woody trees and shrubs across all control and treatment vegetation plots by size class. Size class DBH: 1) <10 cm, 2) 10-20 cm, 3) >20 cm.

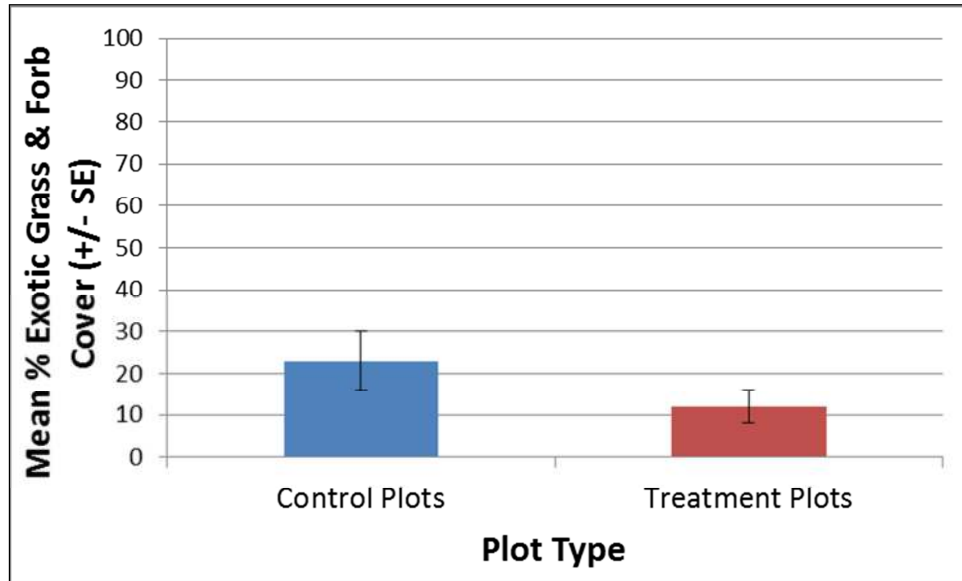
**Figure 7.10.** Mean percent canopy cover of exotic herbaceous vegetation measured from control and treatment vegetation and soils plots.

Both parametric t-tests and non-parametric Wilcoxon rank-sum tests revealed no significant differences between the canopy cover of 1) native herbaceous vegetation and 2) exotic herbaceous vegetation between the control and treatment plots. Figure 7.9 and Figure 7.10 display the mean cover values and standard error bars respectively for those variables. The figures also show that canopy cover of native plant species and exotic plant species were approximately the same across control and treatment BEMP plots.

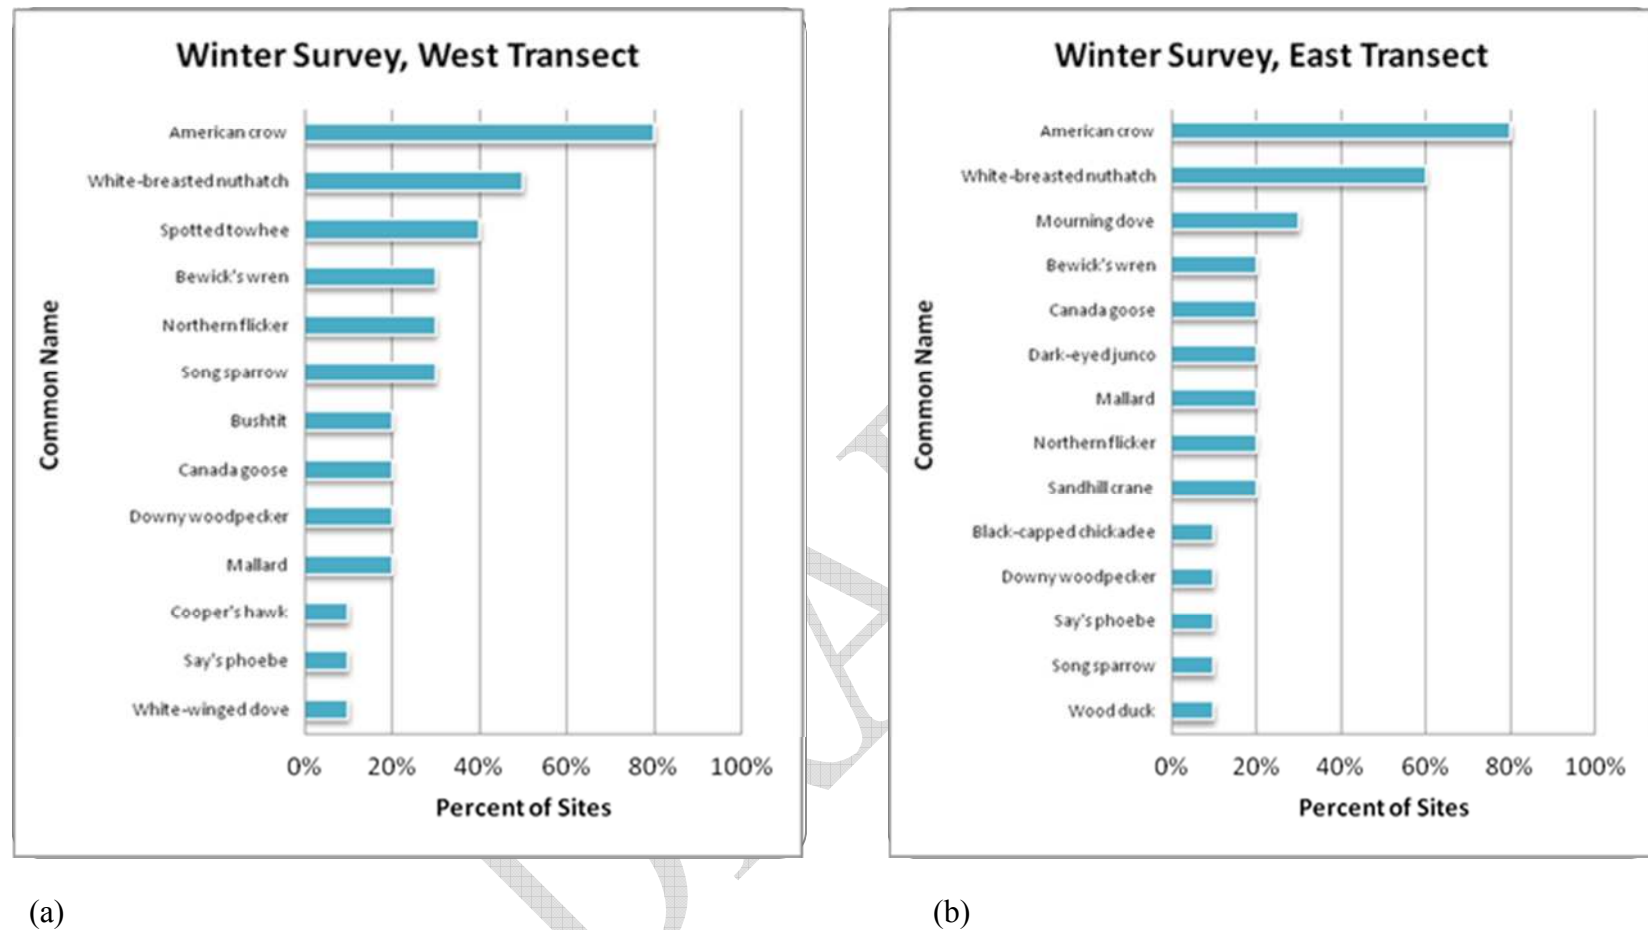
**Figure 7.11. Species Detection Frequency, expressed as the Percentage of Sites where a Species was Recorded. February 2014 surveys.**

In February, the American crow and the white-breasted nuthatch were the species most frequently detected both on the west and east sides (Figure 7.11). In May, the black-chinned hummingbird was associated with the highest detection frequency on the east and west sides (Figure 7.12). In June, that same species was among the two species most often recorded along both sides of the river (Figure 7.13). In July, the black-chinned hummingbird, yellow-breasted chat, and ash-throated flycatcher were the species most frequently detected both on the west and east sides (Figure 7.14).

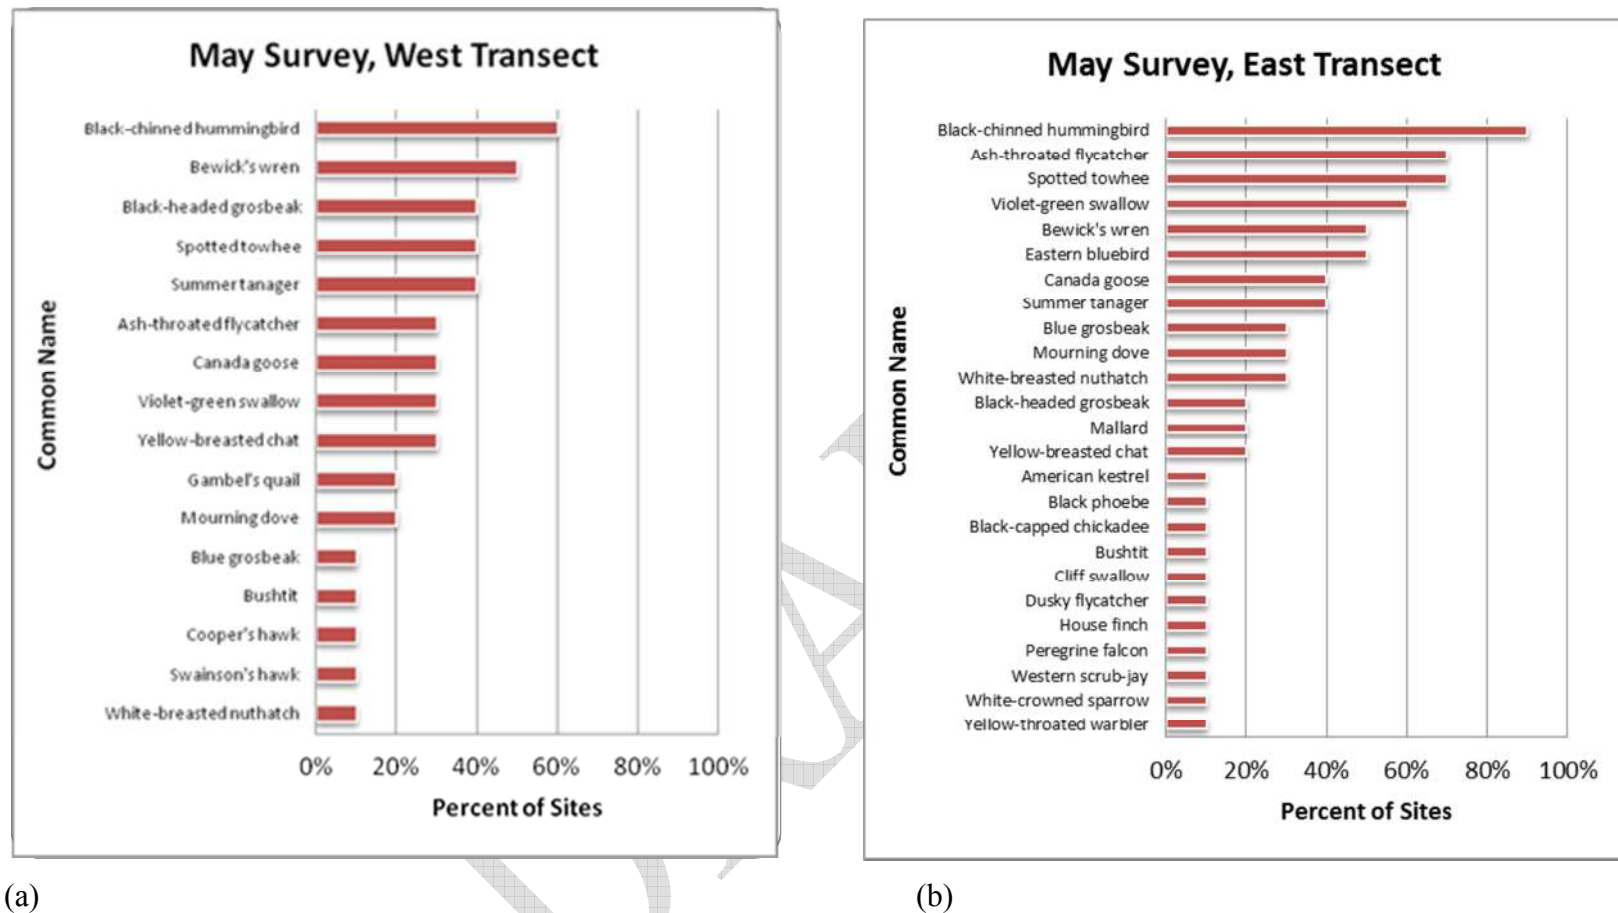
Figure 7.12. Species Detection Frequency, expressed as the Percentage of Sites where a Species was Recorded. May 2014 surveys.

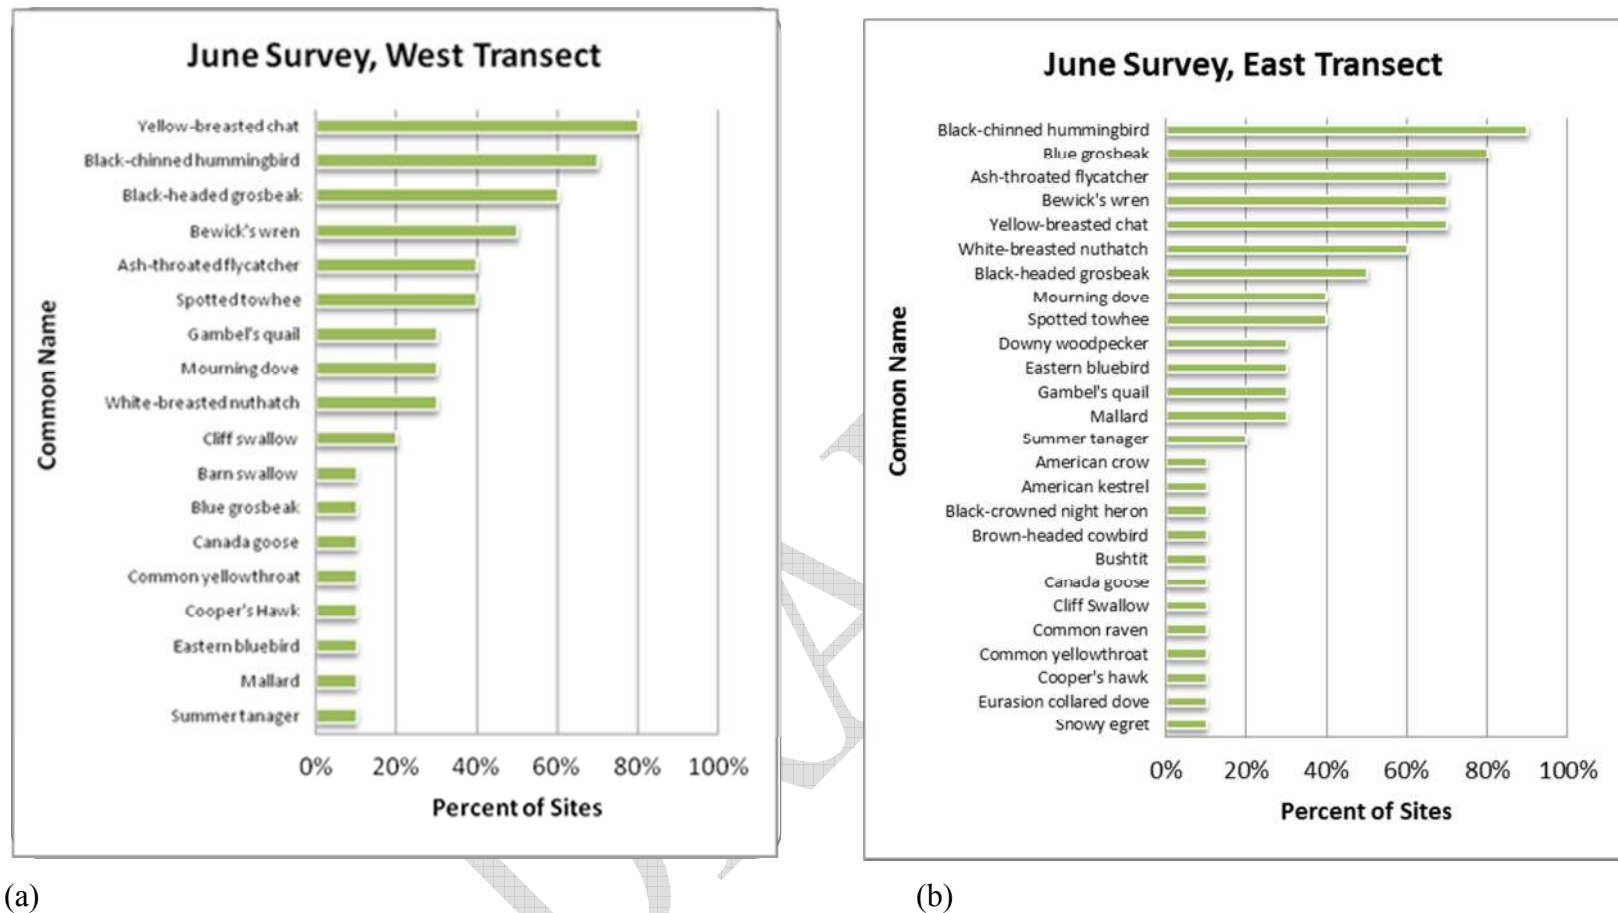
**Figure 7.13. Species Detection Frequency, expressed as the Percentage of Sites where a Species was Recorded. June 2014 surveys.**

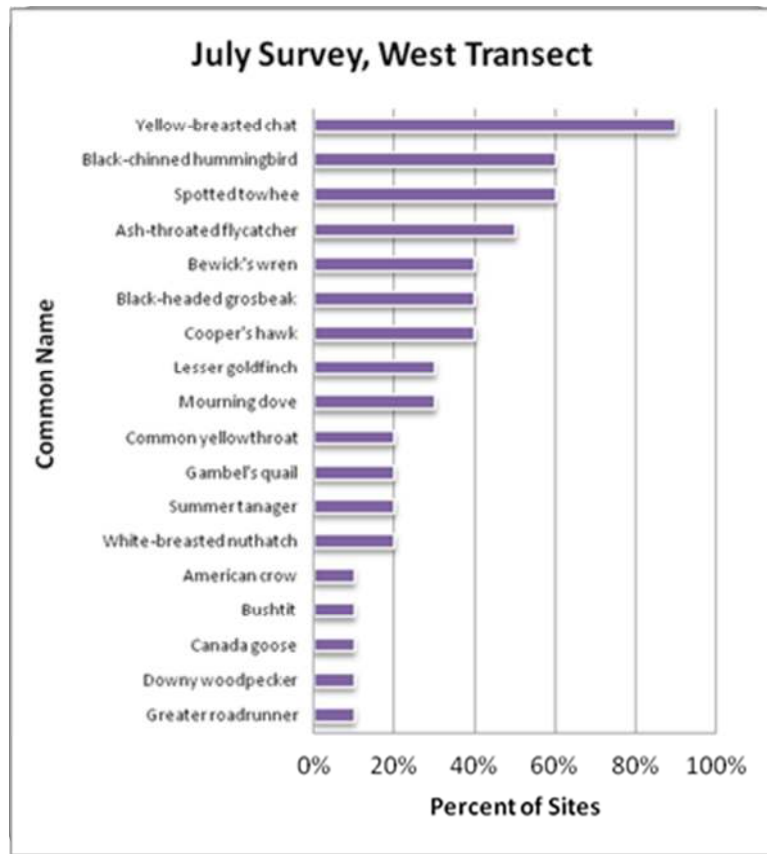
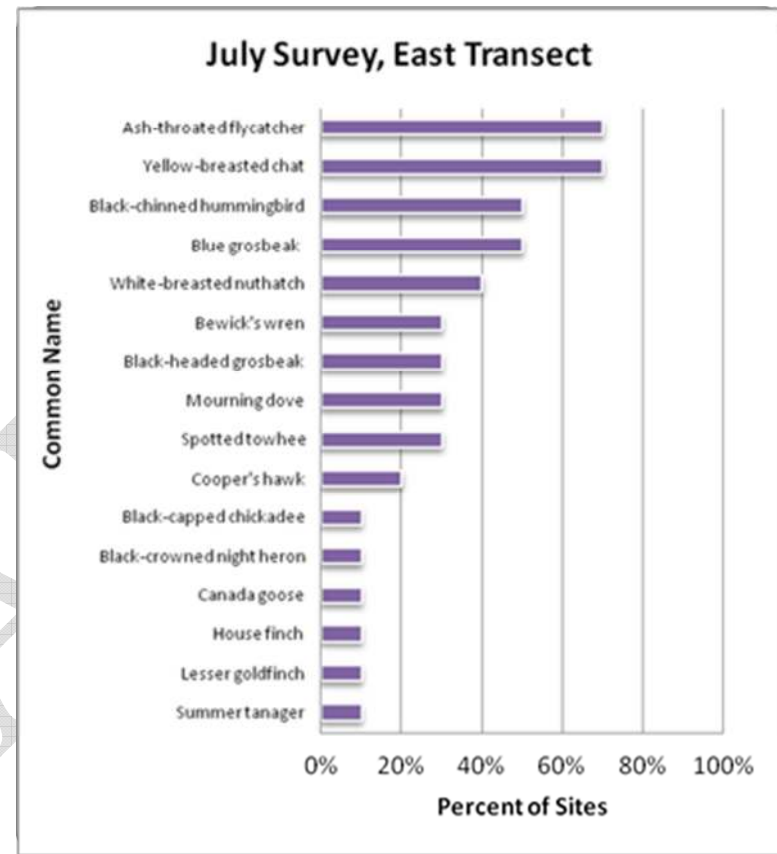
**Figure 7.14. Species Detection Frequency, expressed as the Percentage of Sites where a Species was Recorded. July 2014 surveys.**
