**Rio del Norte Bosque Trail
Improvement Project: 2015 Post-
Construction Environmental
Monitoring Report, Central Avenue to
Interstate 40**

City of Albuquerque, Open Space Division

SWCA Environmental Consultants

January 2016

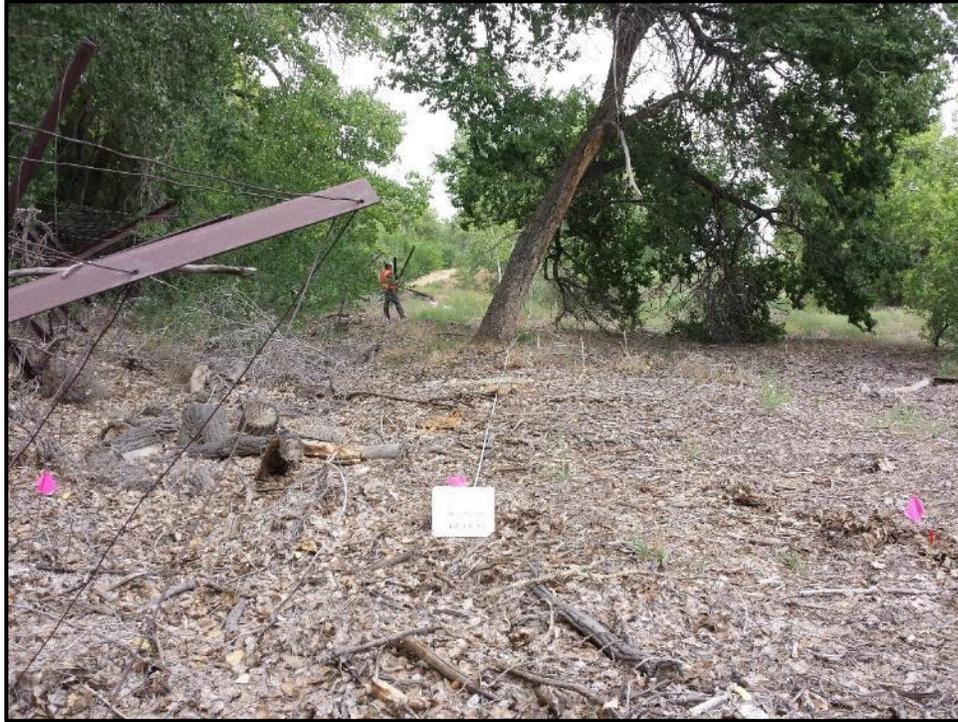
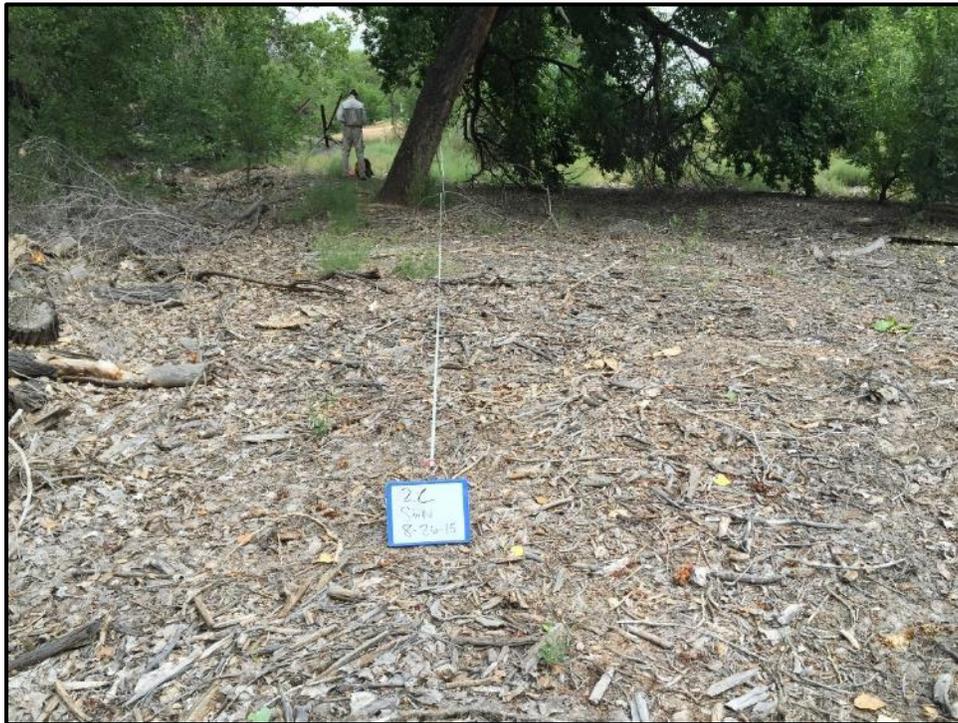
Figure A.1. Plot 2 control, view south to north; a. 2014, b. 2015. SWCA photographs, August 2014 and August 2015.

a. Plot 2 control, 2014, view south to north.

b. Plot 2 control, 2015, view south to north.

Comments: Slight increase in forb cover

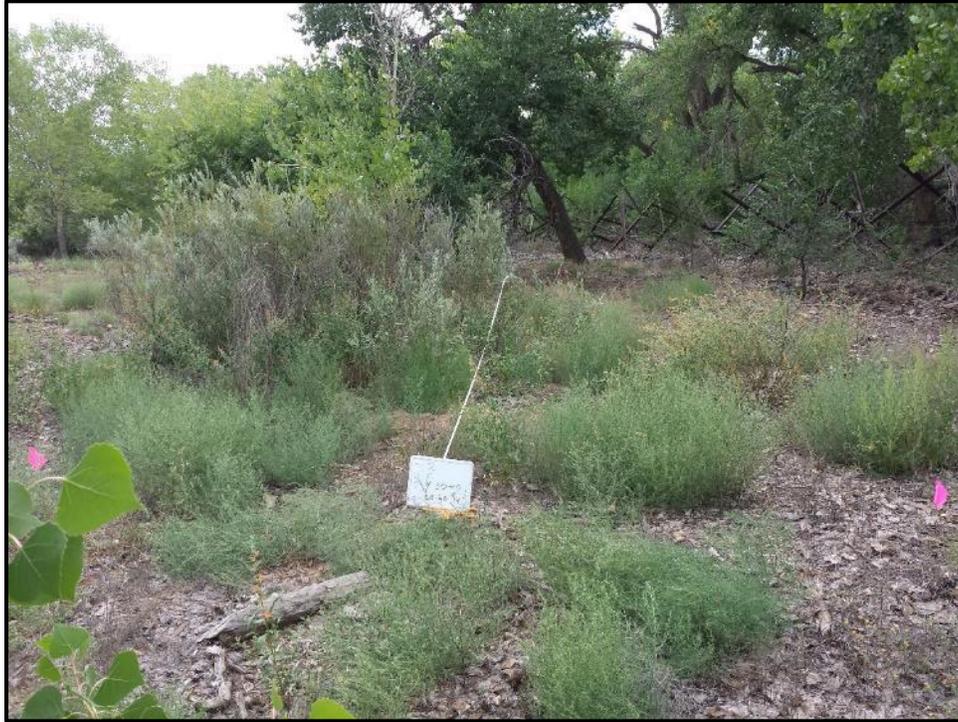
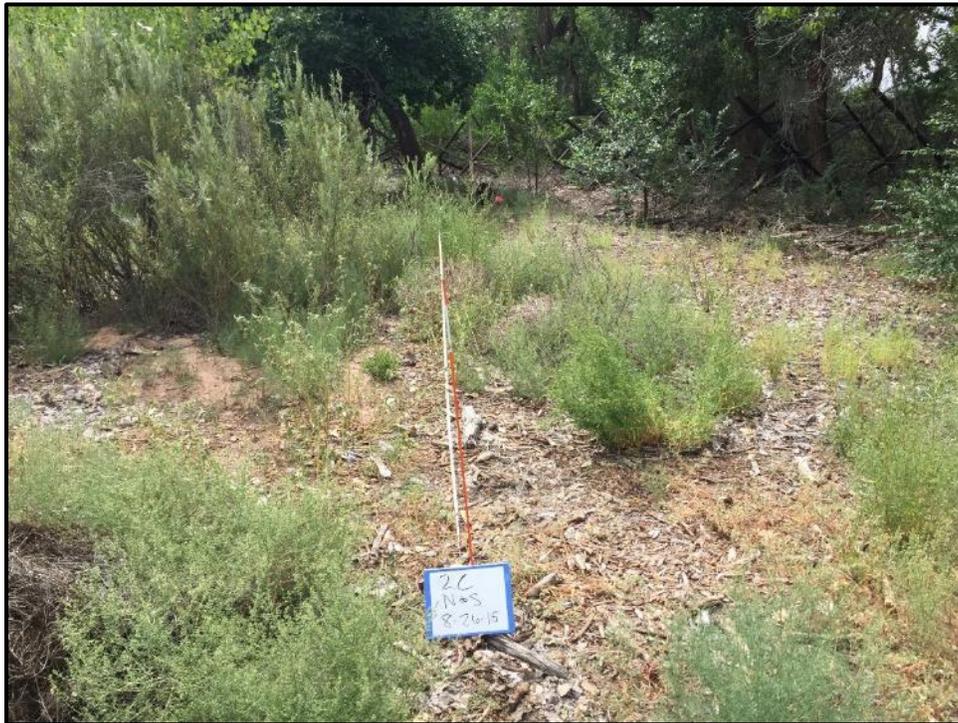
Figure A.2. Plot 2 control, view north to south; a. 2014, b. 2015. SWCA photographs, August 2014 and August 2015.

a. Plot 2 control, 2014, view north to south.

b. Plot 2 control, 2015, view north to south.

Comments: Slight decrease in forb cover

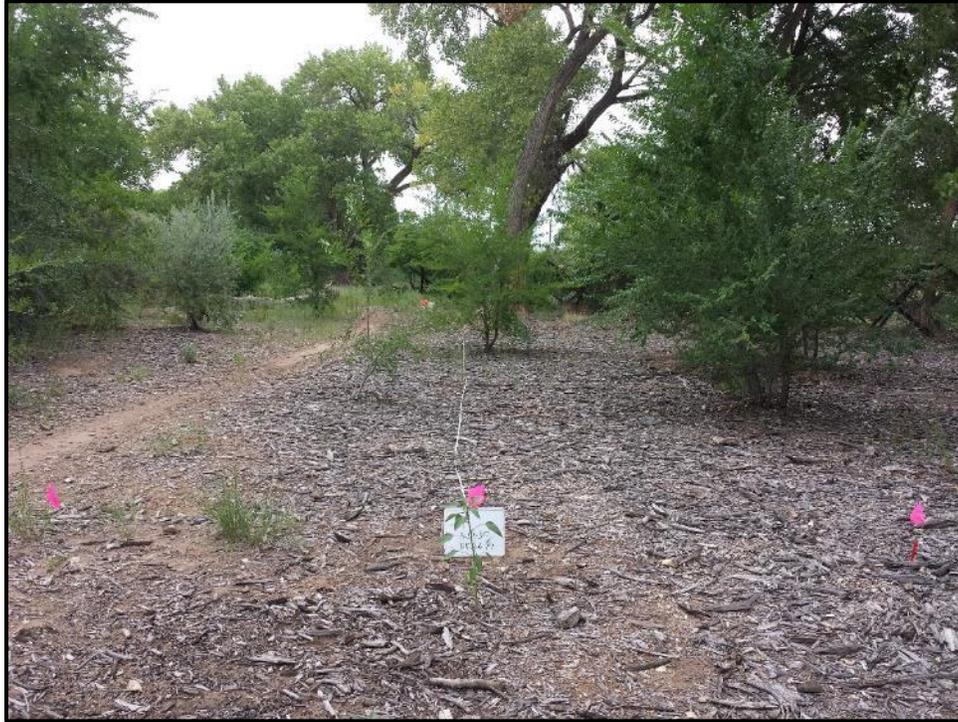
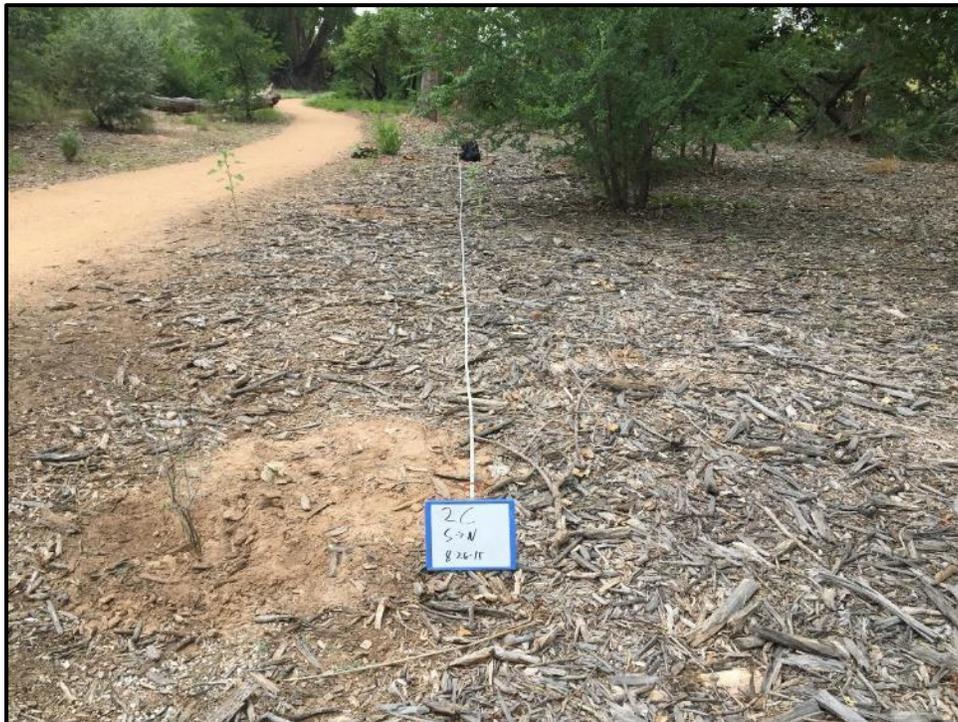
Figure A.3. Plot 2 treatment, view south to north; a. 2014, b. 2015. SWCA photographs, August 2014 and August 2015.

a. Plot 2 treatment, 2014, view south to north.

b. Plot 2 treatment, 2015, view south to north.

Comments: Trail and planted New Mexico olive

Comments: Slight decrease in forb cover

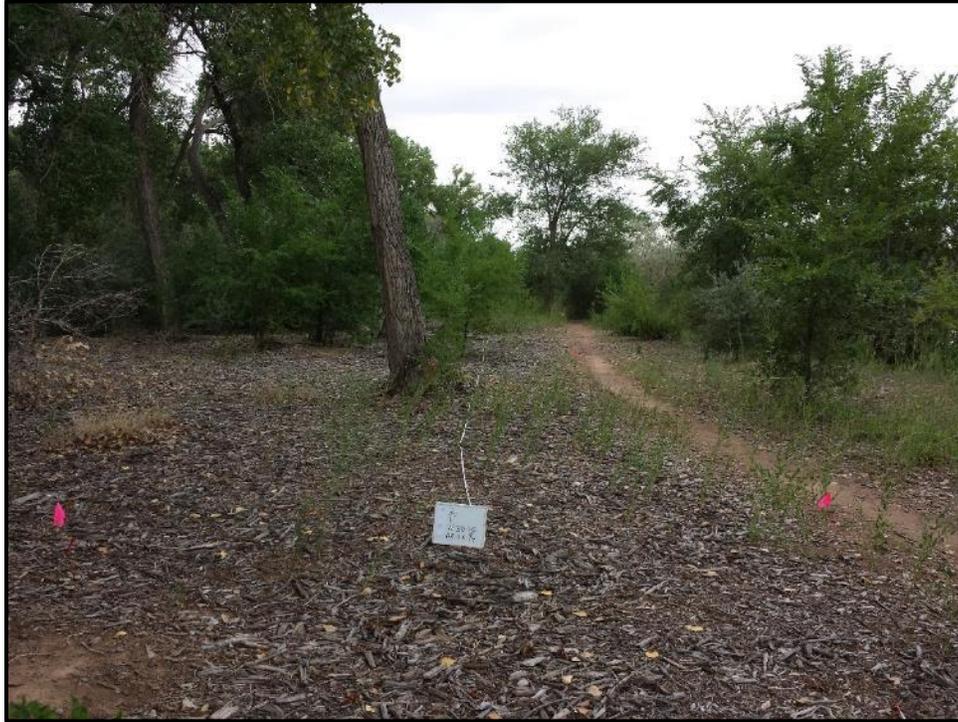
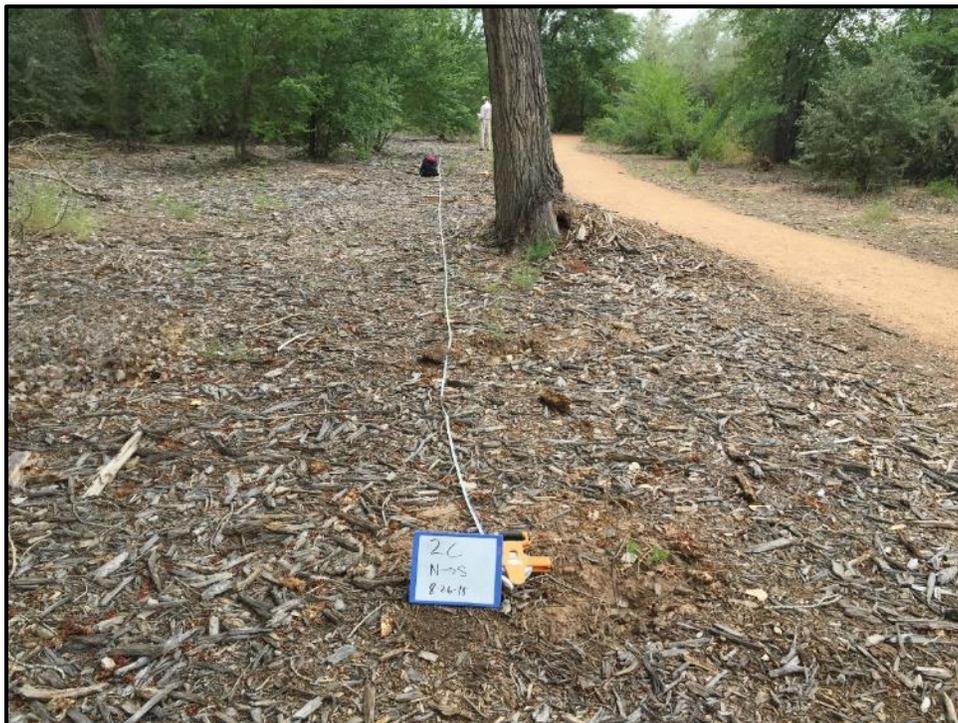
Figure A.4. Plot 2 treatment, view north to south; a. 2014, b. 2015. SWCA photographs, August 2014 and August 2015.

a. Plot 2 treatment, 2014, view north to south.

b. Plot 2 treatment, 2015, view north to south.

Comments: Trail widened

Comments: Slight decrease in forbs

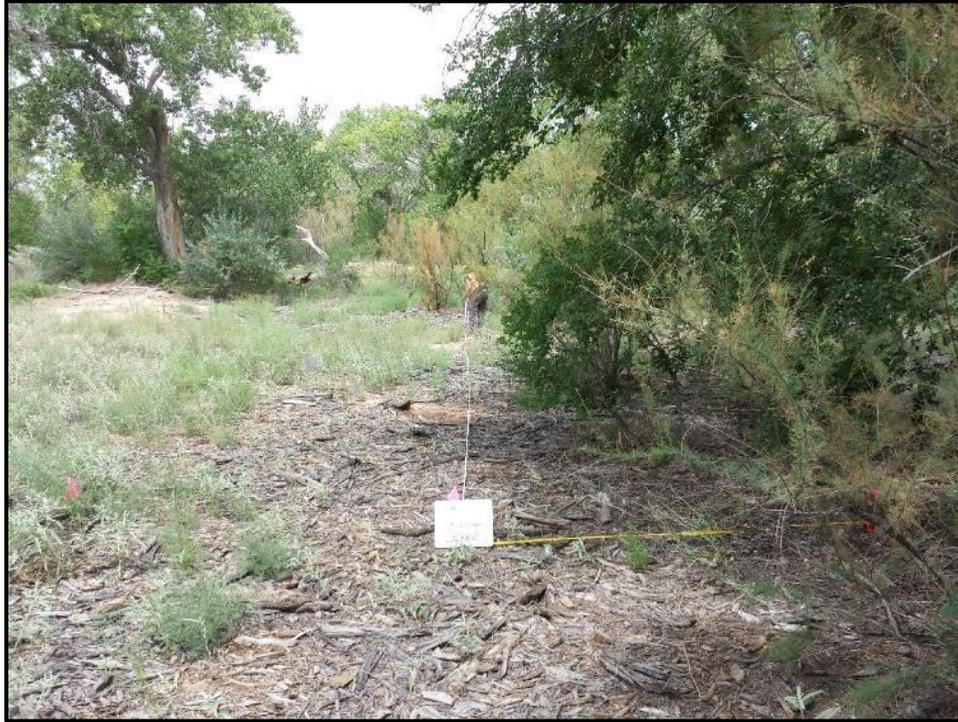
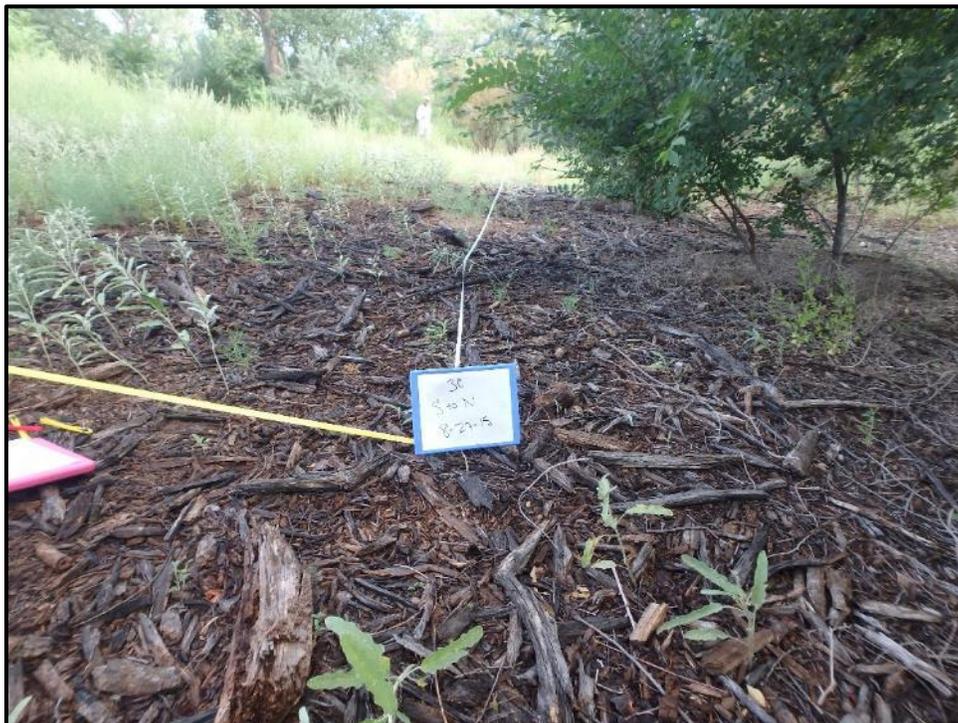
Figure A.5. Plot 3 control, view south to north; a. 2014, b. 2015. SWCA photographs, August 2014 and August 2015.

a. Plot 3 control, 2014, view south to north.

b. Plot 3 control, 2015, view south to north.

Comments: Saltcedar removed

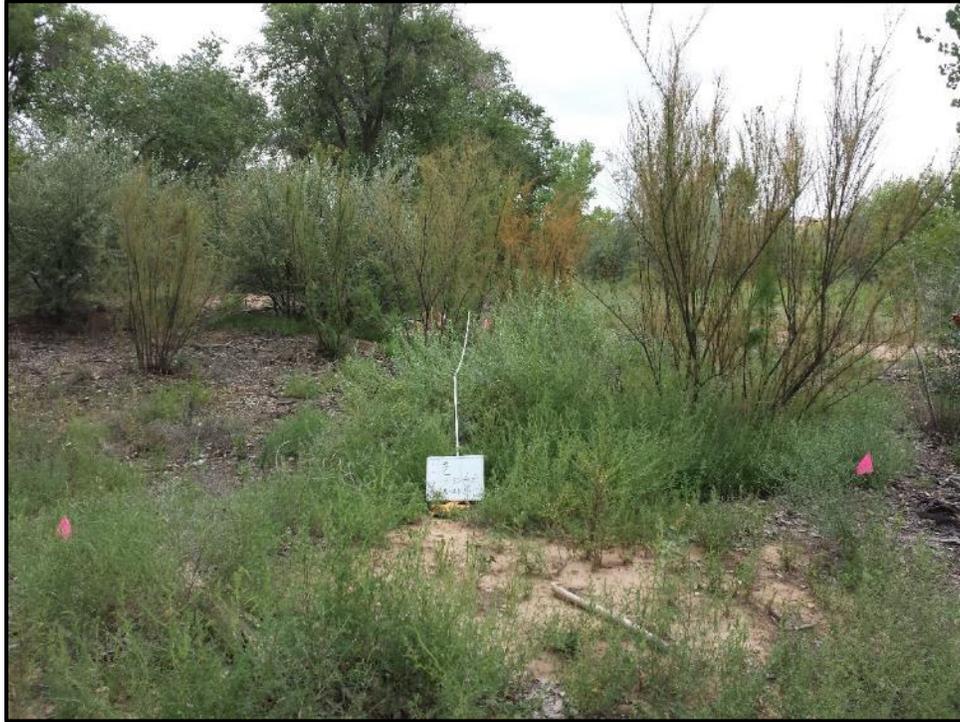
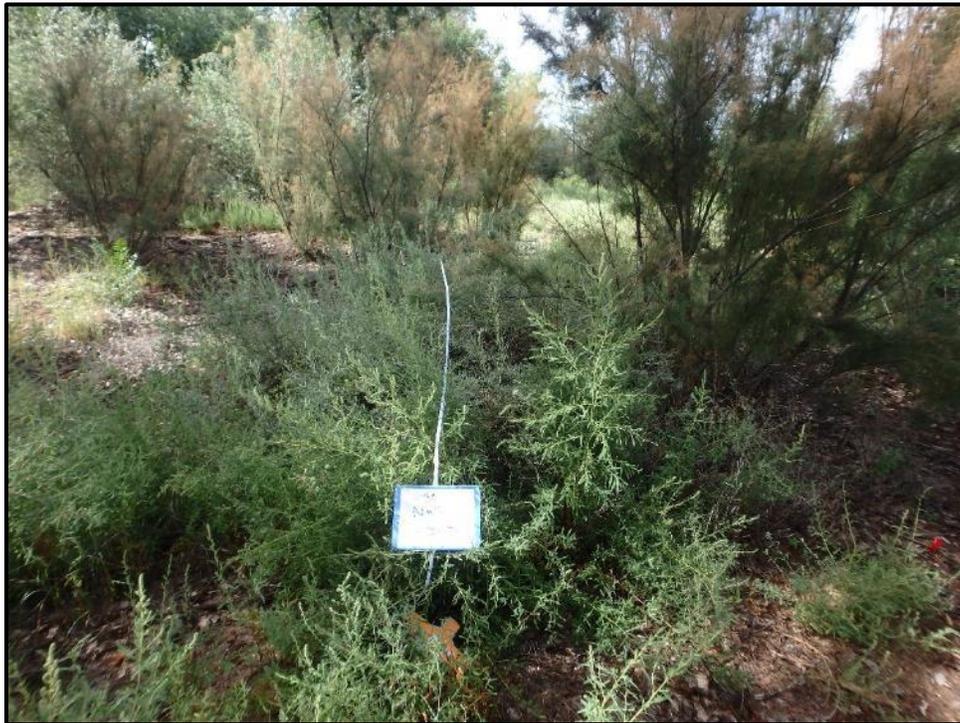
Figure A.6. Plot 3 control, view north to south; a. 2014, b. 2015. SWCA photographs, August 2014 and August 2015.

a. Plot 3 control, 2014, view north to south.

b. Plot 3 control, 2015, view north to south.

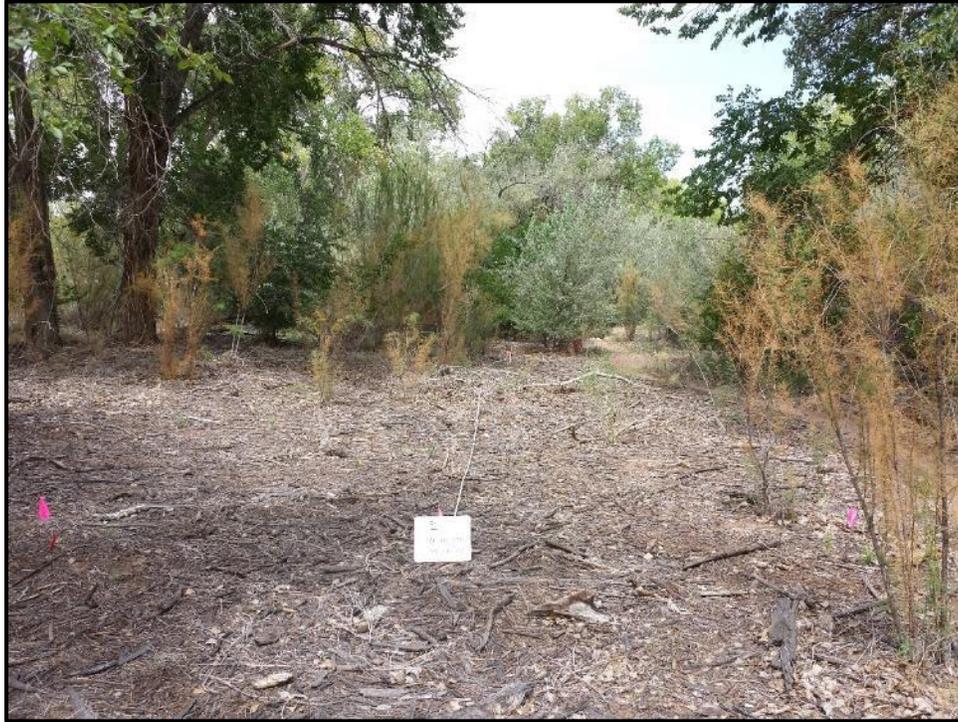
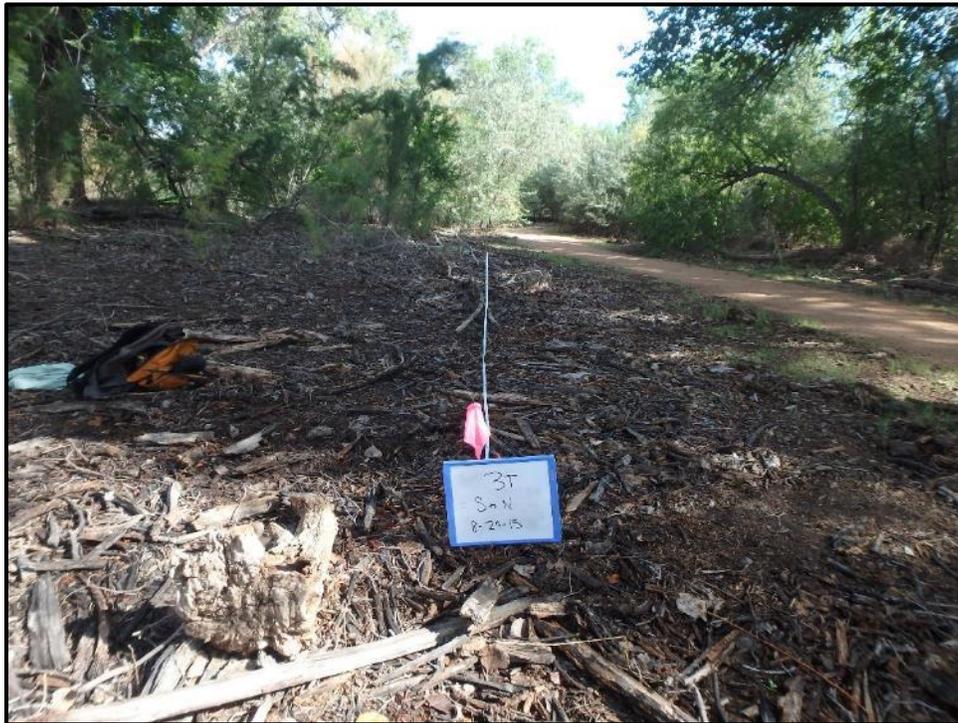
Figure A.7. Plot 3 treatment, view south to north; a. 2014, b. 2015. SWCA photographs, August 2014 and August 2015.

a. Plot 3 treatment, 2014, view south to north.

b. Plot 3 treatment, 2015, view south to north.

Comments: Trail widened

Comments: Saltcedar removed

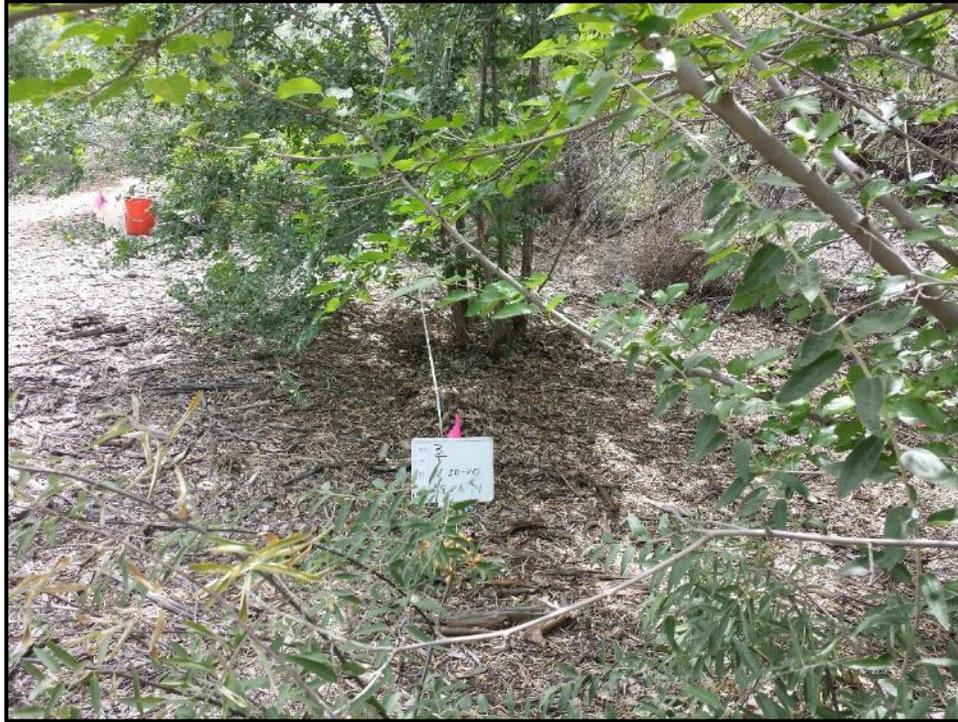
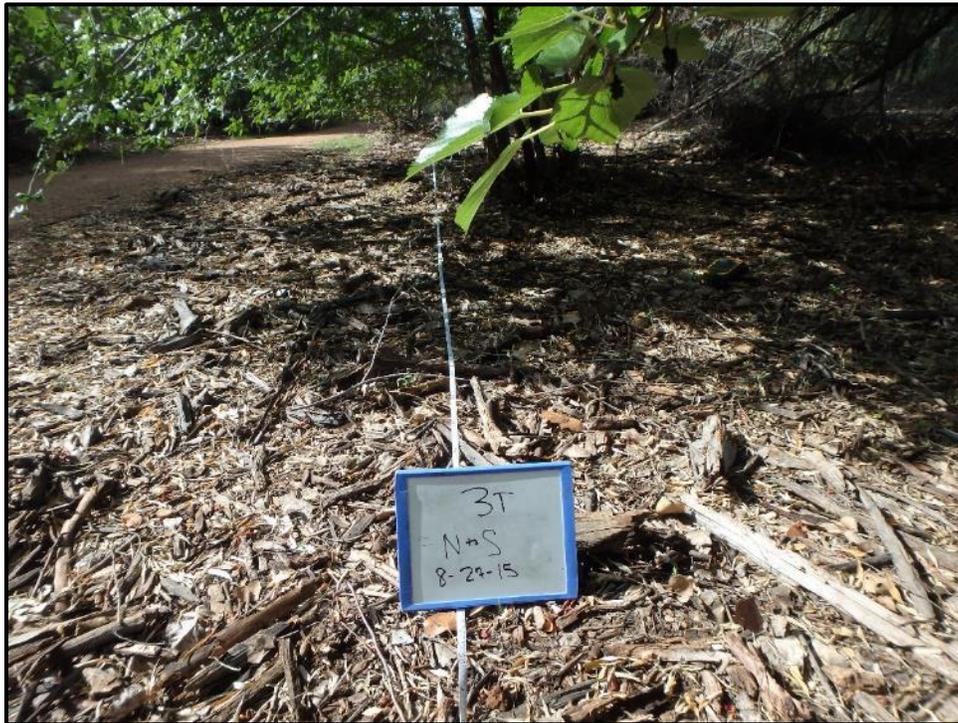
Figure A.8. Plot 3 treatment, view north to south; a. 2014, b. 2015. SWCA photographs, August 2014 and August 2015.

a. Plot 3 treatment, 2014, view north to south.

b. Plot 3 treatment, 2015, view north to south.

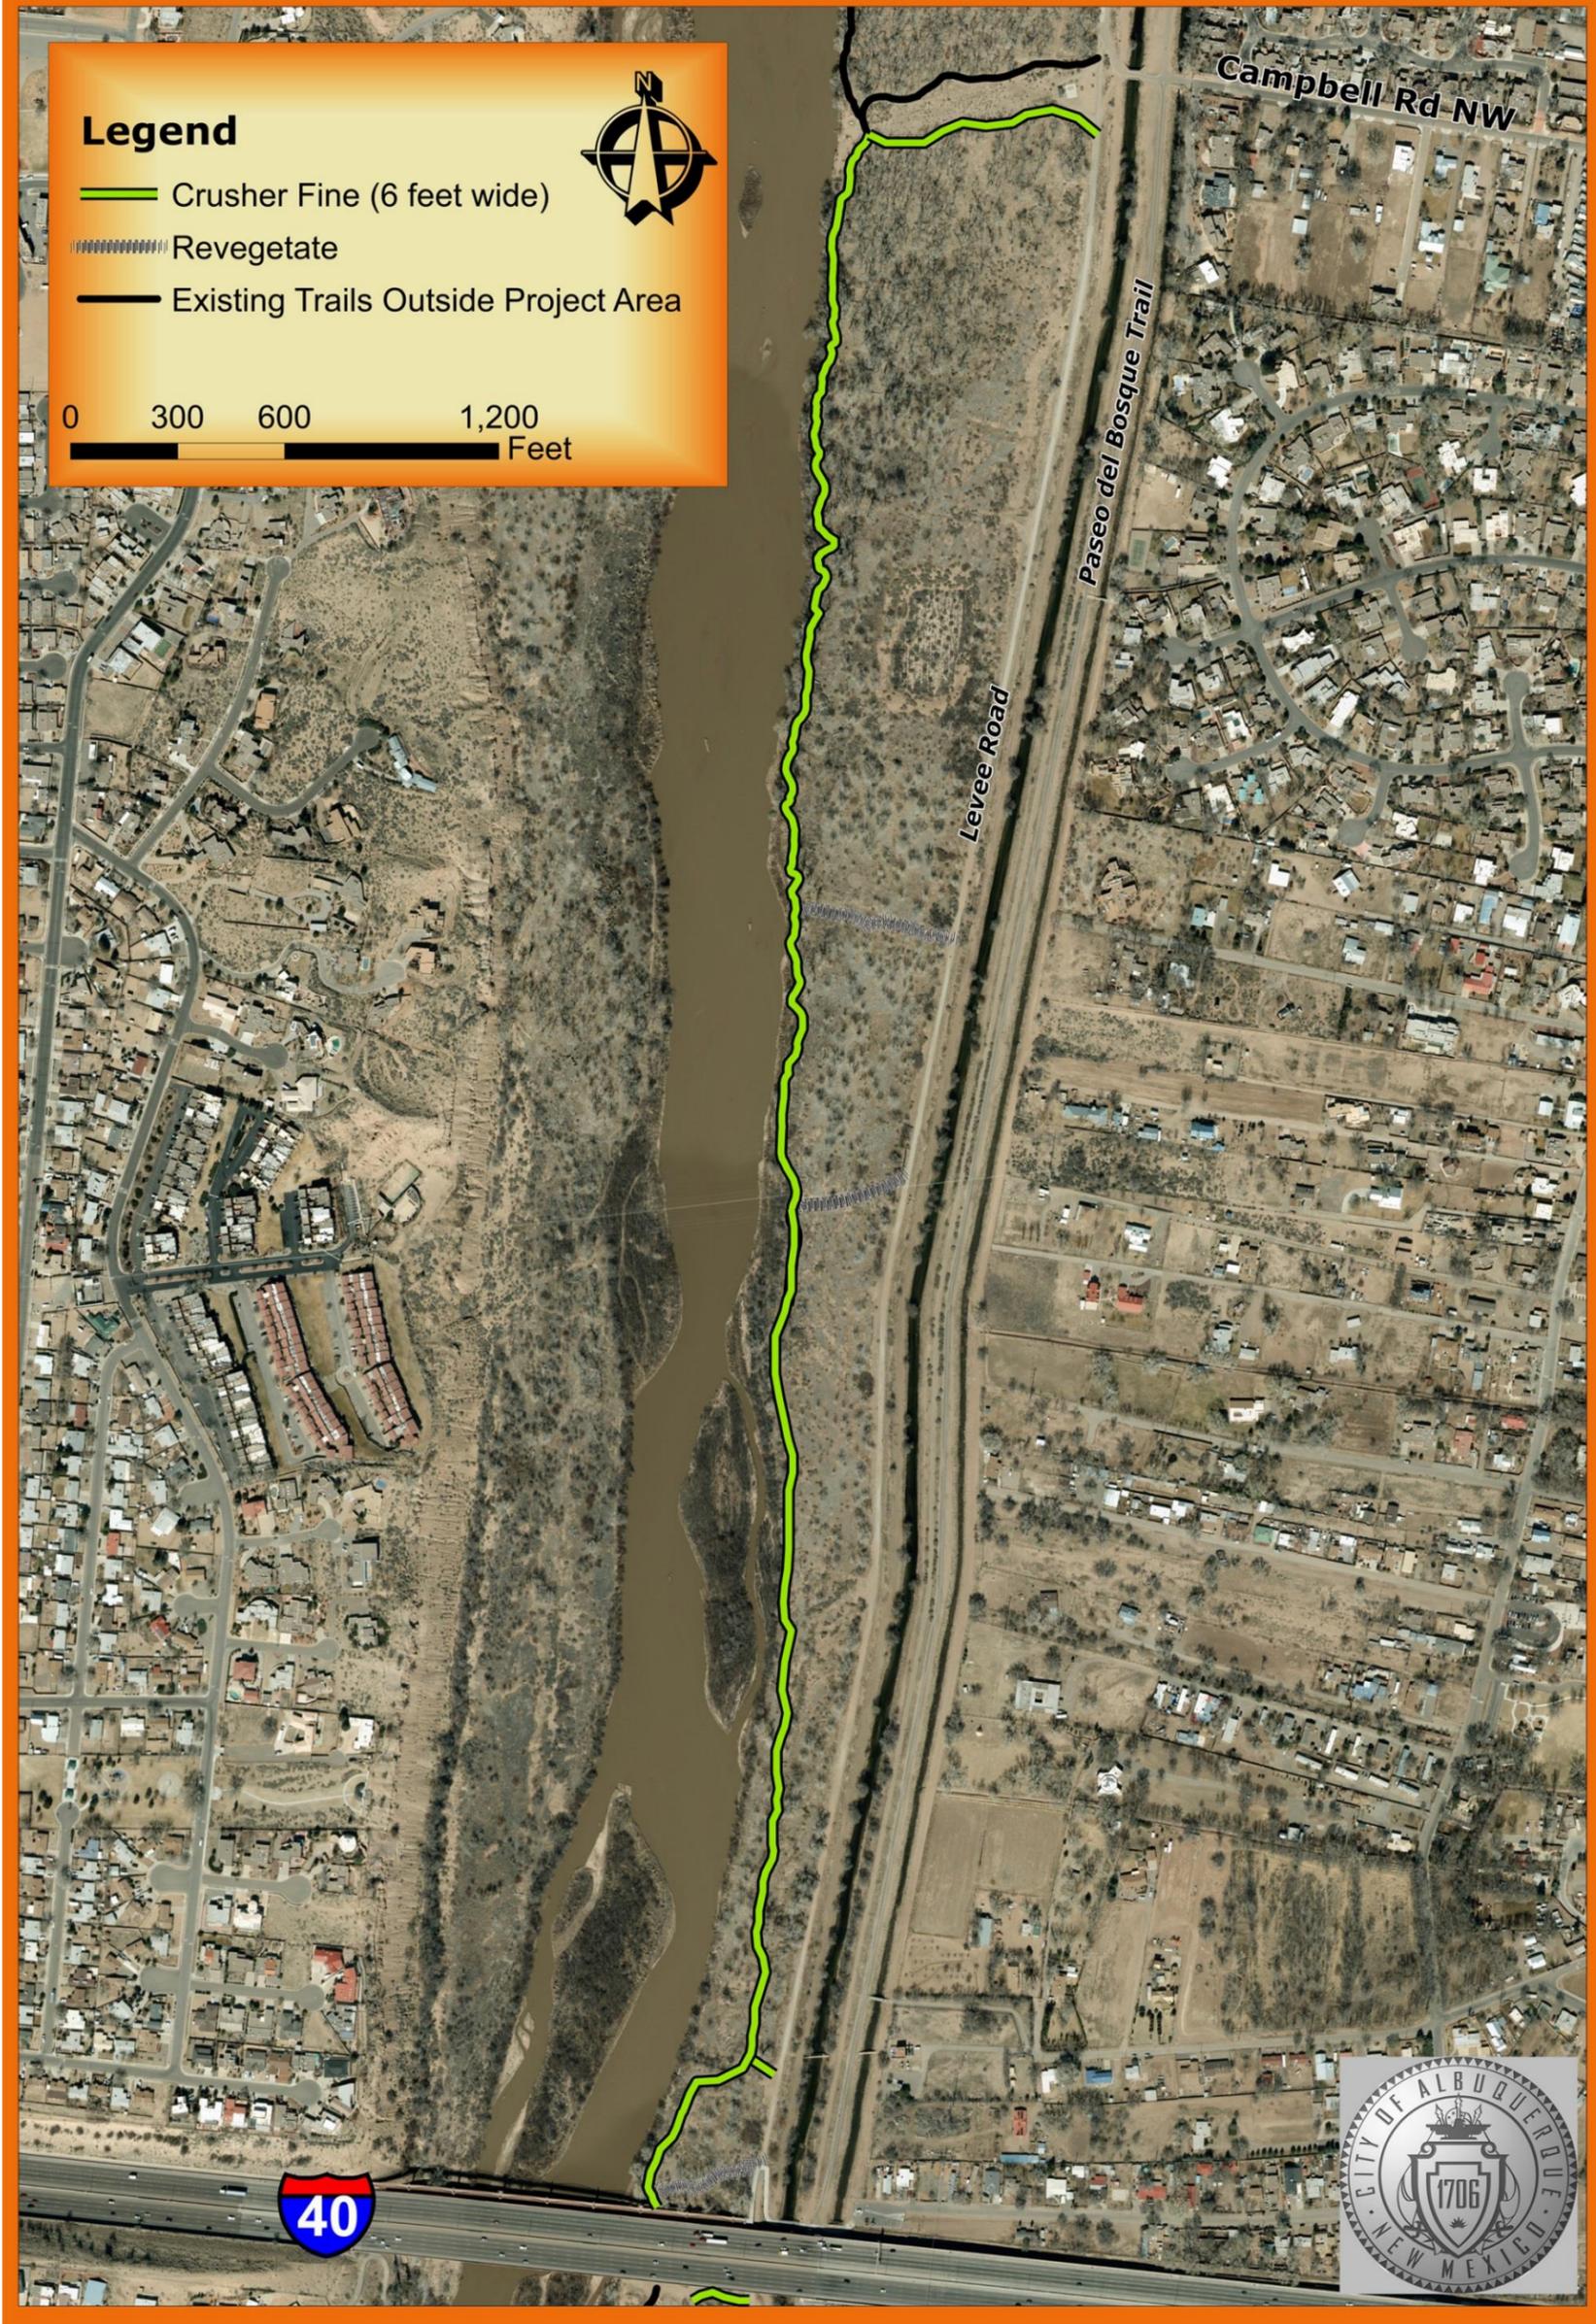
Alternative 1: Crusher Fine Path on Existing Path Alignment

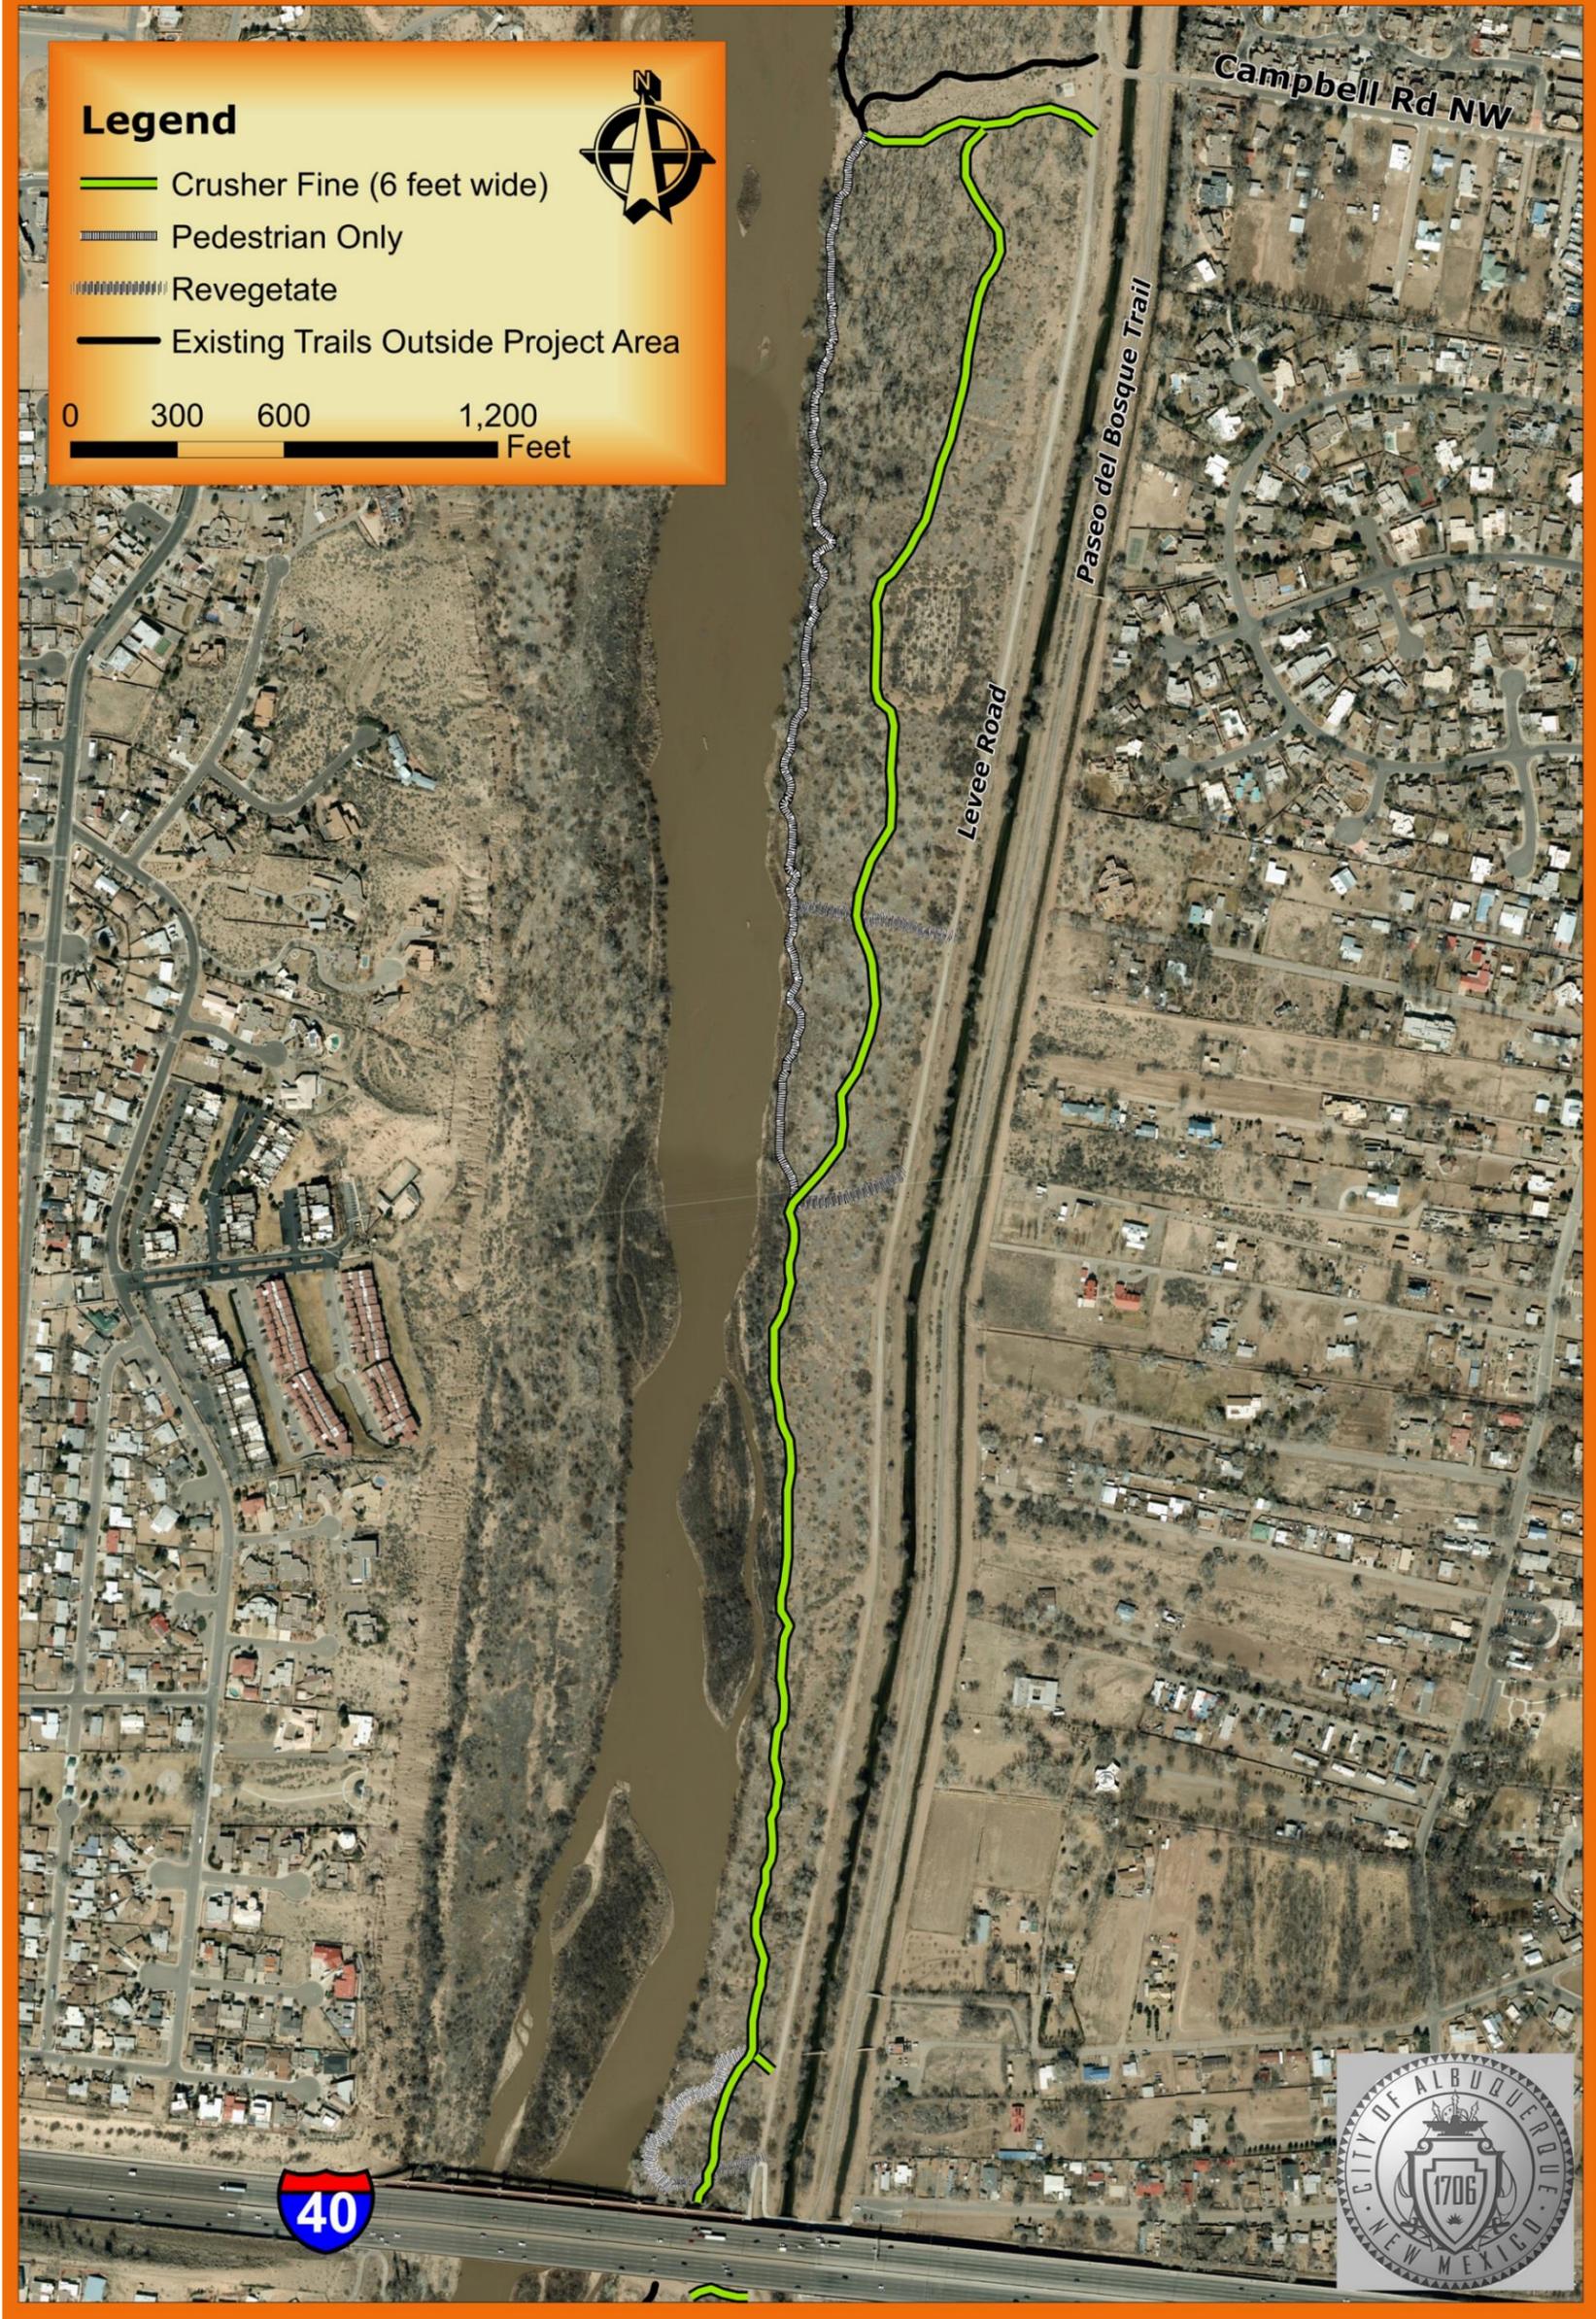
Alternative 2A: Crusher Fine Path on Existing Path Alignment and Former Restoration Road

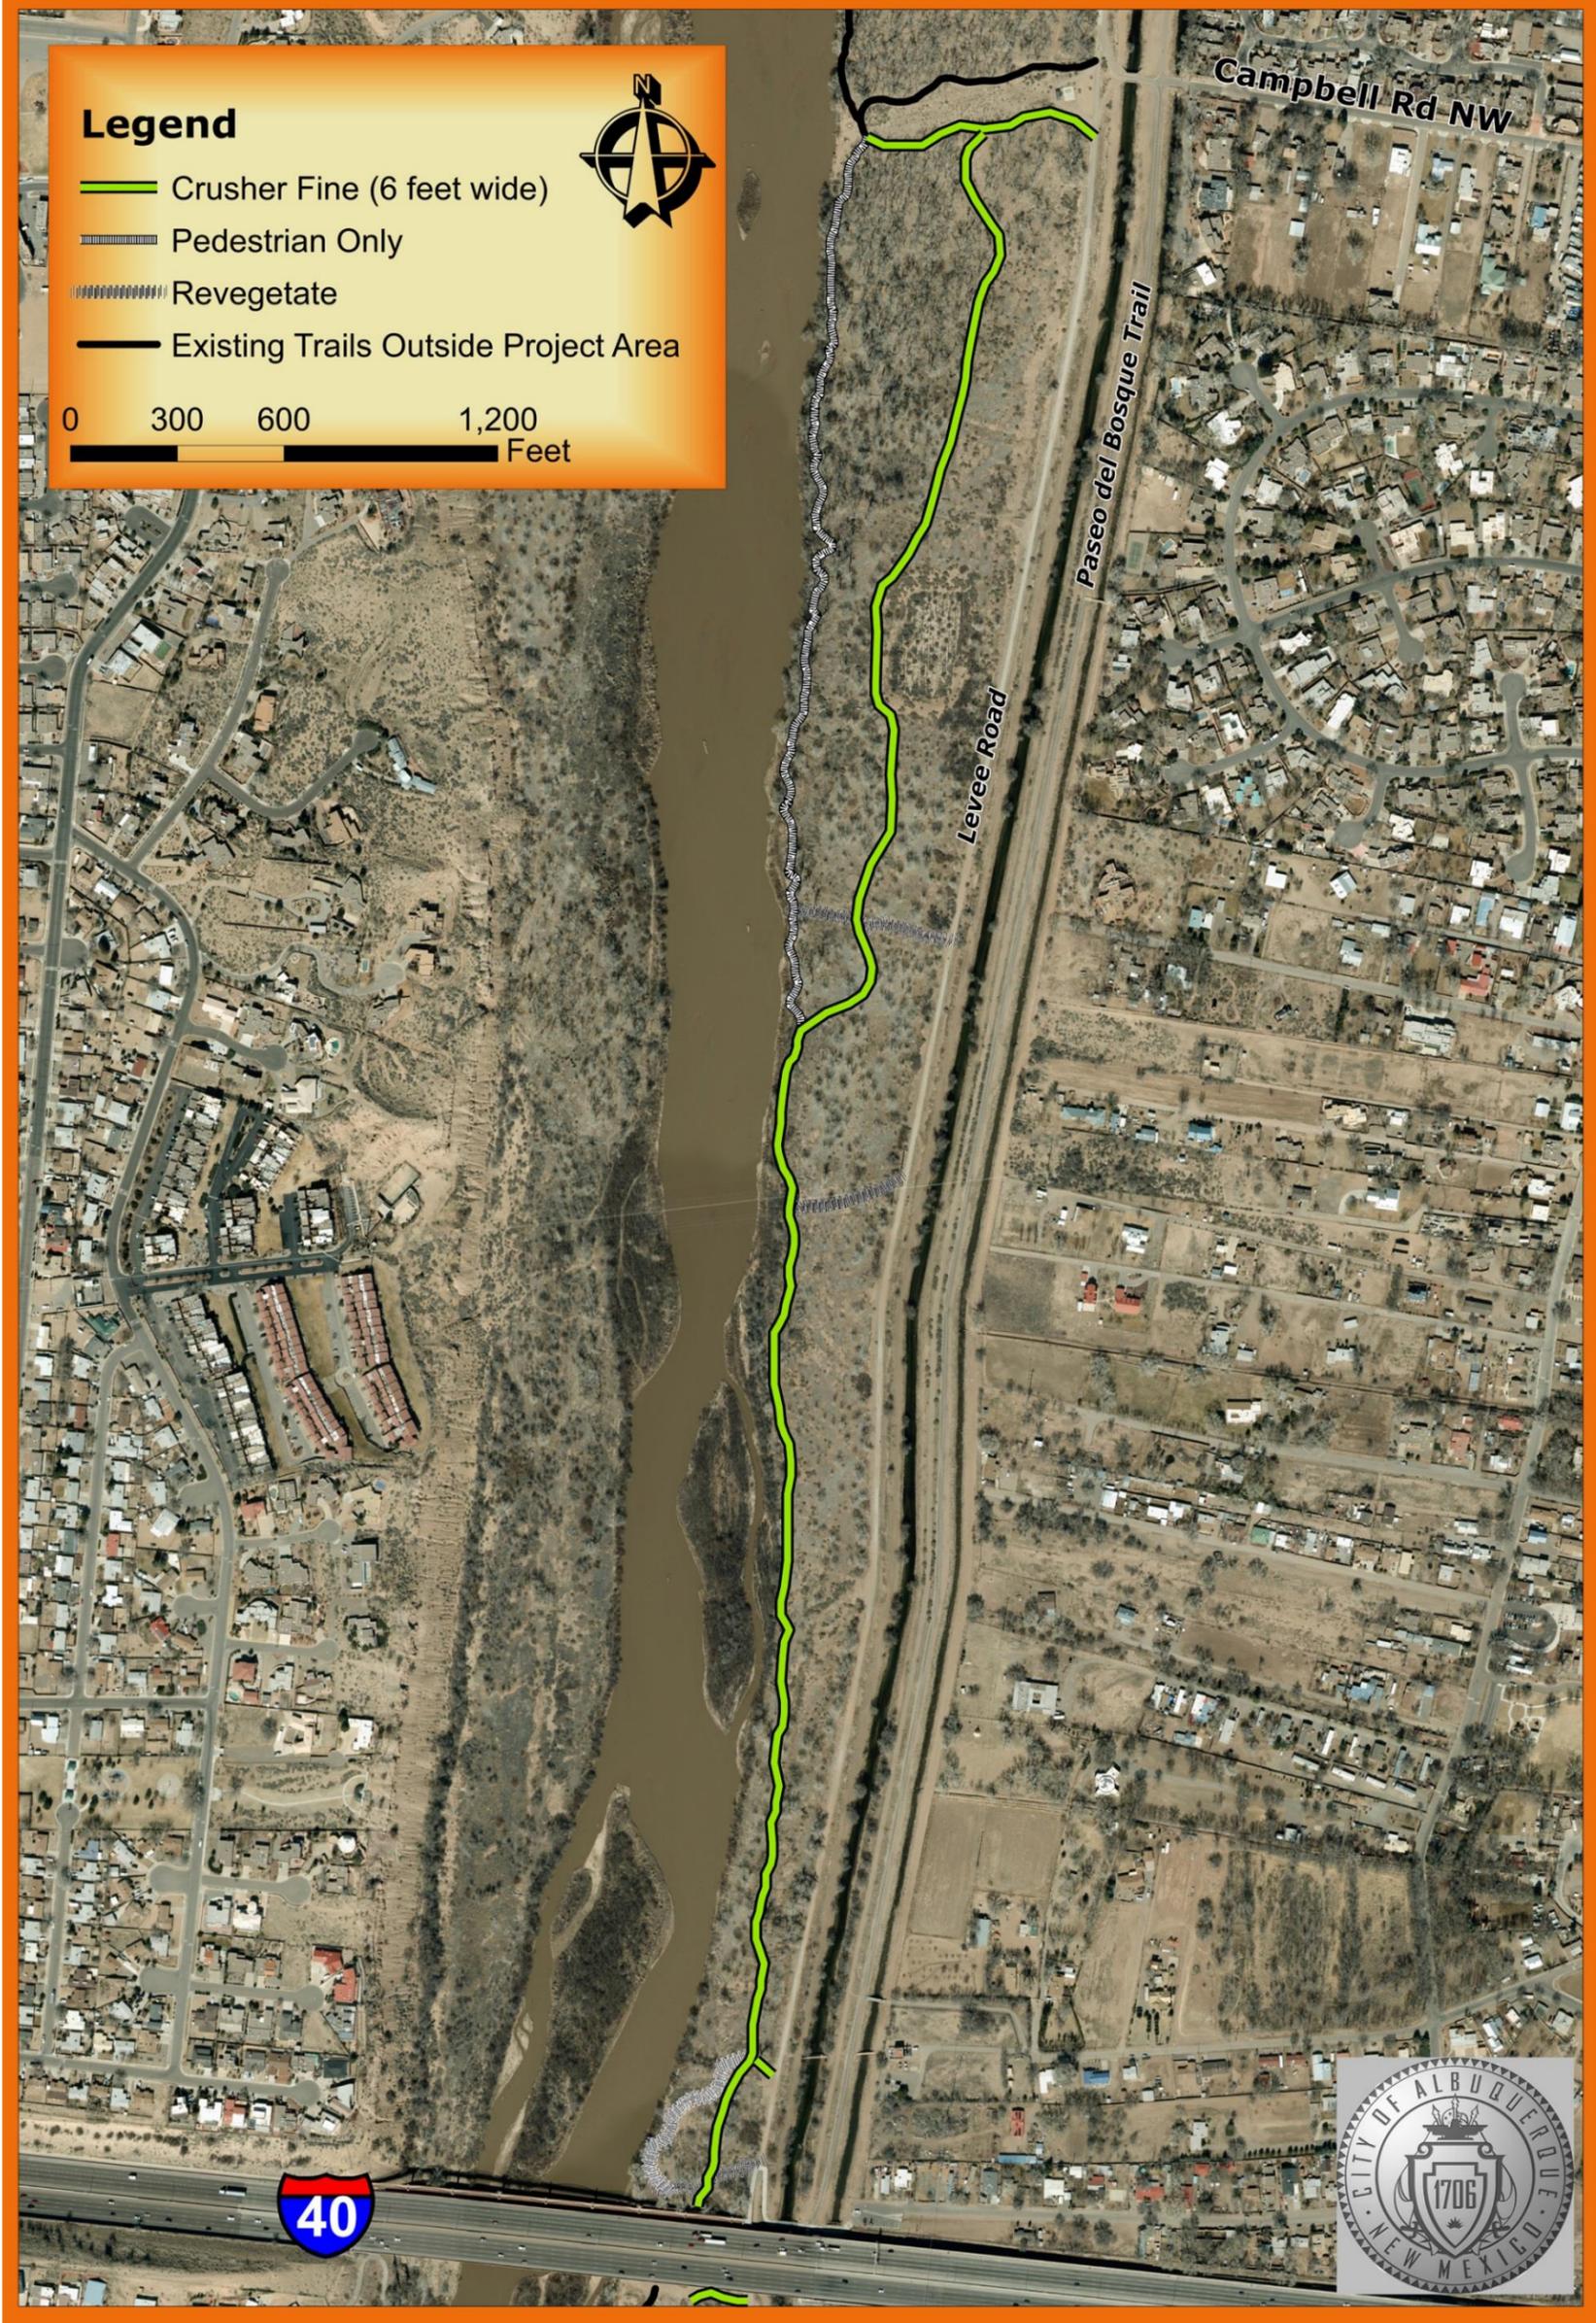
Alternative 2B: Crusher Fine Path on Existing Path Alignment and Former Restoration Road
