**Rio del Norte Bosque Trail
Improvement Project: 2015 Post-
Construction Environmental
Monitoring Report, Central Avenue to
Interstate 40**

City of Albuquerque, Open Space Division

SWCA Environmental Consultants

January 2016

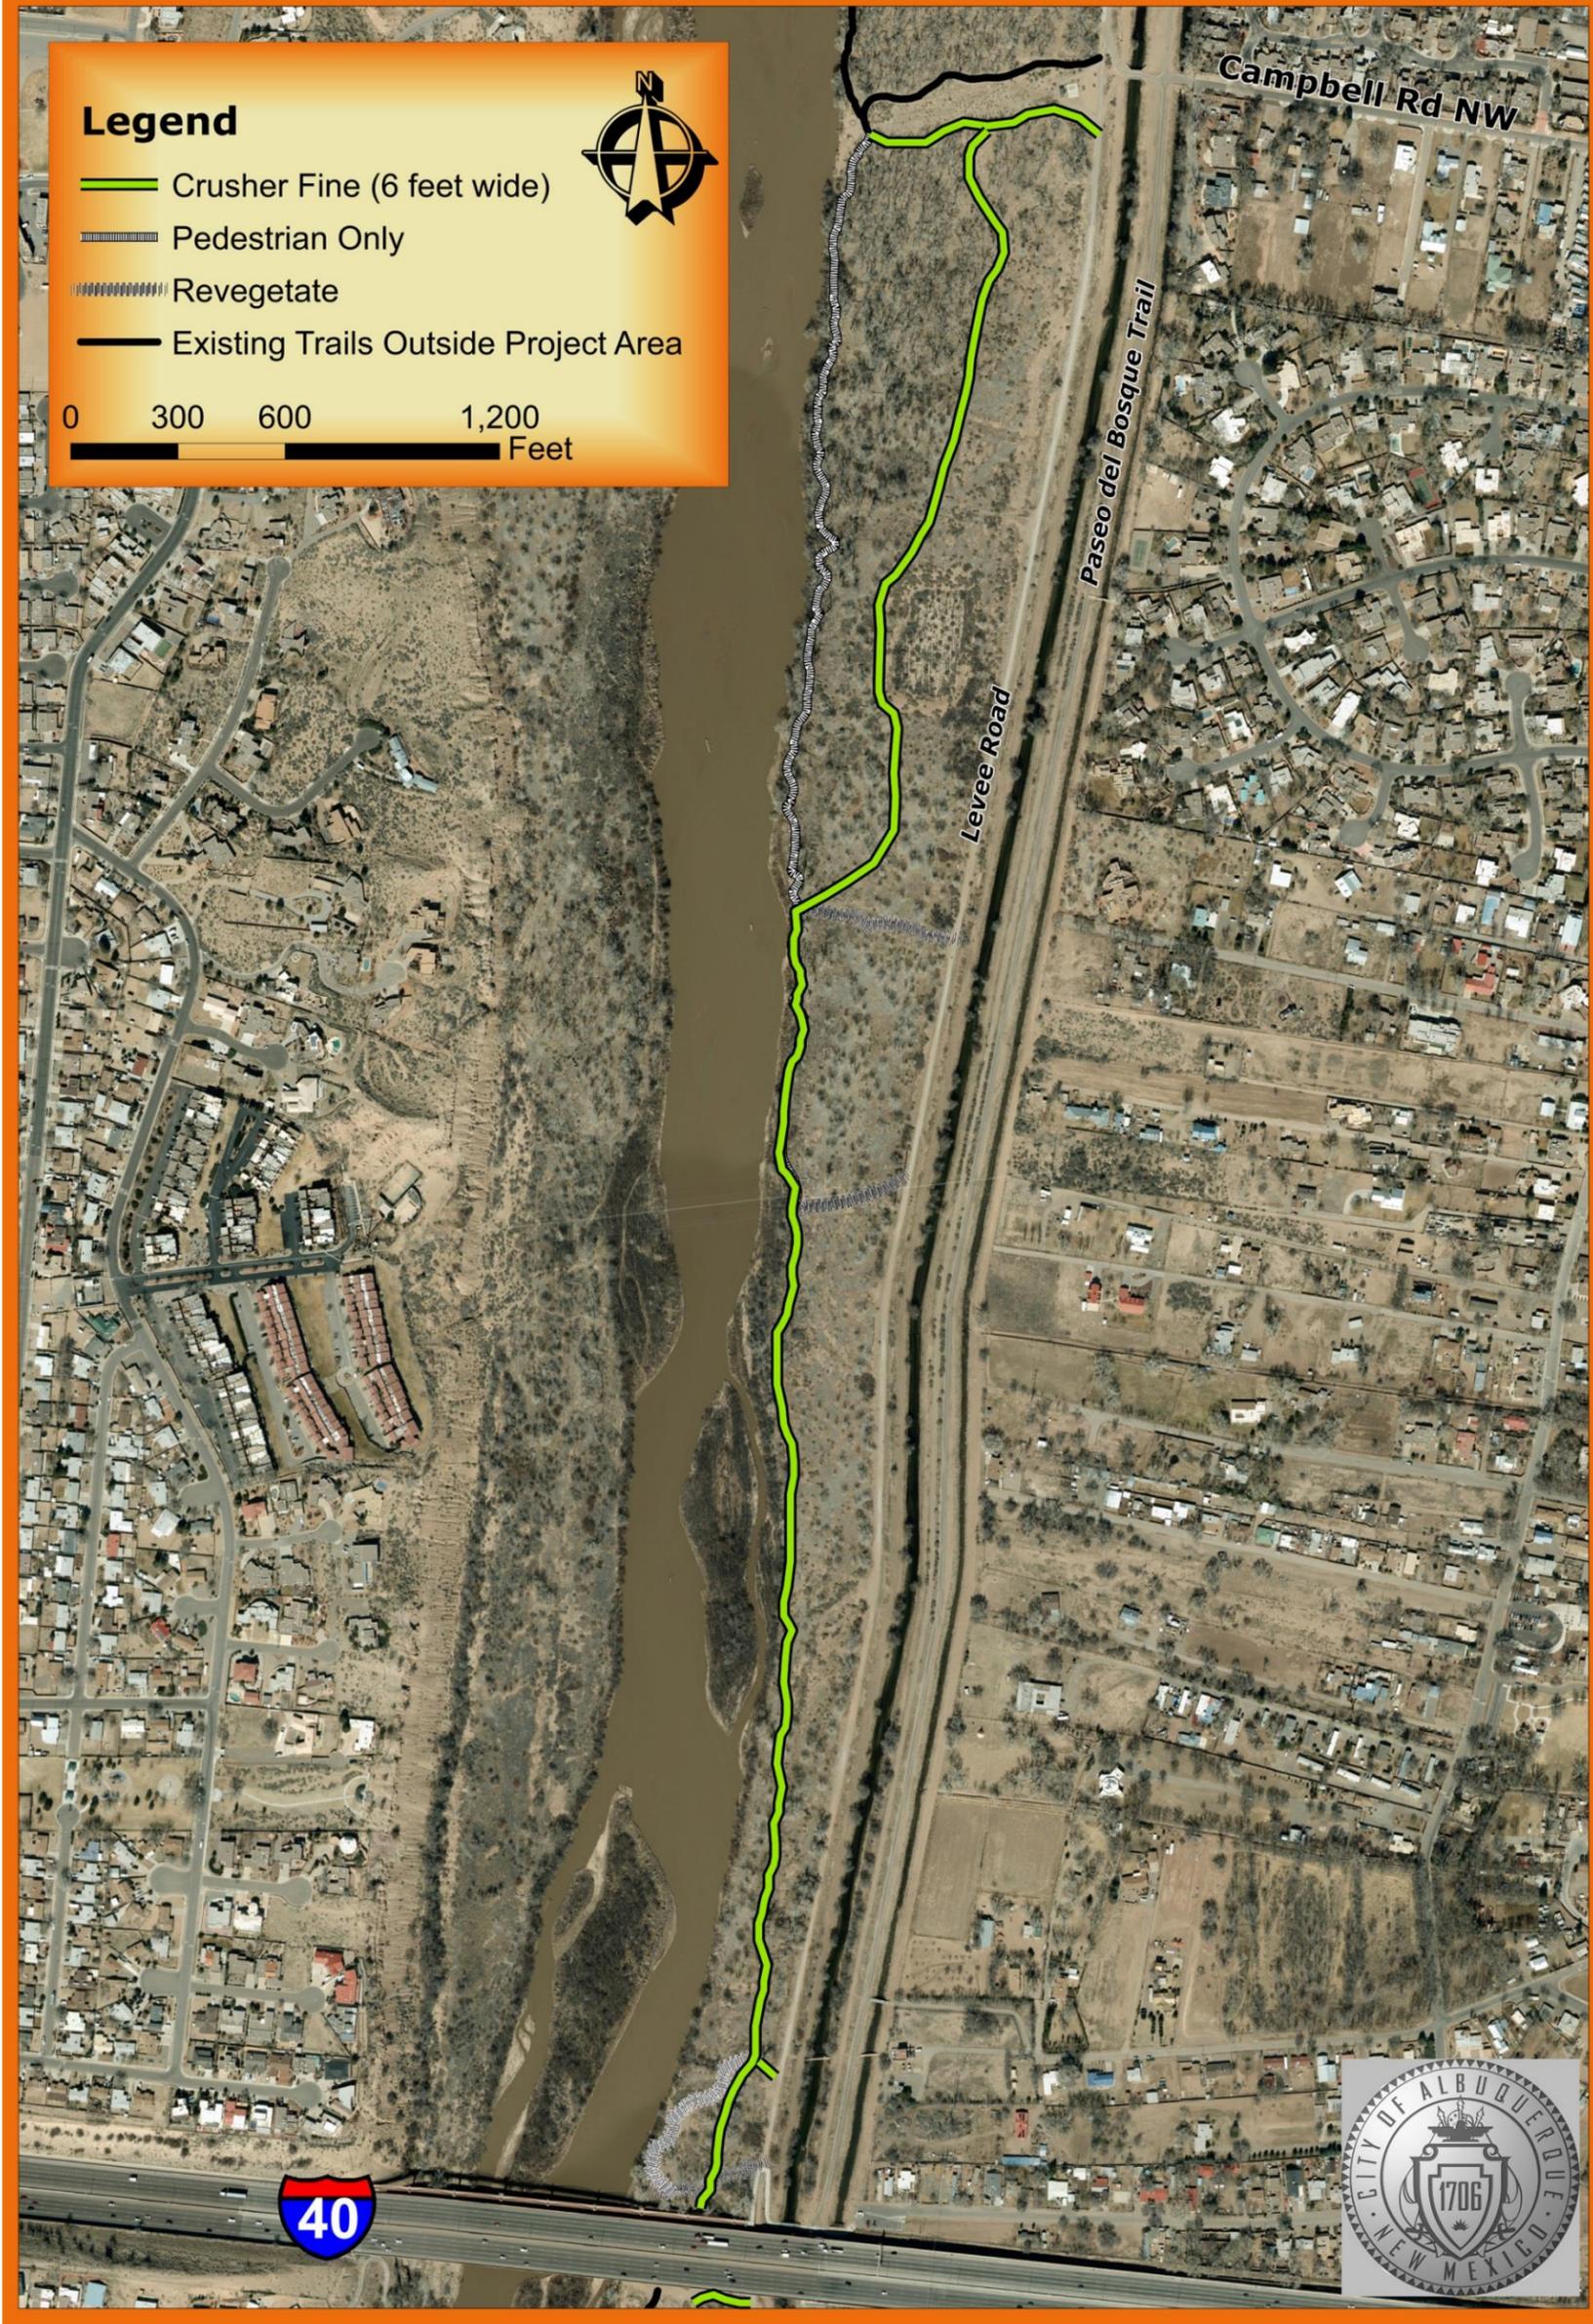
Alternative 2C: Crusher Fine Path on Existing Path Alignment and Former Restoration Road

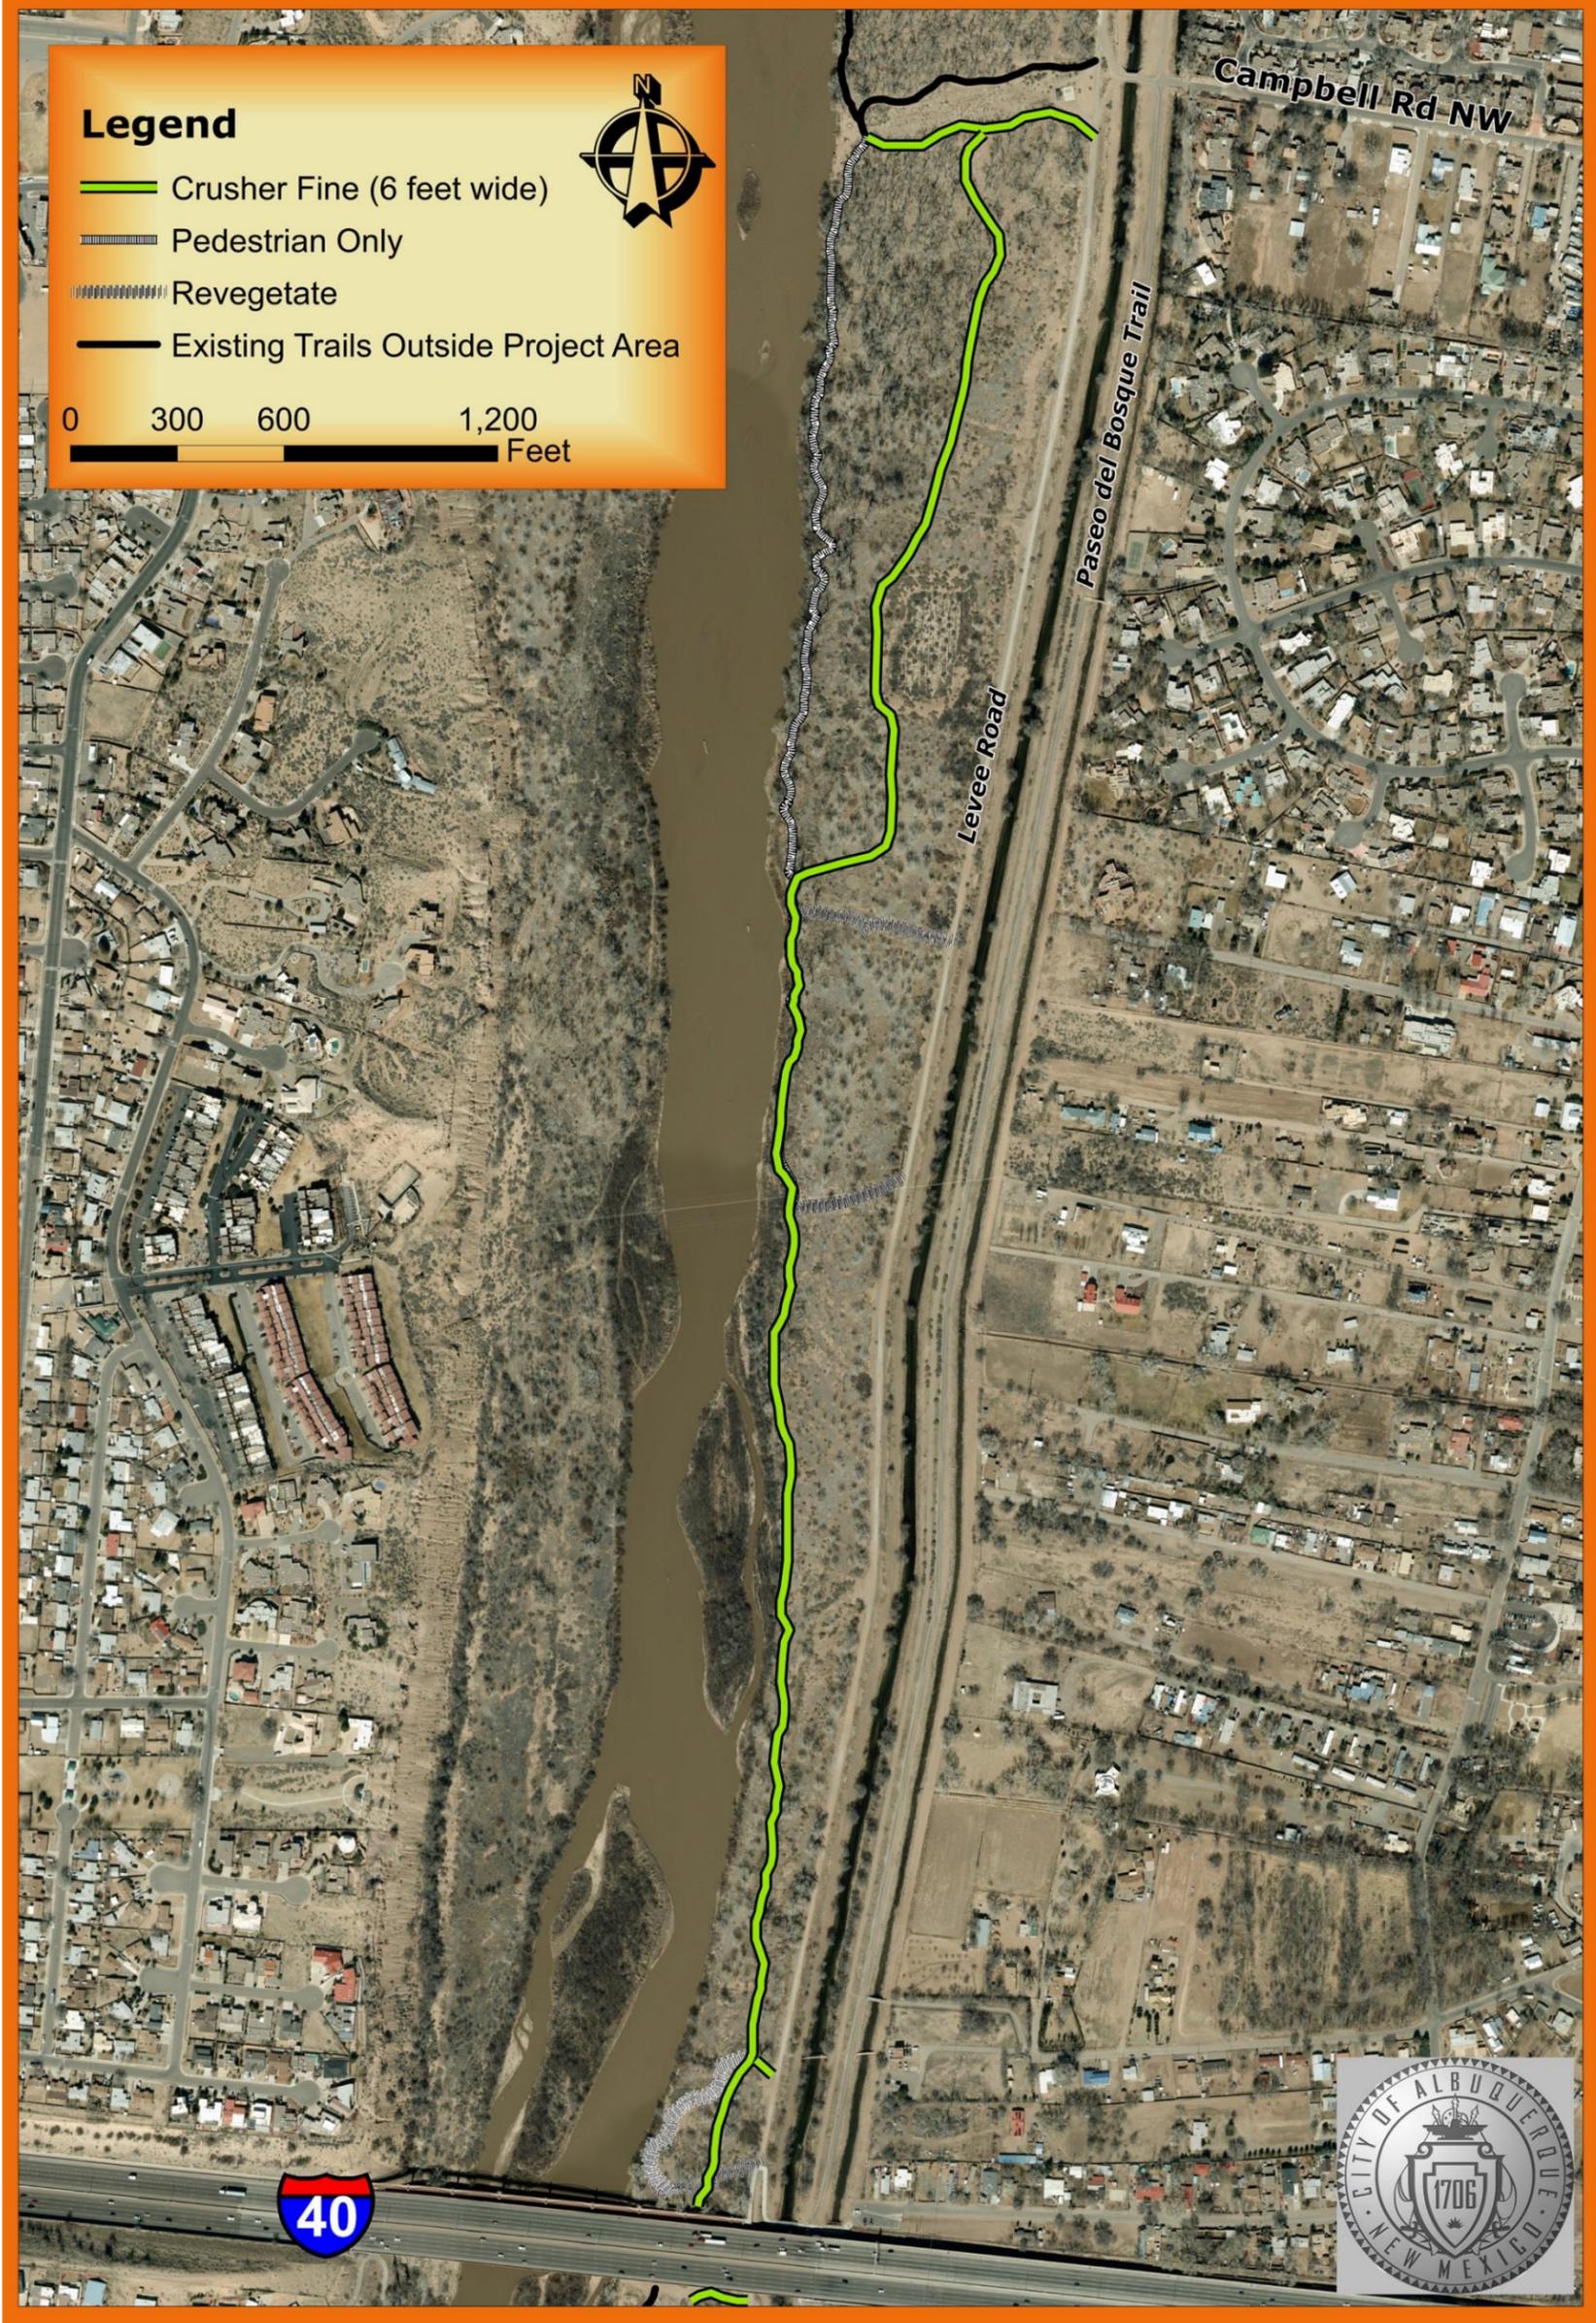
Alternative 2D: Crusher Fine Path on Existing Path Alignment and Former Restoration Road

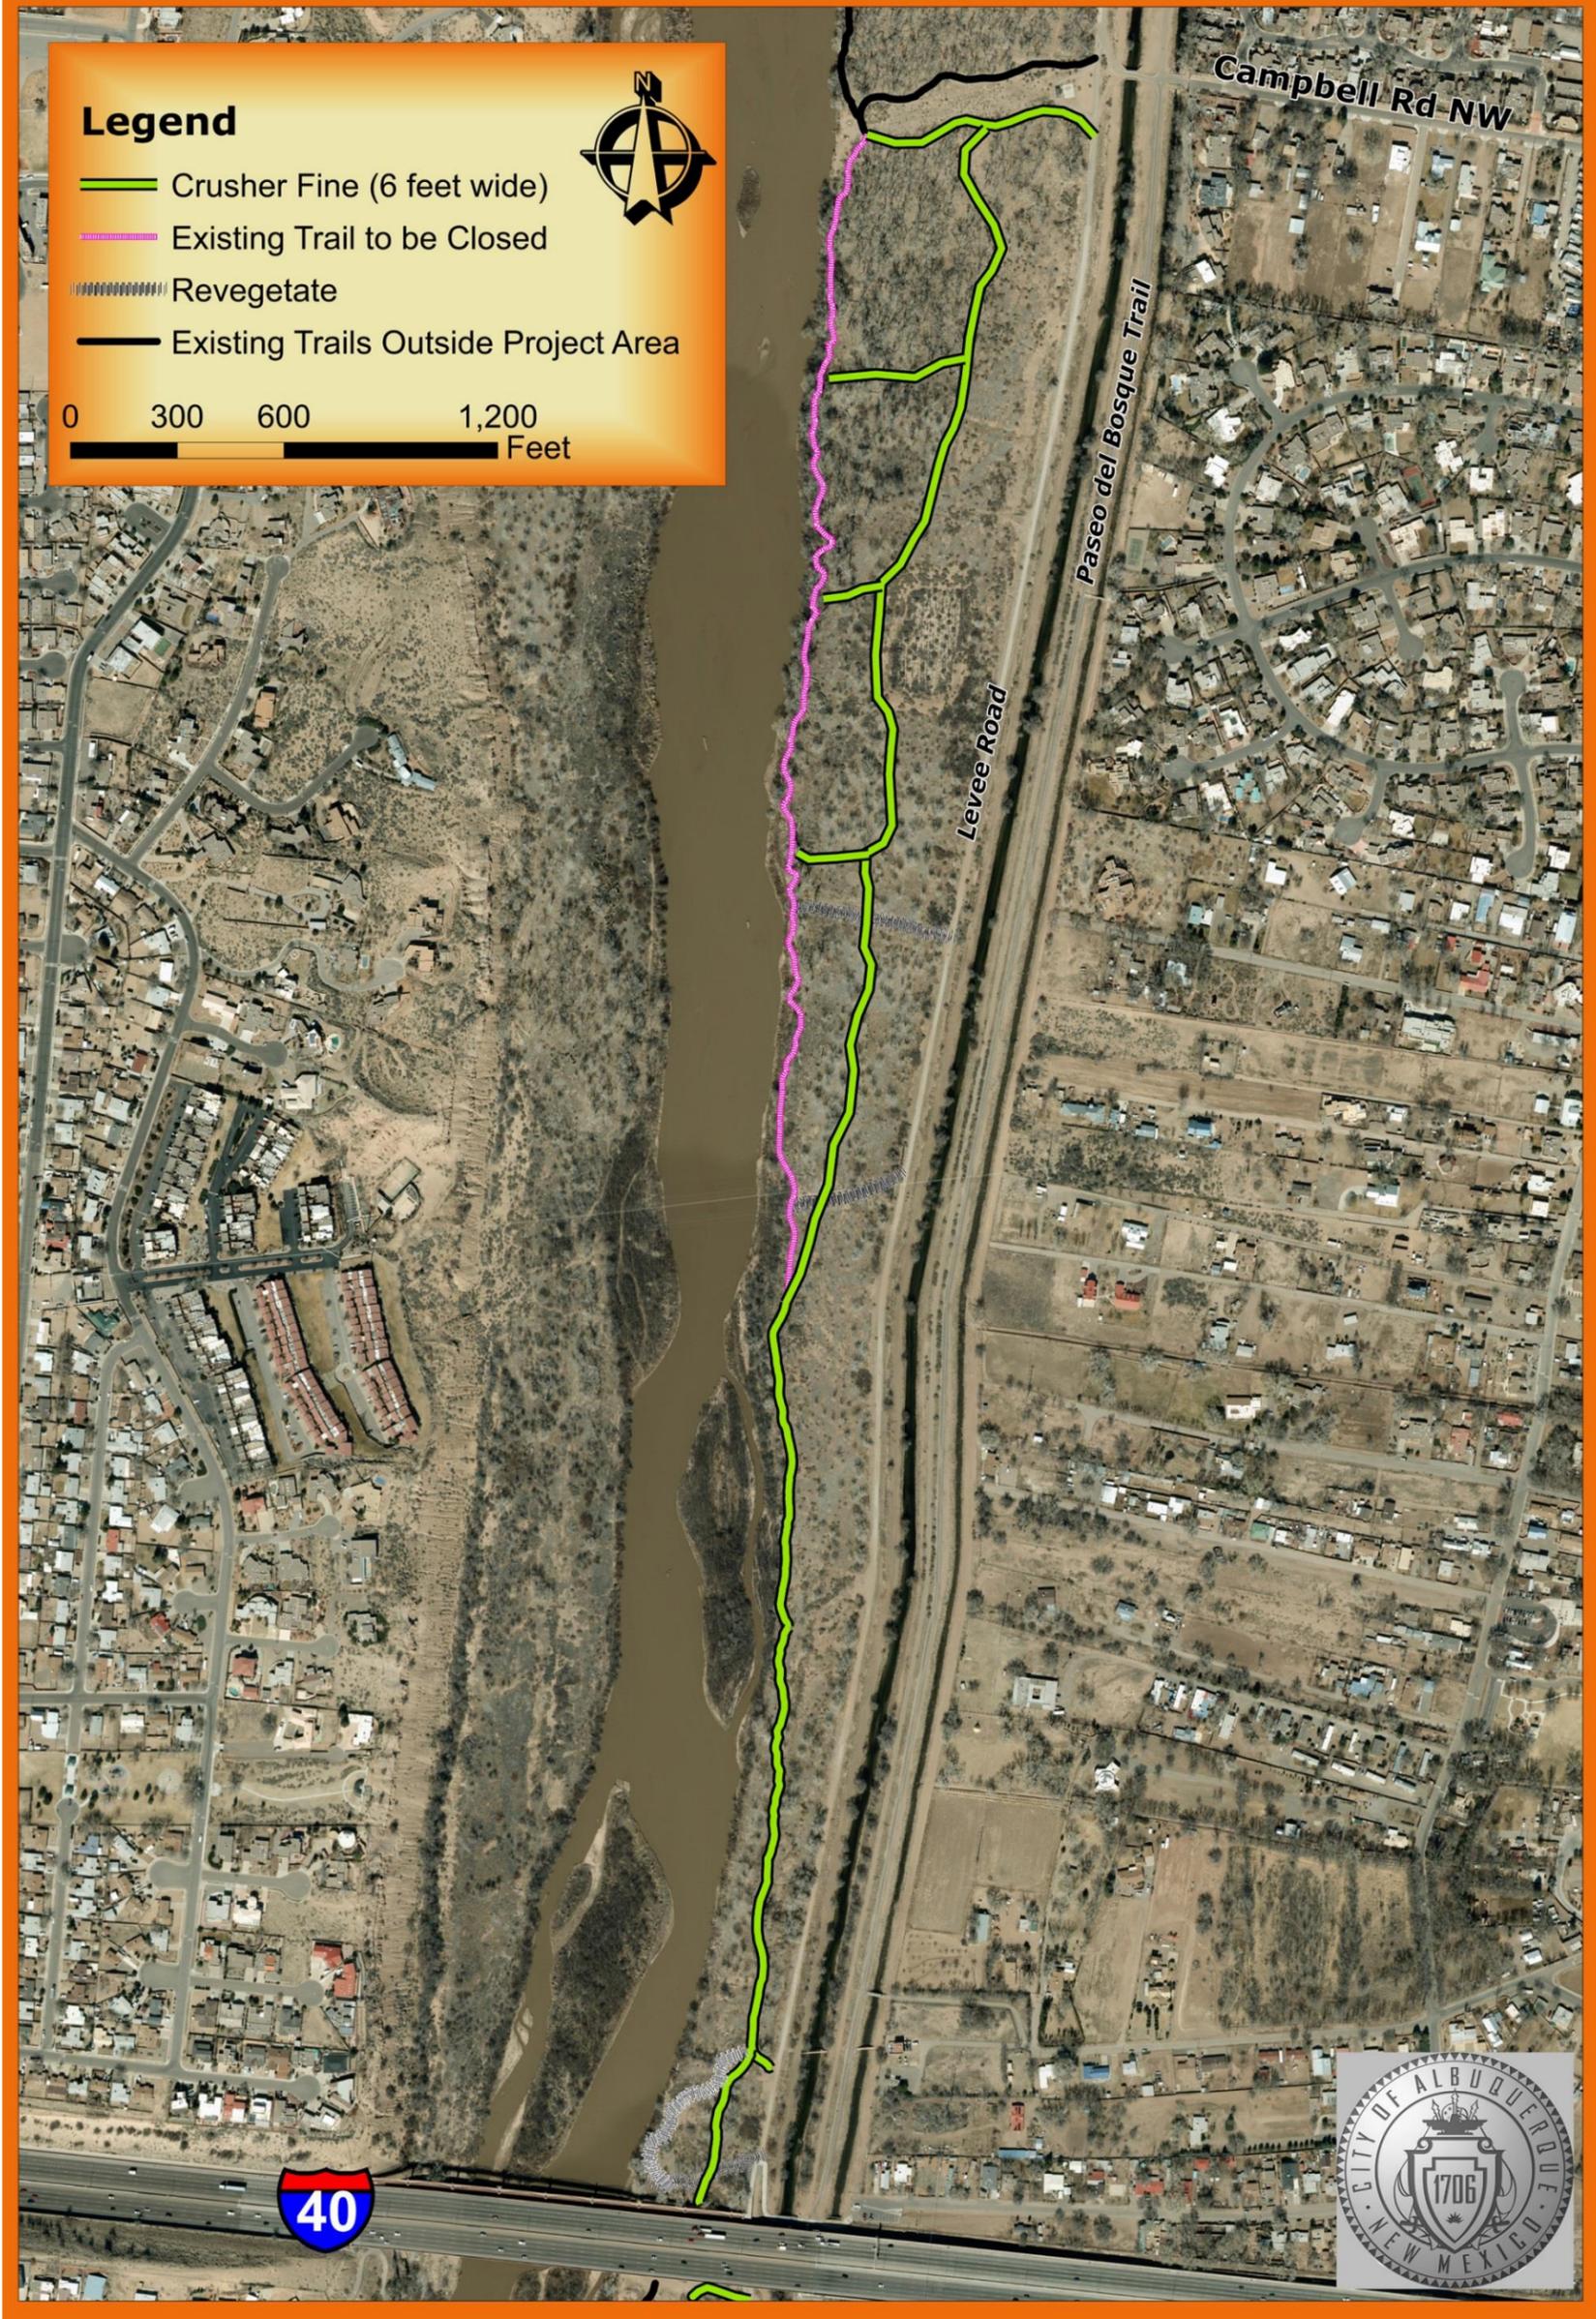
Alternative 3: Crusher Fine Path on Existing Path and Former Restoration Road with Side Spurs to River
