**Central Avenue to Interstate 40  
Bosque Trail Improvement Project:  
2015 Post-Construction Environmental  
Monitoring Report**

**City of Albuquerque, Open Space Division**

**SWCA Environmental Consultants**

January 2016

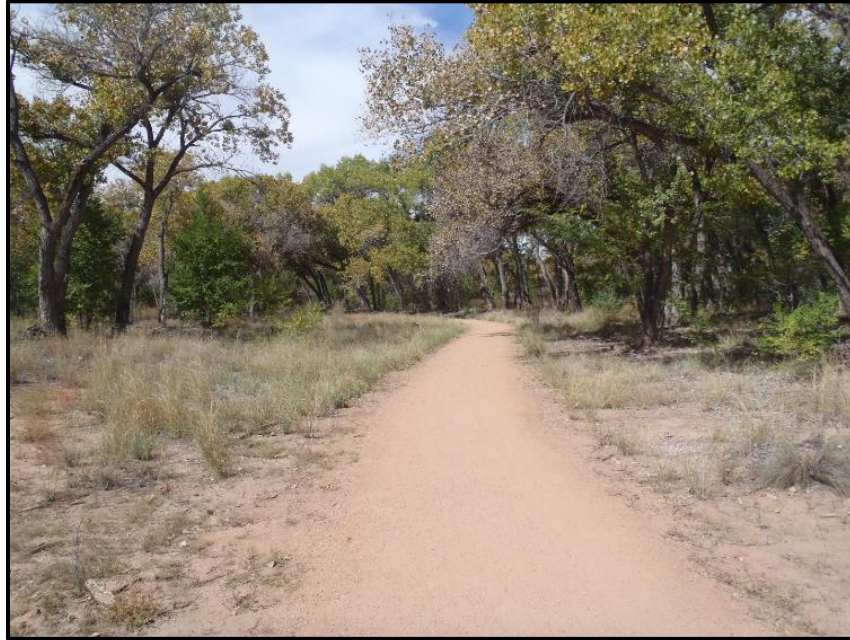
**Figure 1.1. The Rio del Norte Bosque Trail about 0.25 mile north of Central Avenue. Note the crusher fine gravel surface and approximate 6-foot width of the newly leveled and surfaced trail. SWCA photograph, October 2015.**

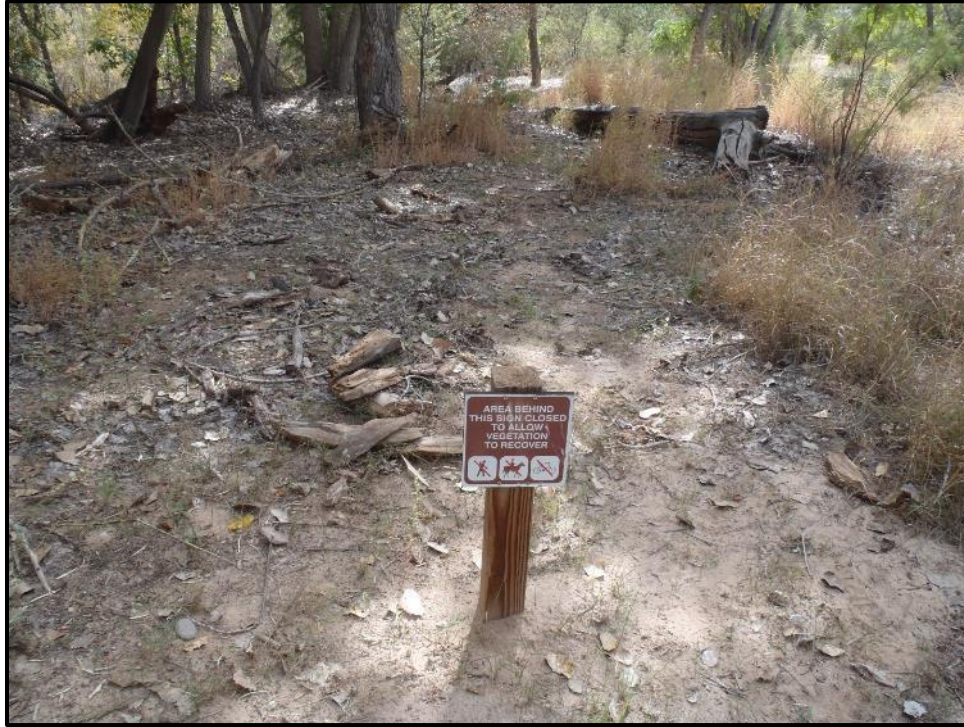
**Figure 1.5. Example of an unofficial visitor-created unofficial side trail that was closed for restoration. SWCA photograph, October 2015.**

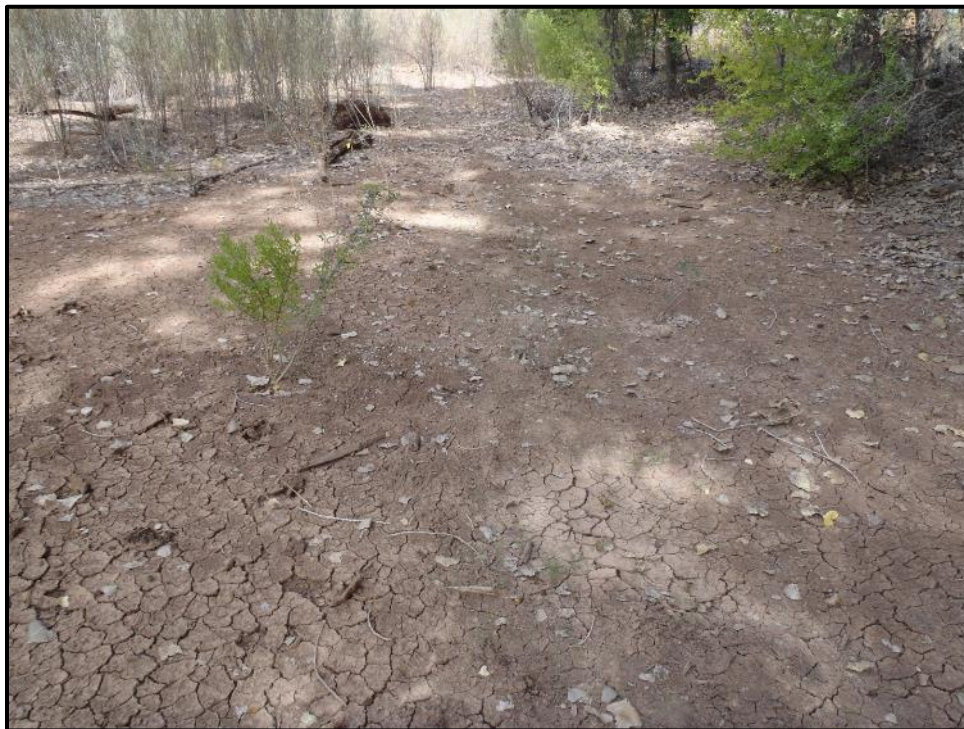
**Figure 1.6. A New Mexico olive shrub (upper left foreground) and grass seedlings (lower right foreground to upper center) planted along a closed unofficial side trail in 2015. SWCA photograph, October 2015.**

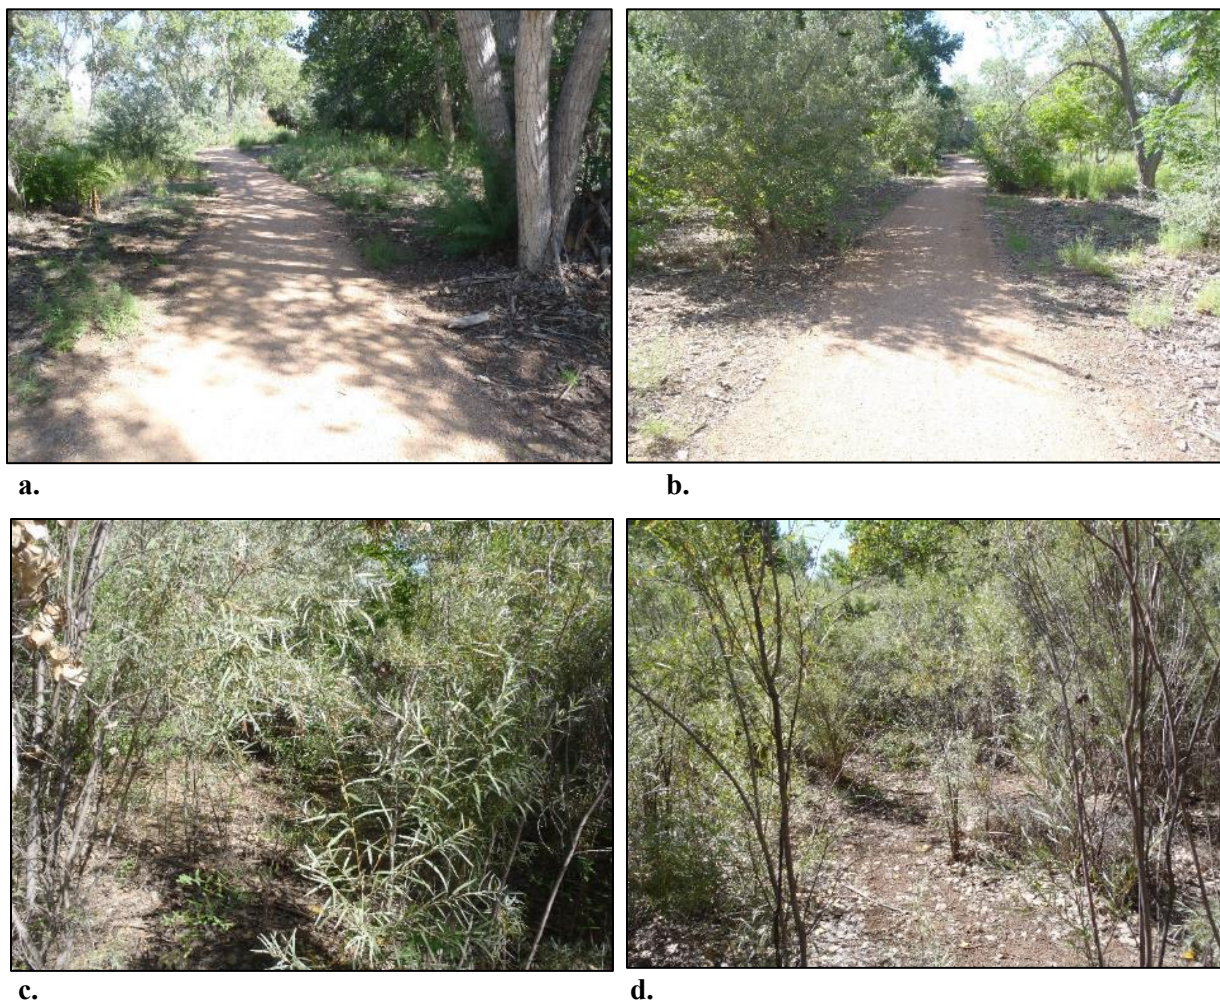
**Figure 2.18.** Example 100-m trail repeat photo point photographs along the trail at point 10, 1 km north of Central Avenue a. Trail view north. b. Trail view south. C. Control 30 m east of the trail view north. d. Control 30 m east of the trail view south.

A series of new repeat photo points was established along the trail at 100-m intervals from Central Avenue to I-40 in 2015 (see Figure 1.8). From the trailhead at Central Avenue, a point was established along the trail every 100 m, and paired control points were established 30 m to the east of each trail point for comparison. At each trail (treatment) and control point, a photograph was taken providing a view to the north and another photo taken providing a view to the south. Figure 2.18 is an example of one set of such photographs from location 10, 1 km north of Central Avenue (see Figure 1.8). The 100-m photo points will be re-photographed each year, and new ones added as trail improvements extend north of I-40. In addition to the plot and transect monitoring, these 100-m photo points will provide almost continuous views of the trail over the coming year to help evaluate the environmental effects of the trail.

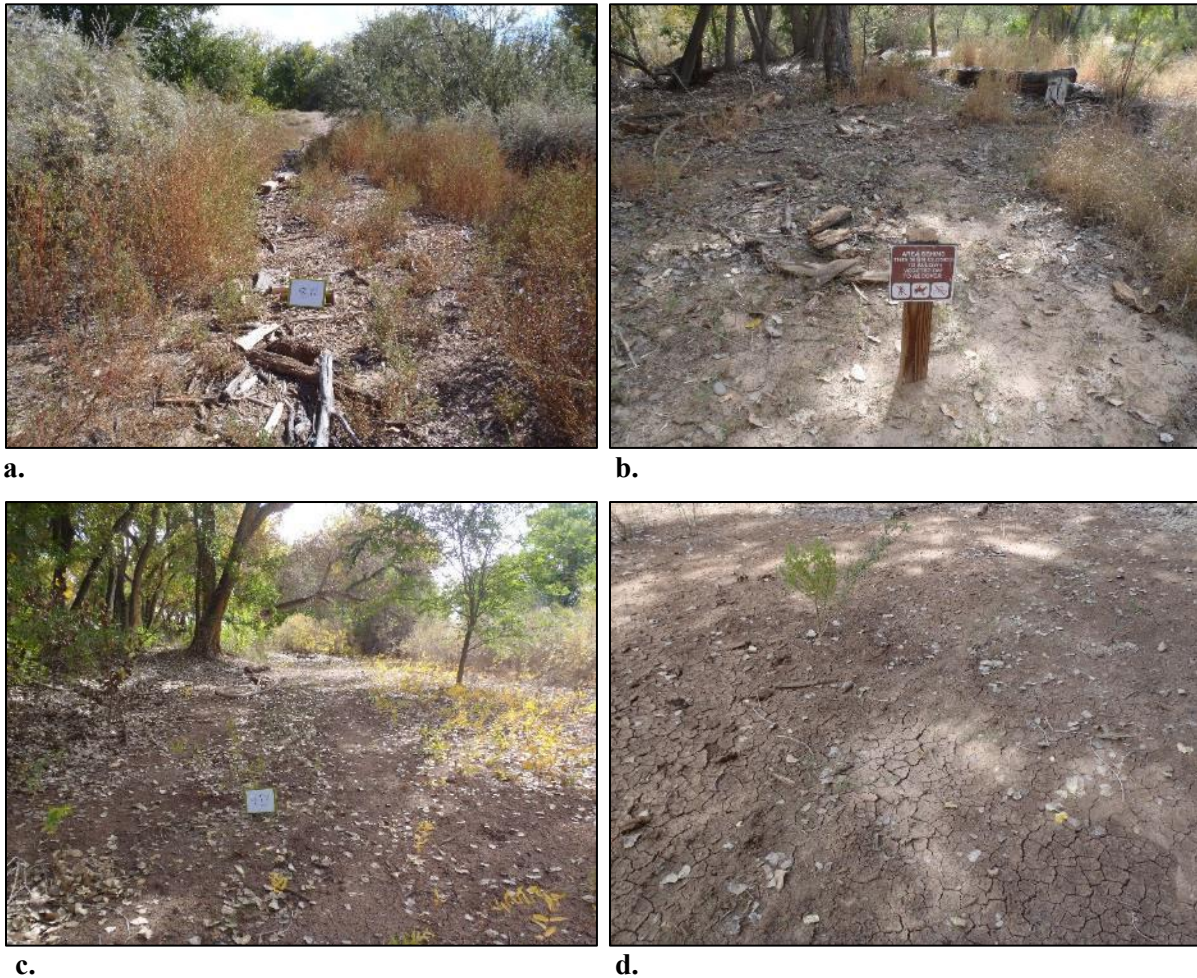
**Figure 2.20. Unofficial visitor created side trails that connect to the trail. a. side trail with wood debris placed to discourage access and to stabilize soil surfaces. b. Sign asking visitors to stay off closed trail. c. Closed side trail that was seeded with native grass. d. New Mexico olive and seeded grass on closed side trail.**
