# ELENA GALLEGOS OPEN SPACE SITE IMPROVEMENTS PROPOSED SITE IMPROVEMENTS

Elena Gallegos Open Space has experienced an increase in visitors over the last few years and is in need of specific improvements to facilities. Improvements include repaving of the Loop Rd used to access parking and trailheads, updates to reservation areas, picnic areas, and vault toilets, removal of the barn near the Cottonwood Springs Area, and repairs and improvements along the ADA accessible Cottonwood Springs Trail.

## **EDUCATION CENTER - COMPARATIVE SITE ANALYSIS**

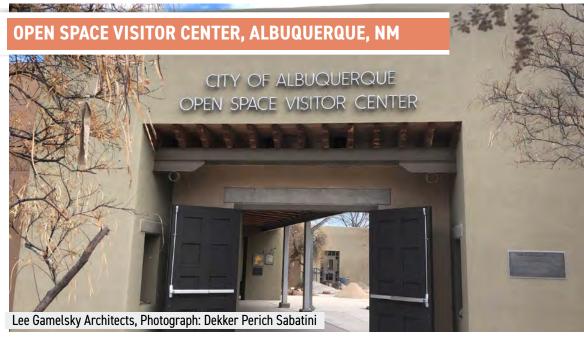
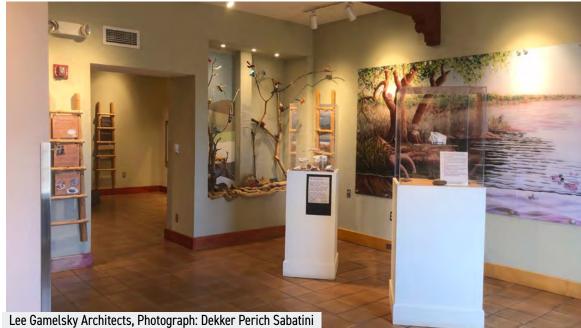
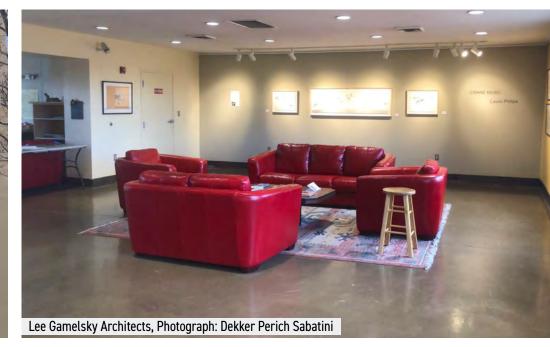
PROS	CONS
Adequate Space Available for Visitor Volume	Underutilized Space
Adaptive Reuse	Small Rooms
Juxtaposition of Historic & Educational Elements	Small Restrooms
Spectacular Views to Bosque, Sandia Mountains	Confusing Layout

The following precedent projects are examples of developed visitor/education centers throughout the Albuquerque area that showcase the natural environment of the Bosque and invite the community to observe and learn about the flora and fauna of the environments found within the area. All three precedent projects are located near or within the Bosque that surrounds the Rio Grande, with three located within City of Albuquerque Major Public Open Space.

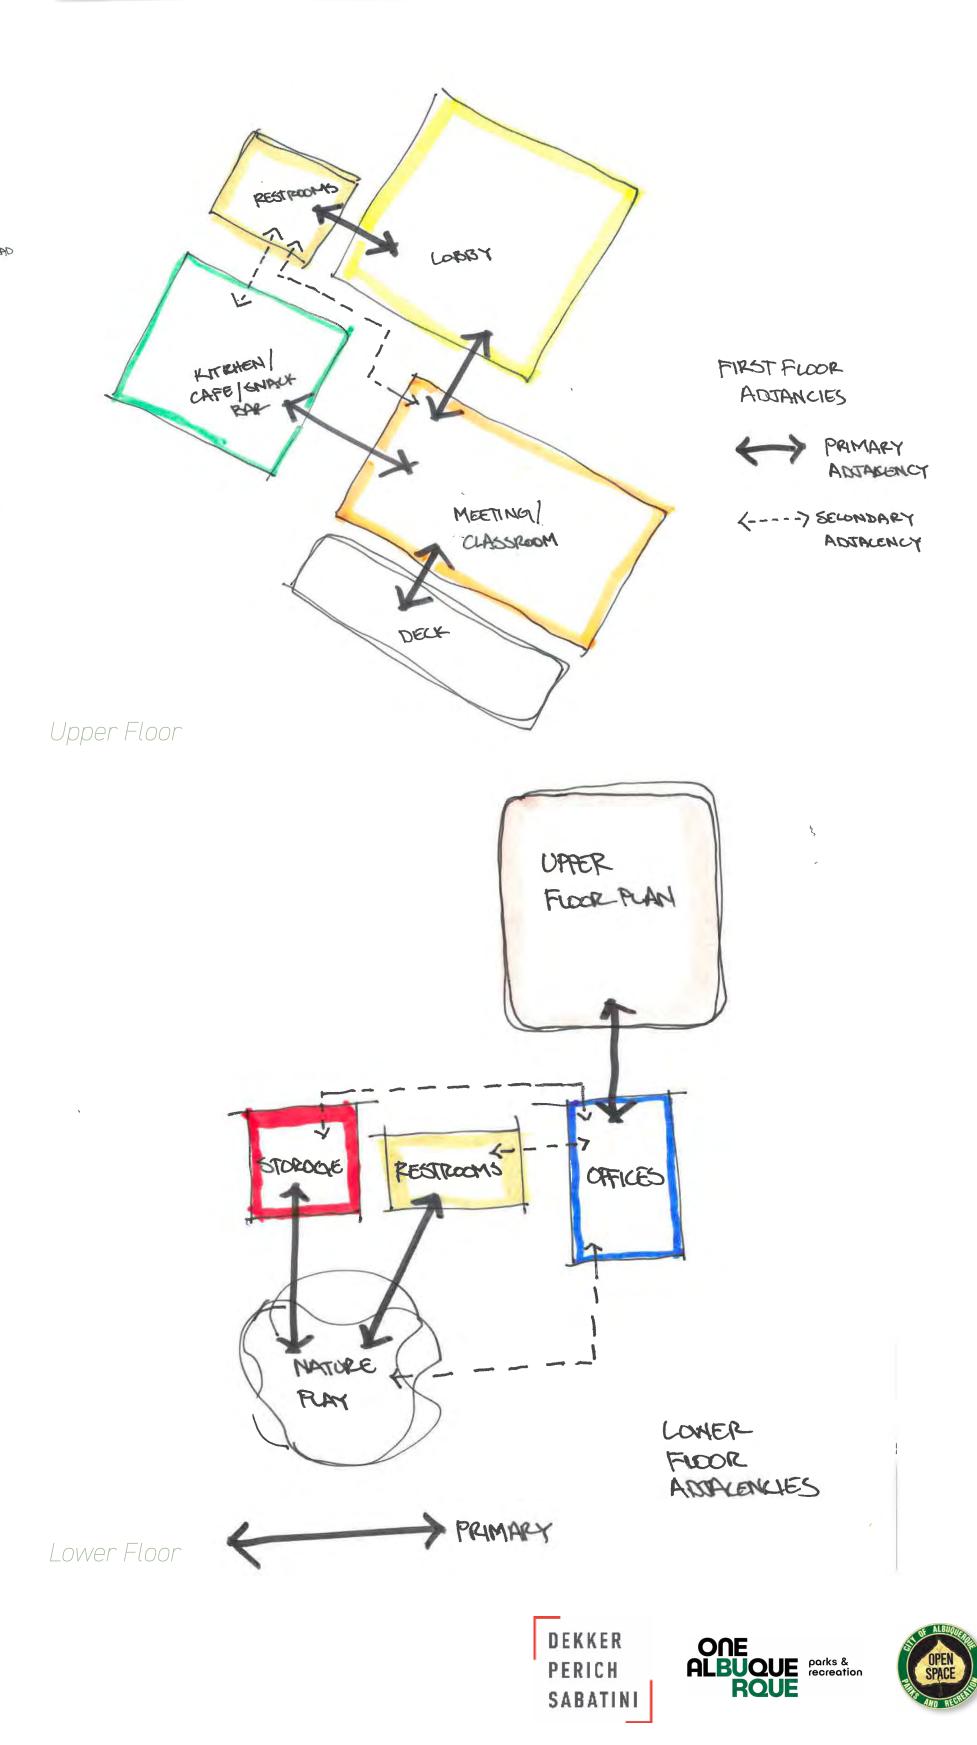
#### BUILDING ADJACENCIES DIAGRAM

This phase of the Feasibility Study identifies the space needs for an education center and generates a corresponding conceptual building footprint and site plan. Using the preferred site location, the project team created a conceptual program for a facility in the approximate range of 6,000 to 10,000 square feet. The building is intended to accommodate a range of activities, be flexible in its layout, and be designed to minimize energy consumption. The following diagrams and measurements offer a conceptual understanding of required square footage for each space and their relationship to each other on the selected site.

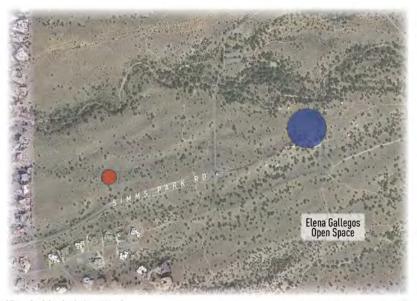
VIEW 1

A viewshed analysis was conducted to determine the impact of a two-story building at the recommended site location for an education center. Since the building is not architecturally designed at this point, it is indicated as a massing model in green in the image renderings. Each image/diagram provides the views looking directly to the building at different proximities and angles to the site, with each view getting progressively closer to the site.

Two analyses were conducted to further explore potential impacts of an education center to the surrounding environment. A viewshed analysis shows the impact of a two-story building at the preferred site location within Elena Gallegos Open Space while a road analysis details the condition of Simms Park Rd, which is the singular road used to access Elena Gallegos Open Space.

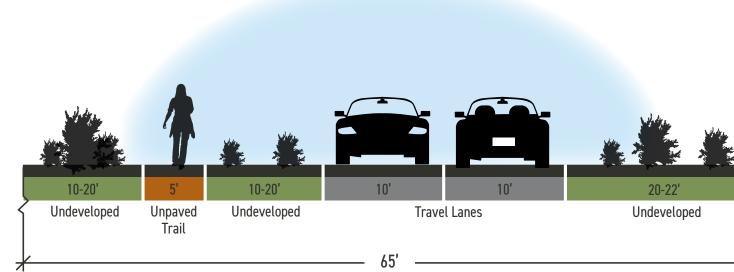
#### Existing Simms Park Road Section

Simms Park Rd is the singular vehicular access point to Elena Gallegos Open Space. Simms Park Road is owned and maintained by the City of Albuquerque, including the portion of the road located outside of the Albuquerque City Limits, on the eastern end near Elena Gallegos Open Space. The condition of the road is fair, with minor cracks and surface deterioration. Simms Park Road is approximately 1.4 miles long from the intersection with Tramway Blvd to the west and the Park Attendant Booth to the east. The public right-of-way is an average of 65 ft wide and widens on the western end near Tramway Blvd while the paved travel lanes are 22 ft wide with no additional paved shoulder. A 5-ft wide compacted dirt trail exists on the south side of the road and accommodates pedestrians and mountain bikers.

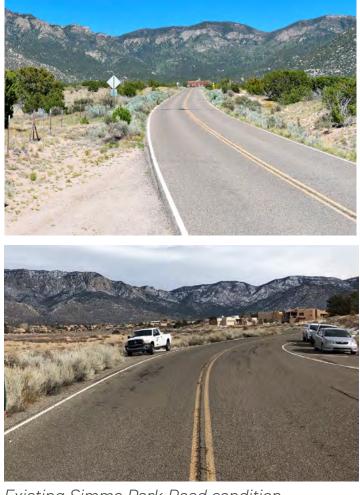
Existing Simms Park Road condition

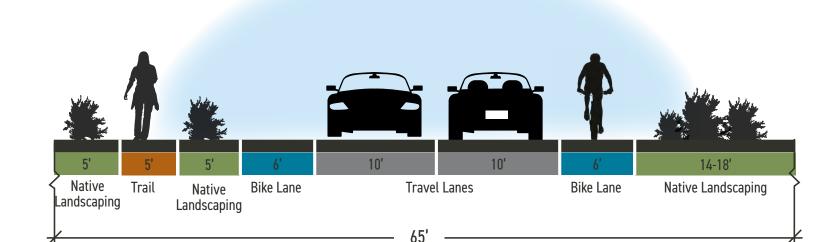
Potential Simms Park Road Section

The existing 65 ft wide public right-of-way provides an opportunity for improvements to Simms Park Road without requiring further right-of-way dedication. The existing paved travel lanes could be resurfaced and restriped and a 6-ft wide bike lane could be added to both sides of the roadway. The improved pavement width with bike lanes would be 34

The remaining 31 ft of right-of-way could be improved by enhancing the existing trail on the south side of Simms Park Road. The trail could be stablized by adding gravel or through compaction. Additional native landscape plantings could be added to the existing natural undeveloped right-of-way.
