Rio Grande Boulevard and Candelaria Road Intersection Evaluation

A/E Job No. 7380-01, NTP #2
PB Project 33612

City of Albuquerque

October 2008

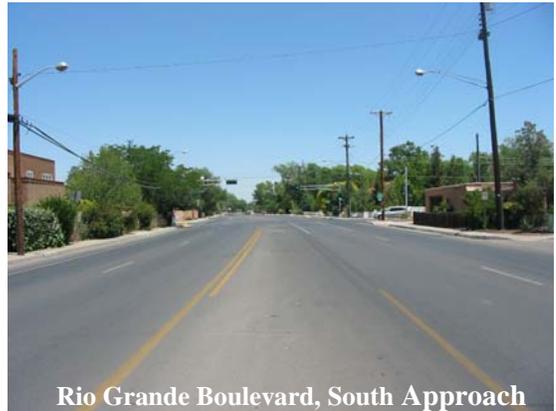
The approaches to the Rio Grande Boulevard and Candelaria Road intersection do not have any adverse horizontal or vertical geometry within the project area. All four approaches are relatively flat in the vicinity of the intersection. There is no horizontal curvature on either Rio Grande Boulevard or Candelaria Road in the vicinity of the intersection. Additionally, the roadway sections appear to have normal crown sections and are without superelevation. Therefore, the intersection and roadways adhere to the geometric requirements of DPM Table 23.3.1 – General Design Criteria for Streets, as shown below.

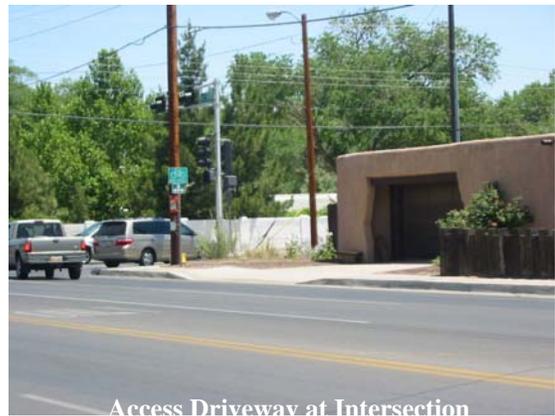
The close proximity of driveways and minor street intersections to the primary intersection can result in operational deficiencies along the roadways and at the Rio Grande Boulevard and Candelaria Road intersection.

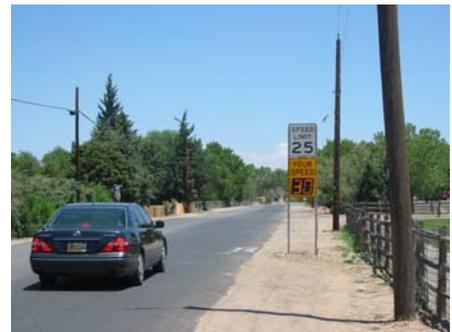
Speed actuated dynamic message signs can be installed along all four of the approaches to the intersections to indicate travel speeds to motorists. The dynamic message board indicates the travel speed as a vehicle approaches the sign. These automated driver feedback signs can be placed in conjunction with a regulatory speed limit sign to alert drivers to speeding violations. The approach speed will register in a different color and will flash if a vehicle is speeding.
