EL VADO MOTEL

Structural Evaluation

Final Report August 2006

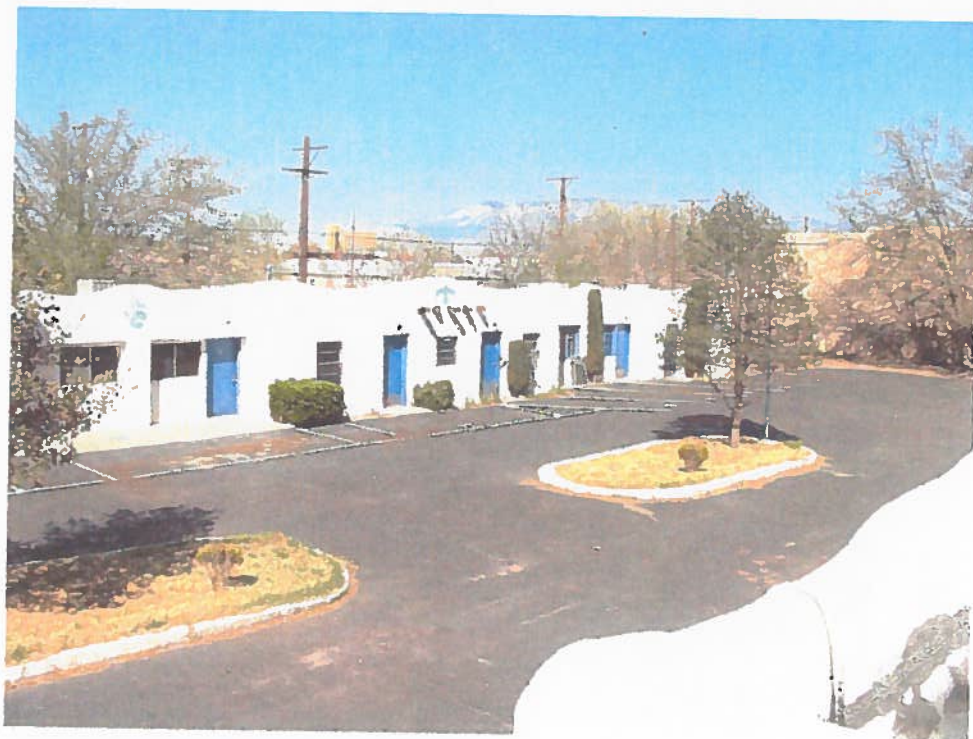
Figure 10 Asphalt Paving and Landscape Island

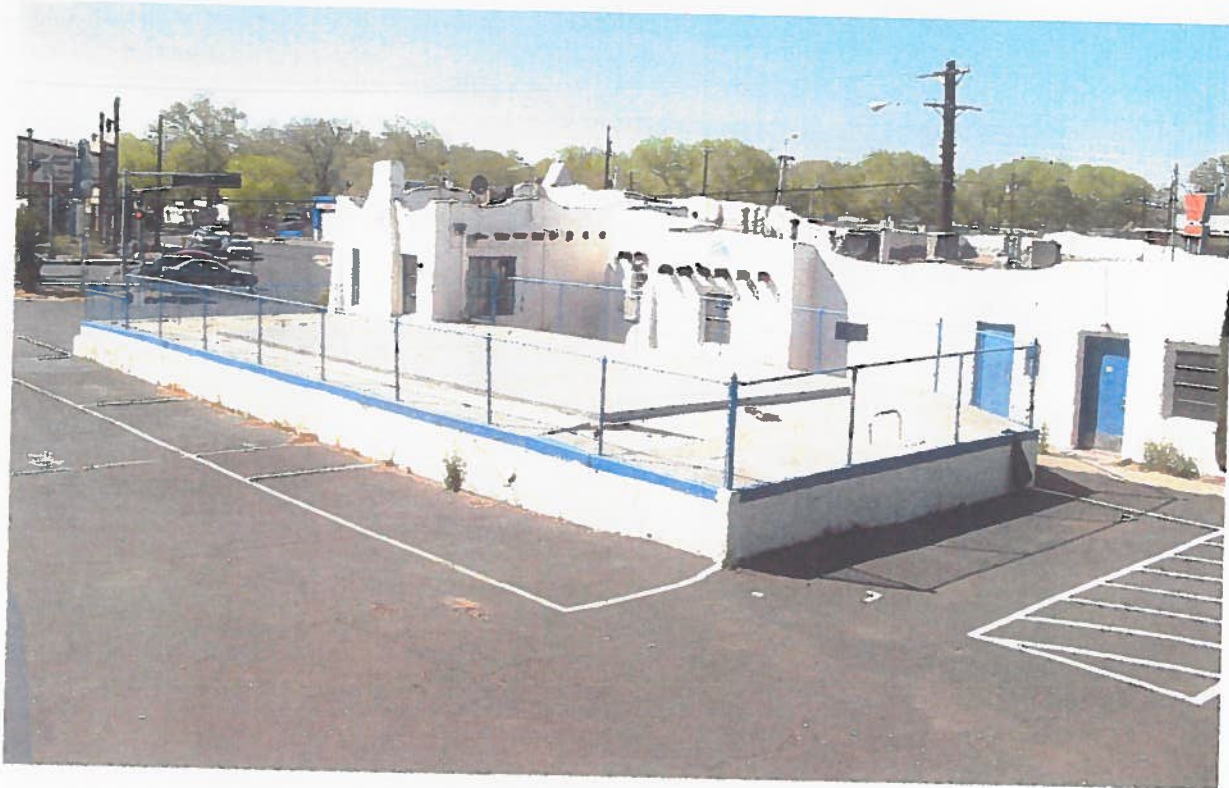
Figure 12 El Vado Swimming Pool

The swimming pool of the El Vado has been closed for a few years due to structural cracks in the concrete walls and decking (Figure 13). Currently the perimeter is enclosed with a chain link fence. The pool surface is covered with plywood panels and asphalt roofing. The mechanical room for the pool is also dilapidated and is out of compliance with plumbing and electrical codes.

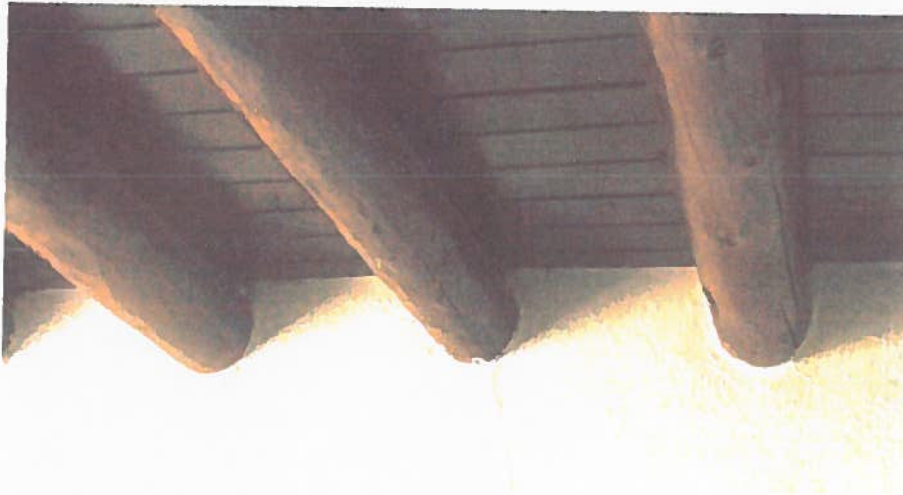
Figure 21 Typical Viga Layout

The main structural framing members for all the roofs of the El Vado are the structural wood vigas. The vigas have diameters ranging from 6-inches to 8-inches at their ends. *Some vigas have serious problems with dry rot at the exposed ends where they are supported on load bearing walls.* The structure of the motel's roofs is composed of a roof ceiling assembly (vigas spanned by 3/4 of an inch thick tongue and groove wood decked ceiling with no insulation above) then layers of roofing material.

- 1. Inspect and evaluate each viga end throughout the buildings to check for rot and repair as necessary.**
- 2. Inspect and evaluate each viga for stress cracks, excessive deflection and repair as necessary.**
- 3. Inspect and evaluate roof sheathing. Replace with 3/4 inch sheathing as necessary.**
- 4. Insulate roofs to code standards and replace entire roof surfaces.**
- 5. Overhangs, gutters etc.**

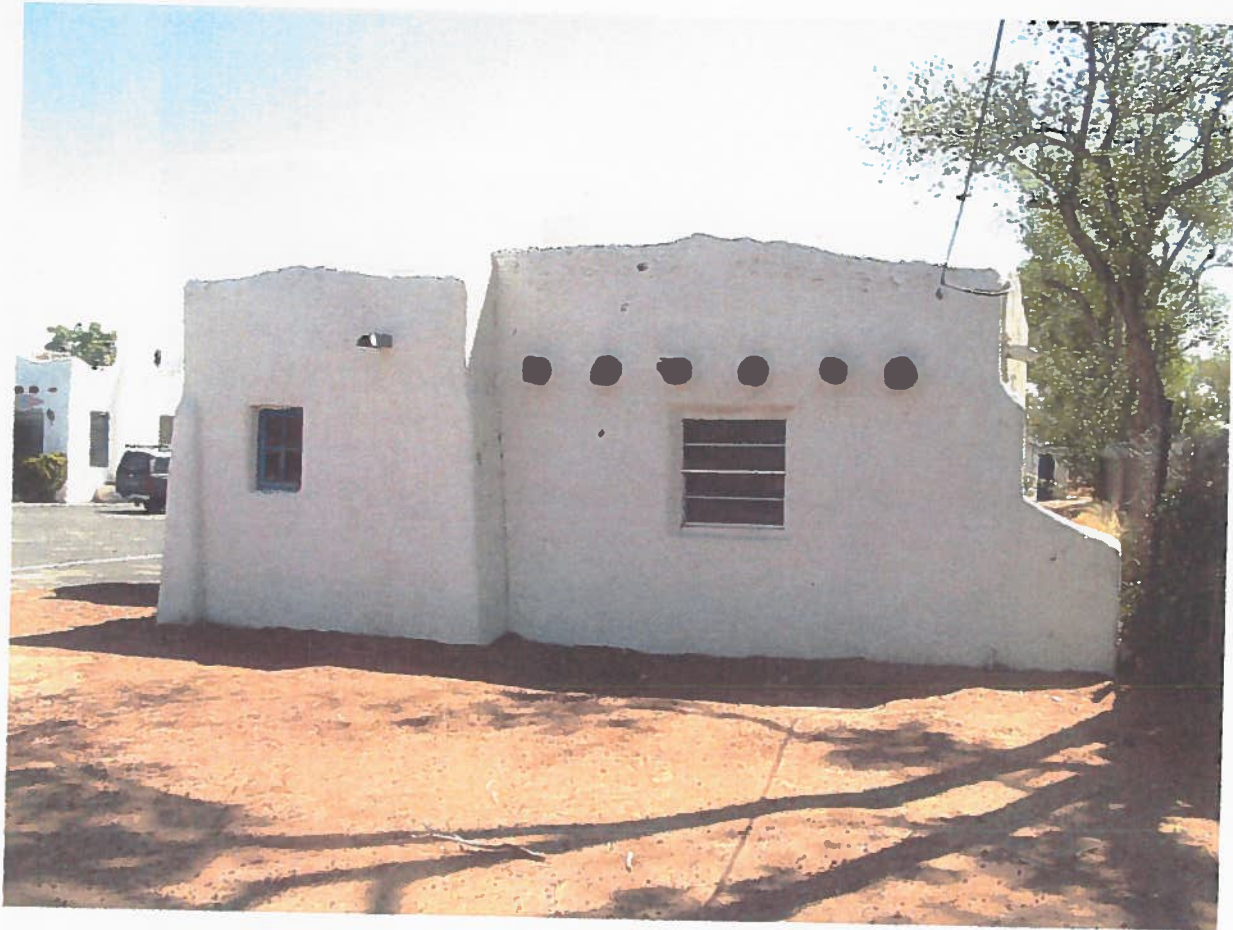
Figure 31 South West Rooms Built of Hollow Clay Tile
