**CONDITIONS ASSESSMENT  
and  
CONSERVATION TREATMENT RECOMMENDATIONS  
for the  
SHALAKO PROCESSION MURALS  
DE ANZA MOTOR COURT,  
ALBUQUERQUE, NM**

*Submitted:*  
April 24, 2007

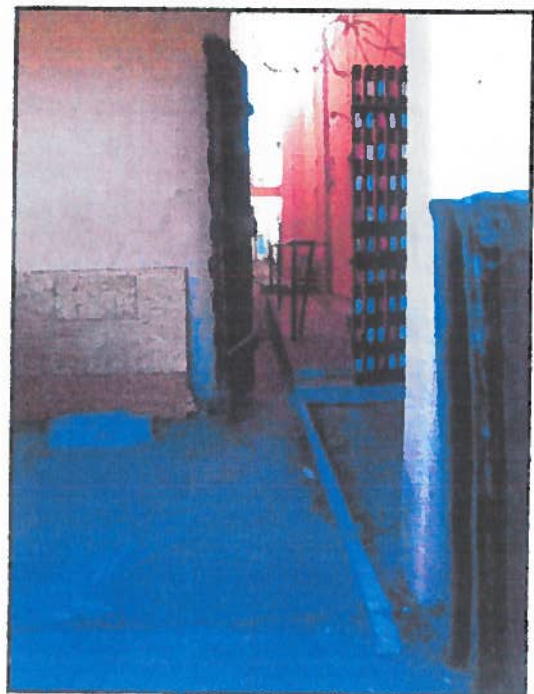
Fig. 3. Pavement and gate to alleyway and access stair. Note also concrete berm.

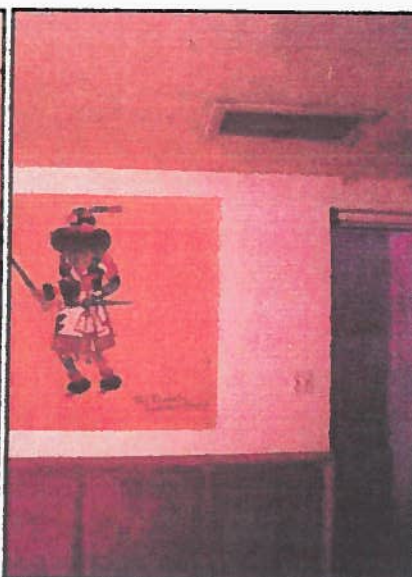
Fig. 5. Vent in soffit to the left of the door.

Neither vent contains a filter and leaves and other debris were found on the inside of the interior grate of the north wall.

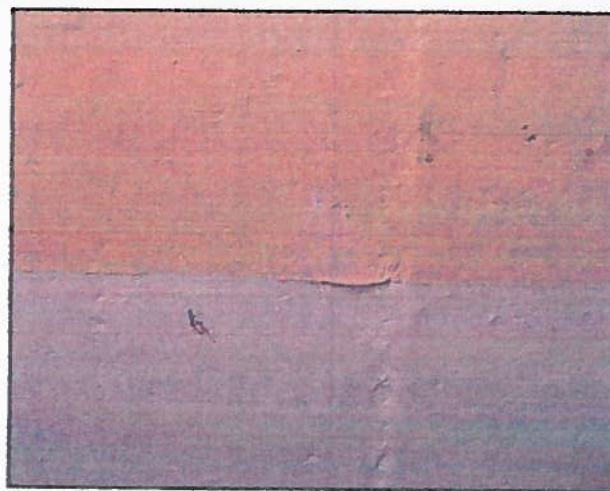
It appears that the artist found the surface of the north wall unacceptable and made fills with a white plaster-like material before painting. A second coat of yellow was then applied over the fills. The presence of two layers of yellow was confirmed in several locations, by various means, across the north wall. By contrast, the fills appear to have only a single layer of yellow underlying the colors of the imagery. The fills themselves can still be detected topographically, as they are generally smoother than the rest of the surface and are often surrounded by some irregularity or disruption at their borders. They are further distinguished by extensive

Fig. 10. Lighter yellow below existing top yellow.
