CITY OF ALBUQUERQUE
SIERRA GRANDE AVE - LOYOLA AVE TO LOYOLA PL
SPEED STUDY

NTMP P803000
TASK 28.17

SPEED STUDY

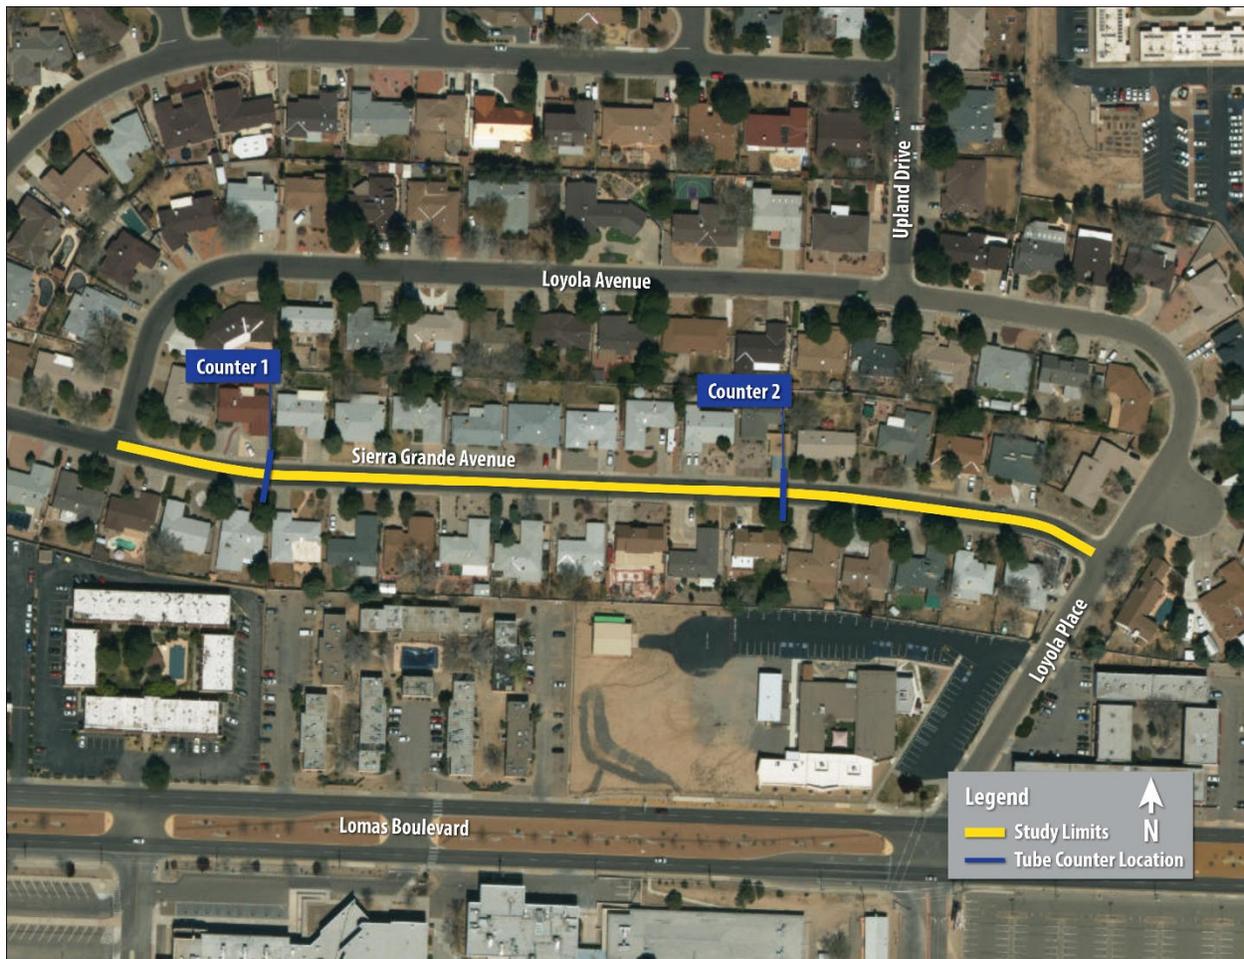
Figure 1: Project Area and Existing Traffic Volumes

The Sierra Grande Avenue project is located in Albuquerque, New Mexico and is a two-lane, undivided local road that runs east-west between Loyola Avenue and Loyola Place. Loyola Avenue is a two-lane, undivided local road that runs east-west and intersects the west end of Sierra Grande Avenue at a T-intersection. Loyola Place is a two-lane, undivided local road that runs north-south and intersects the east end of Sierra Grande Avenue at a T-intersection. See **Figure 1** for a map of the project area.

Sierra Grande Avenue is an urban local road with an Average Daily Traffic (ADT) of 278 vehicles and an existing speed limit of 25 mph. Existing tube count data (volume, speed, and class) was collected for 48-hours on Wednesday, October 14, 2020 and Thursday, October 15, 2020. The full traffic count data can be found in [Appendix A](#).

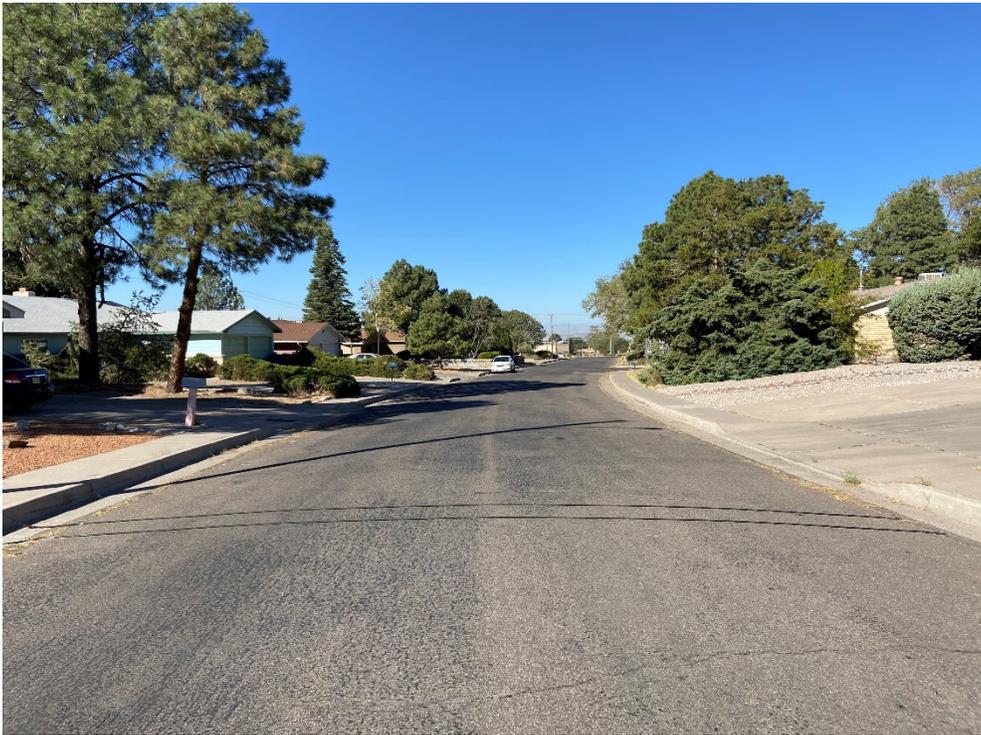
Figure 3: Sierra Grande Avenue looking West

Sierra Grande Avenue is a 28-ft wide roadway with curb and gutter, and 4-ft wide sidewalks. See [Figure 3](#) and [Figure 4](#) for photos of the existing roadway, and [Figure 5](#) for the existing Sierra Grande Avenue typical section.

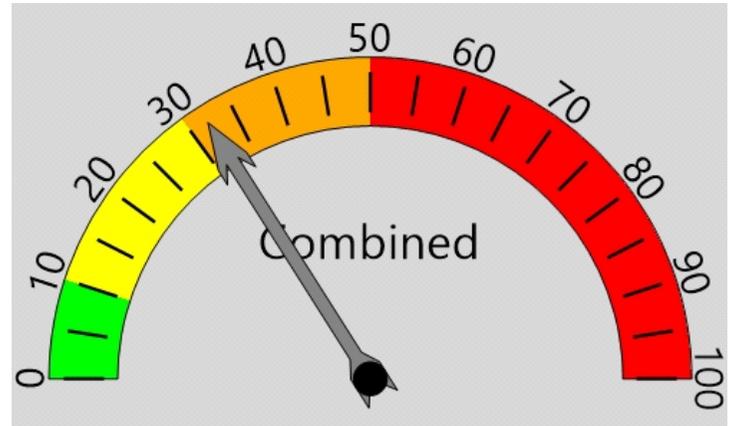
Posted Speed Limit 25 MPH

Enforcement Tolerance 5 MPH

Percent Speeding: 32%

Rating: Medium

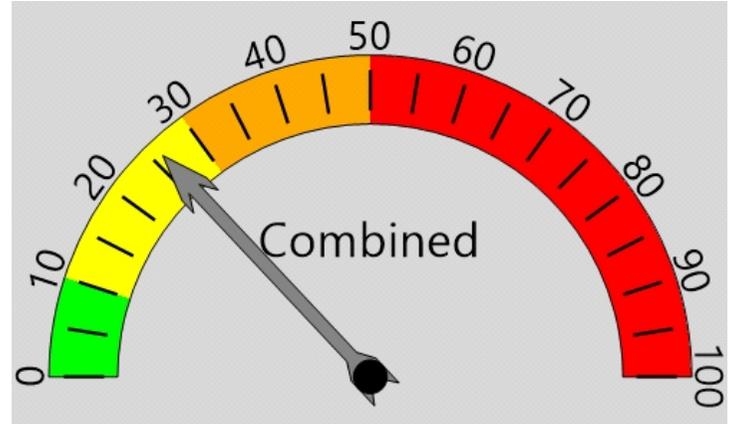
Posted Speed Limit 25 MPH
Enforcement Tolerance 5 MPH

Percent Speeding: 26%

Rating: Medium Low

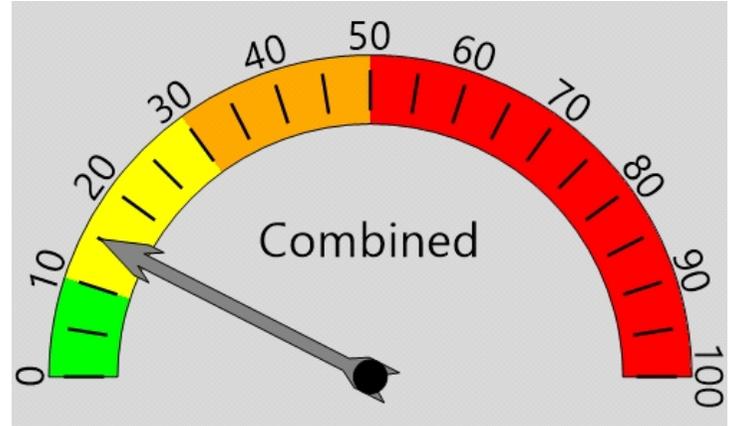
Posted Speed Limit 25 MPH
Enforcement Tolerance 7 MPH

Percent Speeding: 15%

Rating: Medium Low

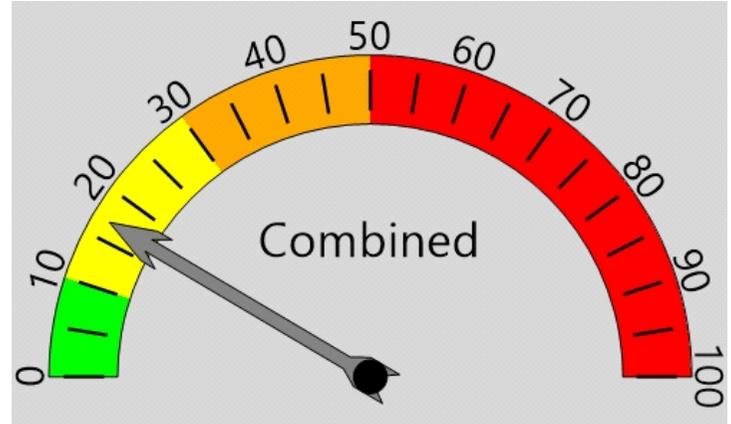
Posted Speed Limit 25 MPH
Enforcement Tolerance 7 MPH

Percent Speeding: 17%

Rating: Medium Low

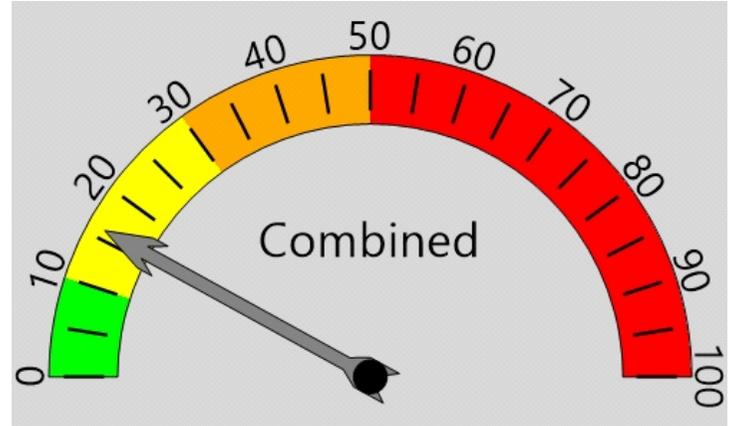
Posted Speed Limit 25 MPH

Enforcement Tolerance 5 MPH

Percent Speeding: 16%

Rating: Medium Low

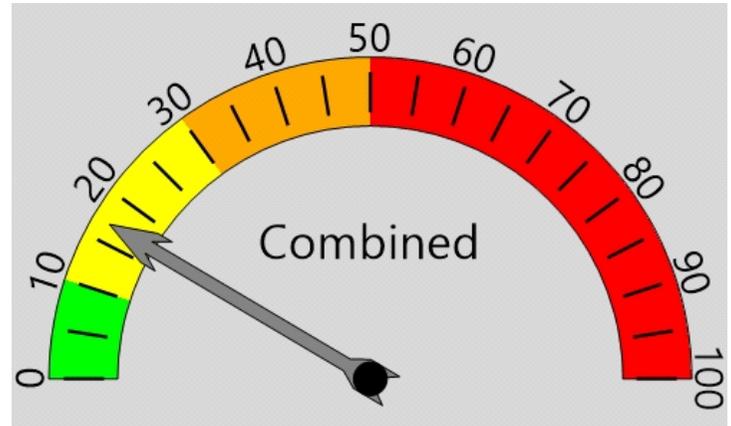
Posted Speed Limit 25 MPH

Enforcement Tolerance 5 MPH

Percent Speeding: 17%

Rating: Medium Low

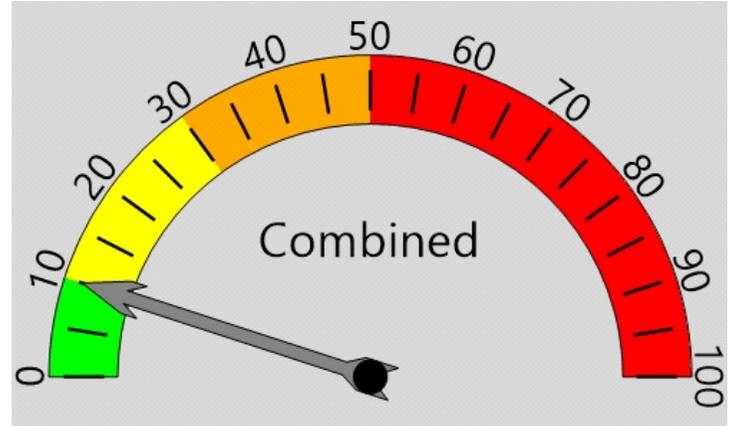
Posted Speed Limit 25 MPH
Enforcement Tolerance 7 MPH

Percent Speeding: 10%

Rating: Medium Low

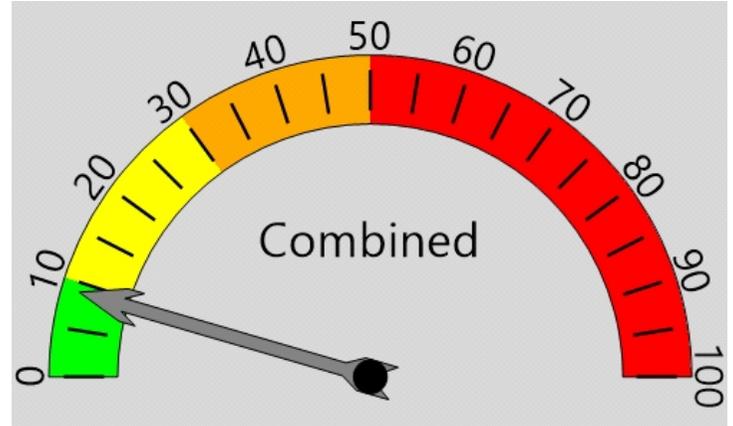
Posted Speed Limit 25 MPH
Enforcement Tolerance 7 MPH

Percent Speeding: 9%

Rating: Low
