National Pollutant Discharge Elimination System Stormwater Program MS4 Annual Report Format

NMR04A014 City of Albuquerque

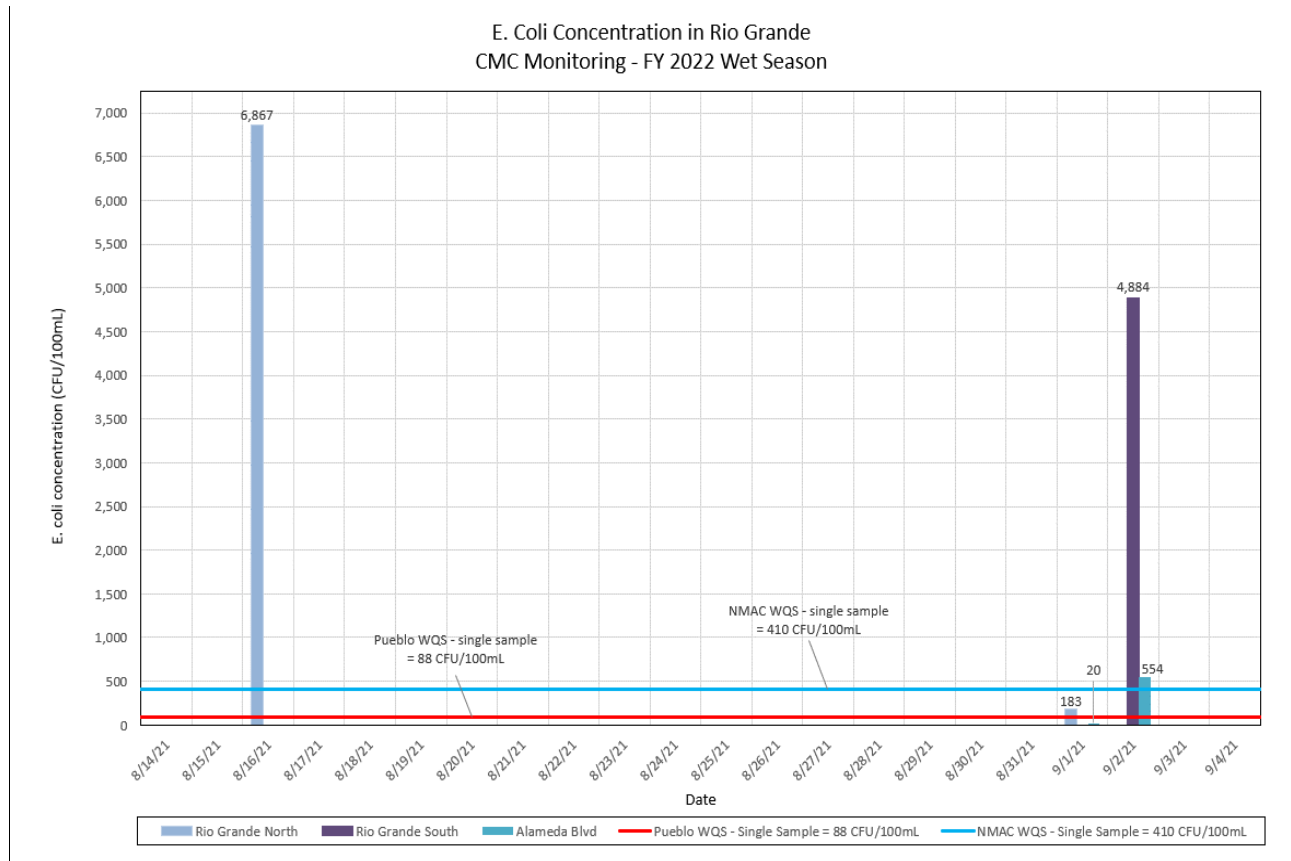
As a reminder, in January 2017 the CMC members clarified with NMED that the units MPN/100 mL and CFU/100 mL are considered to be interchangeable for the purposes of this stormwater quality monitoring reporting. The New Mexico and Pueblo WQS for E. coli are currently in units of CFU/100 mL while the lab reports are typically in units of MPN/100mL. The graph presented in this section uses units of CFU/100 mL to be consistent with the WQS units. Refer to Figure 2 for a graphical representation of E. coli results from August and September 2021.

Figure 2: E. coli Results in Rio Grande CMC Monitoring – FY 2022 Wet Season

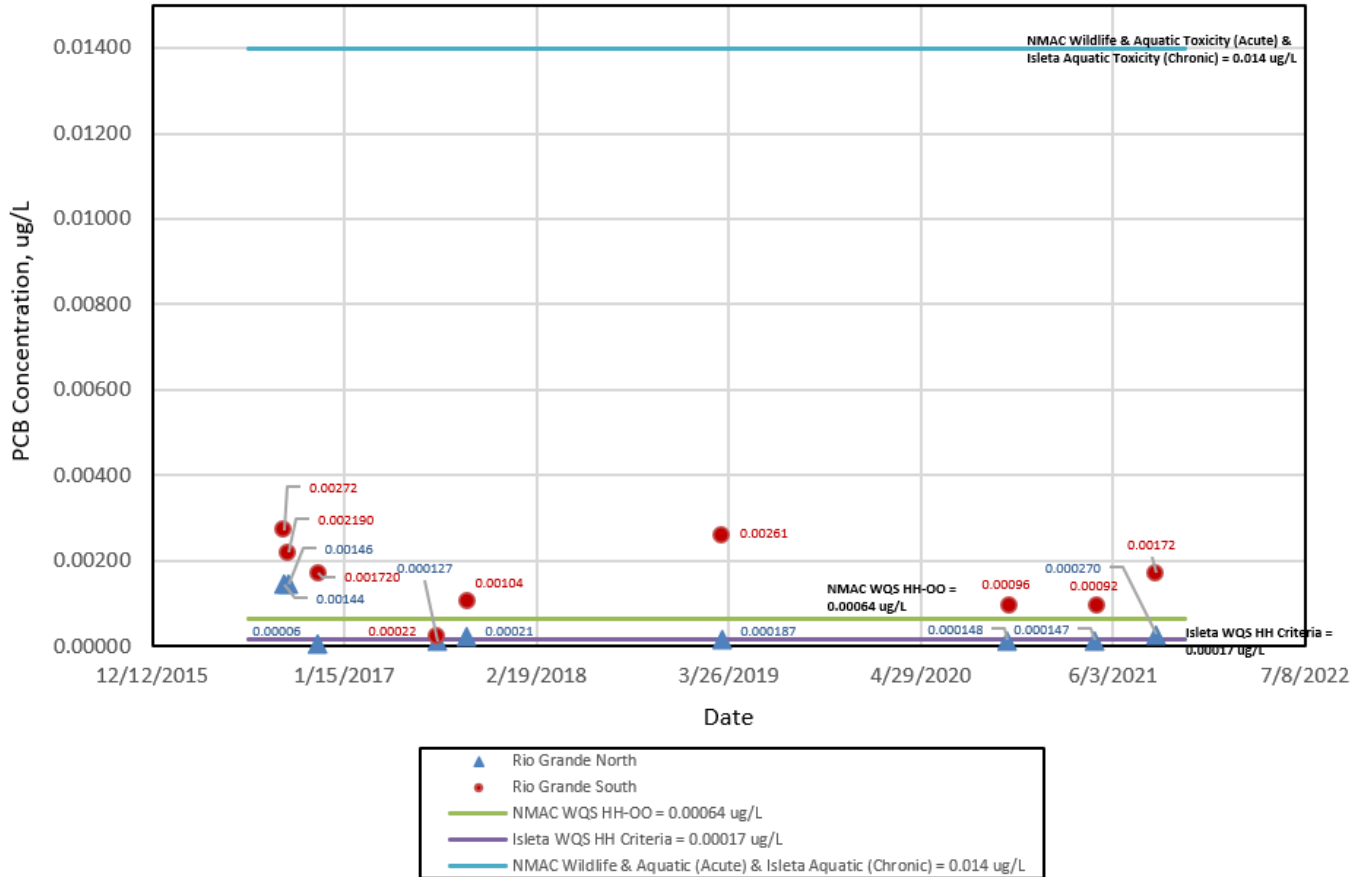
PCB Concentration in Rio Grande - North and South of MRG MS4

Figure 3: PCB Monitoring Results in Rio Grande CMC Monitoring – 2016 - 2021

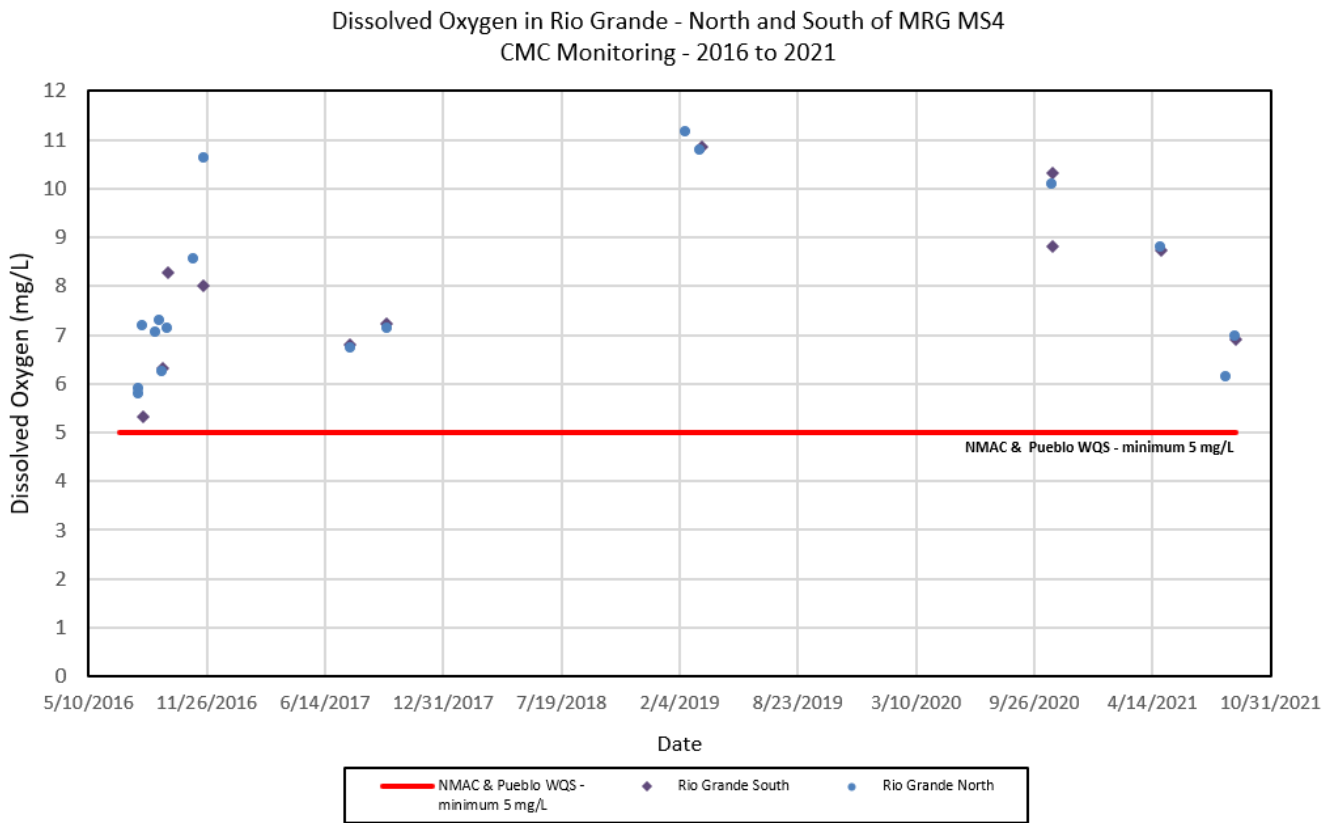
Dissolved oxygen is a water quality concern in the Rio Grande if it is below 5 mg/L. None of the samples taken from the Rio Grande during the FY 2022 wet season monitoring had dissolved oxygen values below 5 mg/L. This provides the MS4s with specific monitoring data showing that stormwater did not cause or contribute to exceedances of applicable dissolved oxygen water quality standards in the Rio Grande from any of the CMC samples from 2016 to 2021. Refer to Figure 4 for CMC dissolved oxygen results and comparison to applicable WQSs.

Figure 4: Dissolved Oxygen Results in the Rio Grande CMC Monitoring – 2016 - 2021

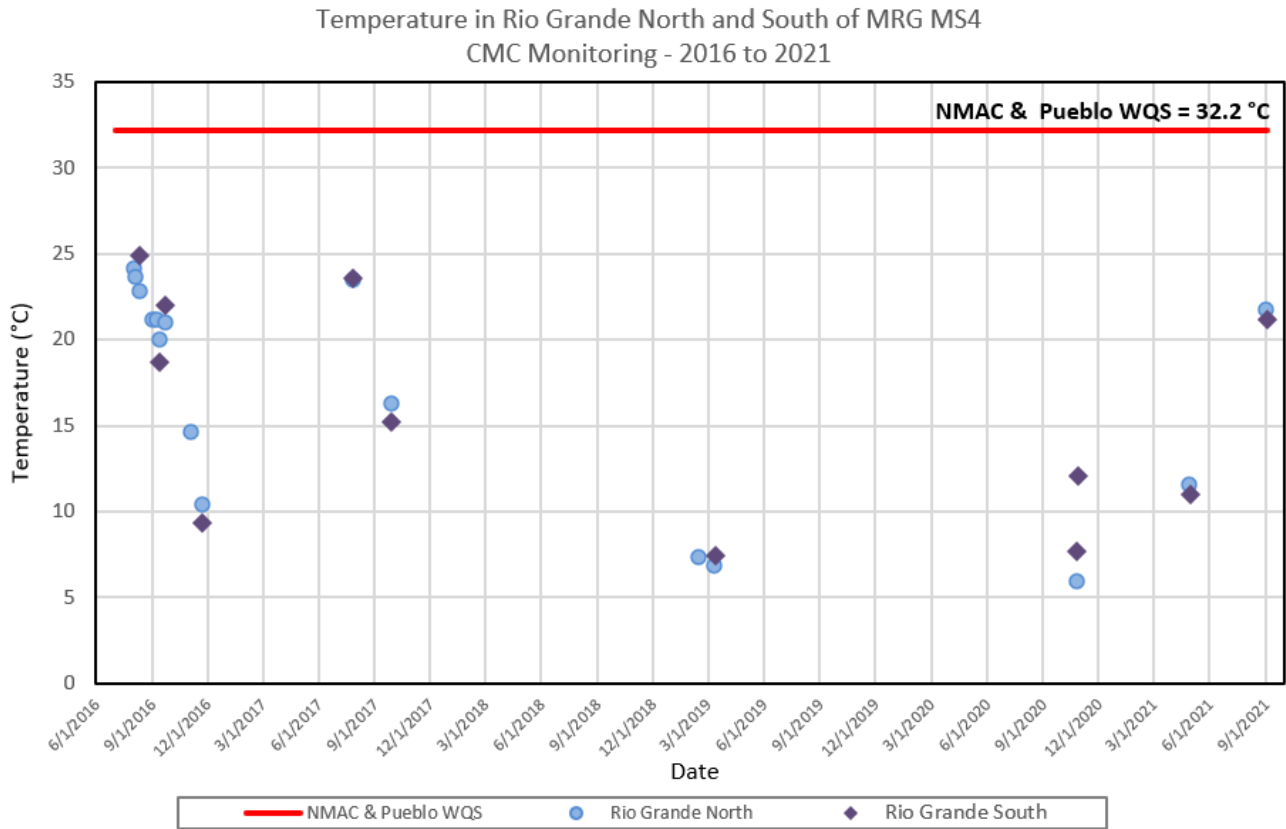
Temperature is listed in the WSB MS4 Permit as a special condition (currently only applicable to the City of Albuquerque and AMAFCA). Past data submitted to EPA and NMED by the MS4 permittees have proven that stormwater discharges into the Rio Grande are not raising the Rio Grande temperature above the WQSs. The data collected during this FY 2022 wet season monitoring also supports this conclusion. All the temperature field readings taken in the Rio Grande during the CMC FY 2022 wet season were below 32.2°C (90°F), which is the WQS for the State of New Mexico and for the Isleta and Sandia Pueblos. Refer to Figure 5 for temperature results and comparison to applicable WQSs for all CMC samples taken upstream and downstream of the MRG MS4 area from 2016 to 2021.

**Figure 5: Temperature Monitoring Results in the Rio Grande
 CMC Monitoring – 2016 - 2021**

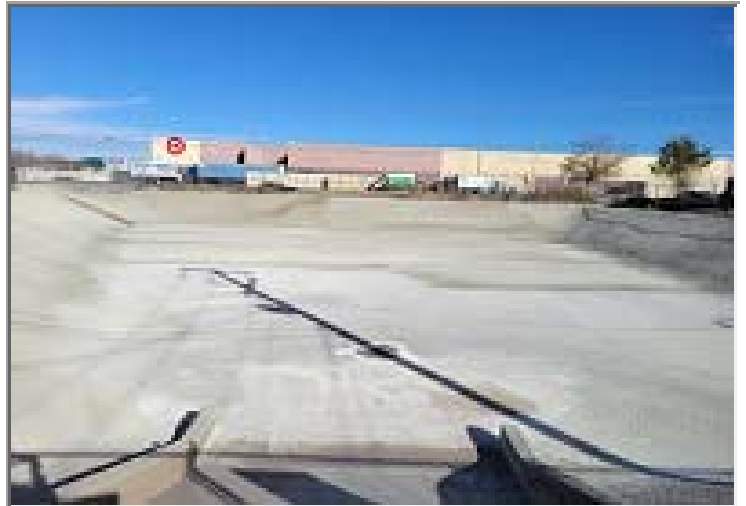
SWQ POND LINING

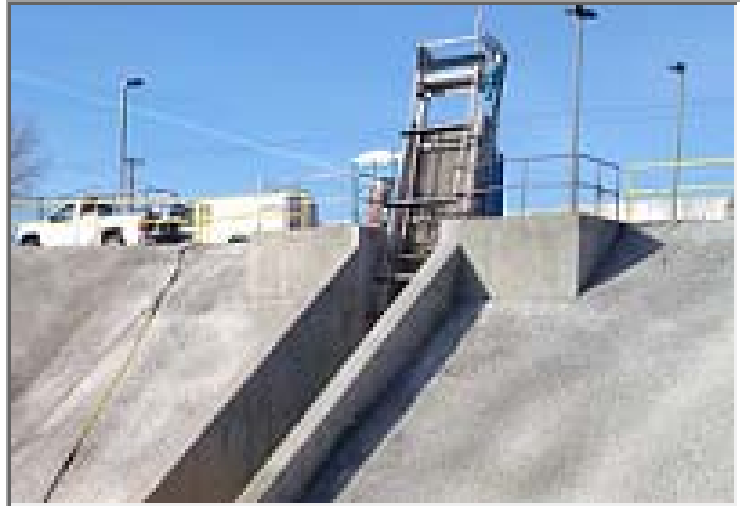
MECHANICAL BARSCREEN

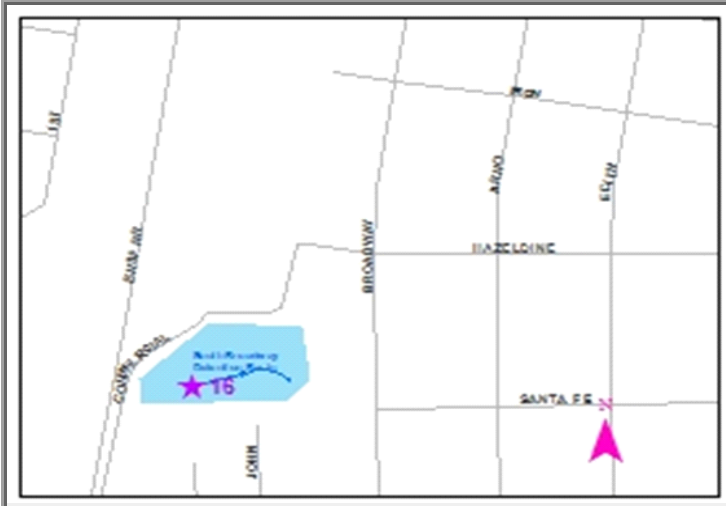
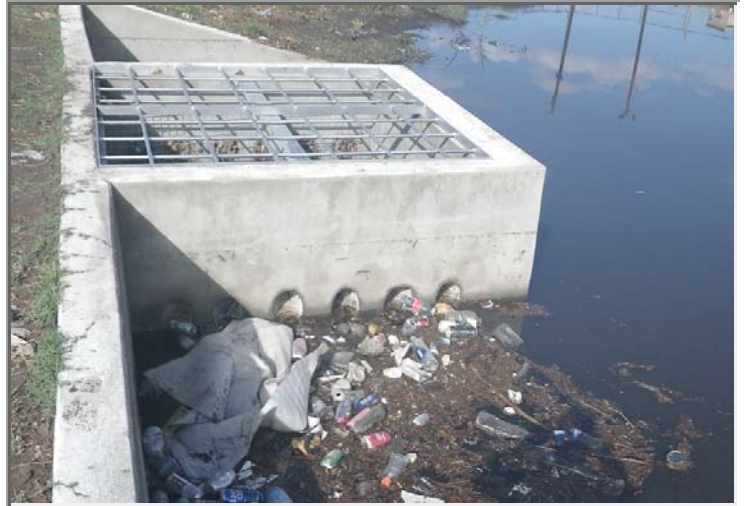
CONCRETE BOX SPILLWAY

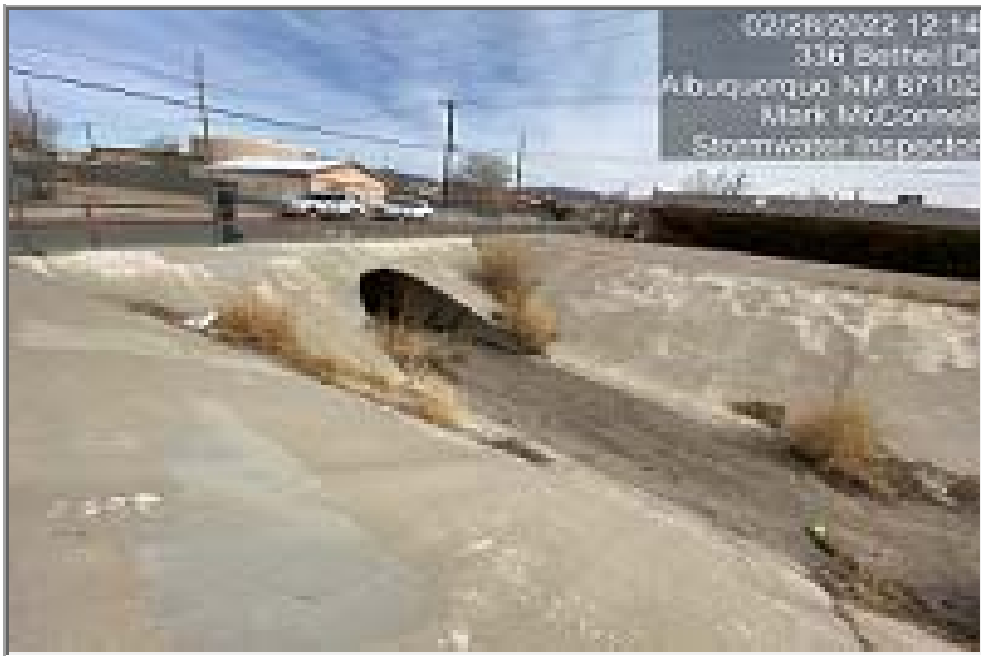
LOCATION **BROADWAY POND INFLOW CHANNEL**

OUTFALL_NO **2** QUAD **SE** GRID **K-14** SAMPLED

AIR_TEMP_F	48	Lab	HALL ENVIRONMENTAL
WATER_TEMP_F	41	Lab_Report	2203901
pH	8.0	E_coli_Coliform_mpn/100ml	1553.1
CONDUCTIVITY_Umos/cm	760	Ammonia_mg/l	<1
BOD_mg/l	20.0	Nitrite_NO2_mg/l	<0.5
COD_mg/l	42	Nitrate_NO3_mg/l	0.82
TSS_mg/l	<4	TKN_Tot_Kjeld_N_mg/l	<1
TDS_mg/l	464	Phosphorus_total_mg/l_P	0.26
N-Hexane Extractable-(Oil_Grease)_mg/l	<9.12	Hardness_mg/l_CaCO3	170
Fluoride_mg/l	0.97	Chlorine_mg/l	<0.05

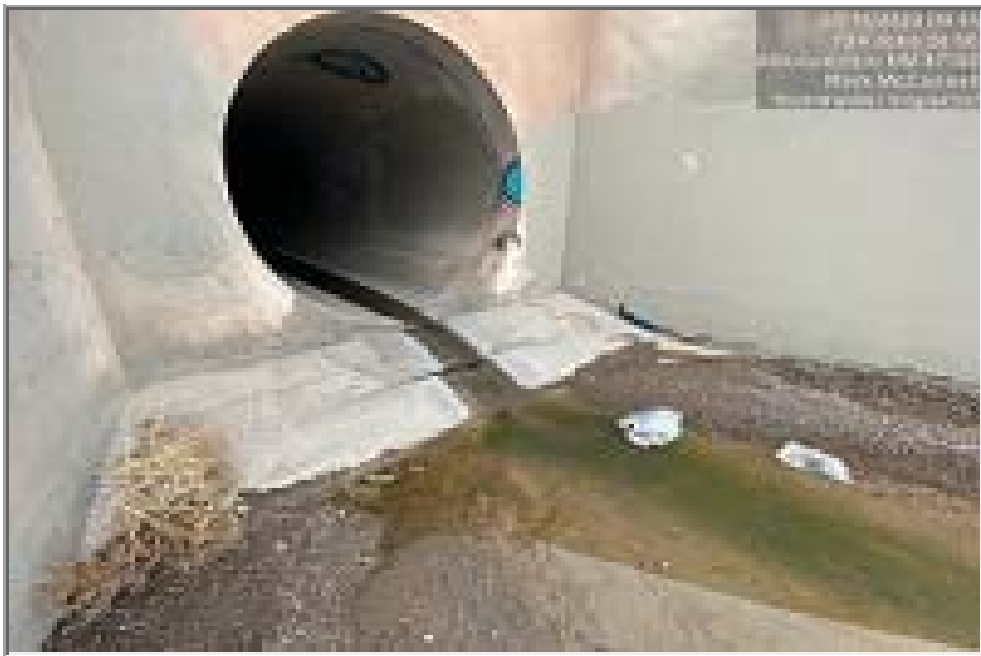
LOCATION **MENAU POND INFLOW CHANNEL**

OUTFALL_NO **3** QUAD **NE** GRID **H-15** SAMPLED

AIR_TEMP_F	59	Lab	
WATER_TEMP_F	na	Lab_Report	
pH		E_coli_Coliform_mpn/100ml	
CONDUCTIVITY_Umos/cm		Ammonia_mg/l	
BOD_mg/l		Nitrite_NO2_mg/l	
COD_mg/l		Nitrate_NO3_mg/l	
TSS_mg/l		TKN_Tot_Kjeld_N_mg/l	
TDS_mg/l		Phosphorus_total_mg/l_P	
N-Hexane Extractable-(Oil_Grease)_mg/l		Hardness_mg/l_CaCO3	
Floride_mg/l		Chlorine_mg/l

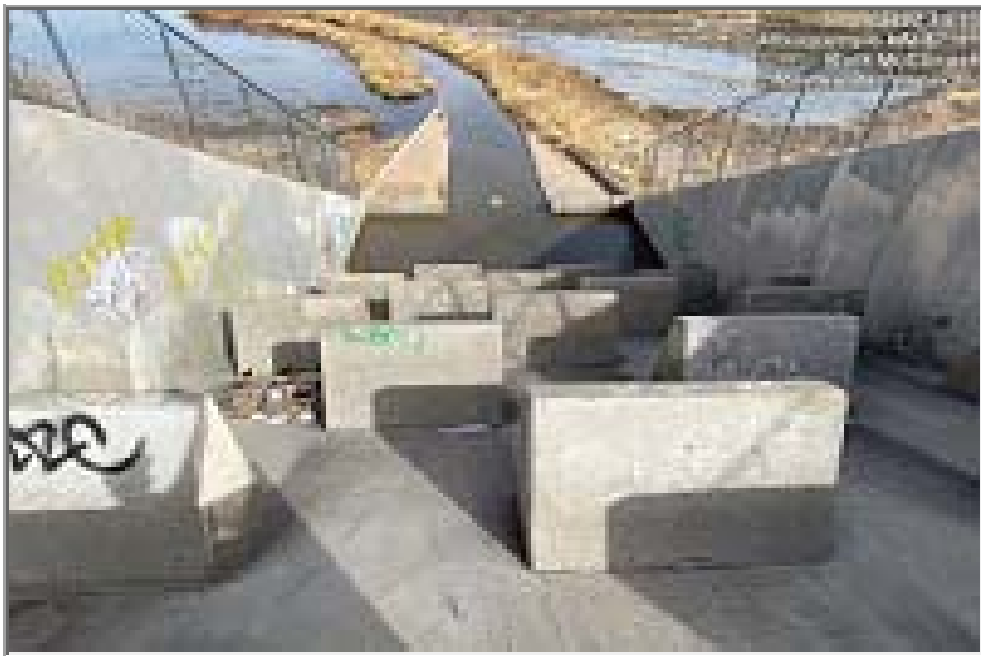
LOCATION **BARELAS PUMPING PLANT INFLOW**

AIR_TEMP_F	<input type="text" value="74"/>	Lab	<input type="text" value="HALL ENVIRONMENTAL"/>
WATER_TEMP_F	<input type="text" value="59"/>	Lab_Report	<input type="text" value="22004D38"/>
pH	<input type="text" value="8.23"/>	E_coli_Coliform_mpn/100ml	<input type="text" value=">2419.6"/>
CONDUCTIVITY_Umos/cm	<input type="text" value="790"/>	Ammonia_mg/l	<input type="text" value="<1.0"/>
BOD_mg/l	<input type="text" value="6.1"/>	Nitrite_NO2_mg/l	<input type="text" value="<0.5"/>
COD_mg/l	<input type="text" value="26.3"/>	Nitrate_NO3_mg/l	<input type="text" value="<0.5"/>
TSS_mg/l	<input type="text" value="<4"/>	TKN_Tot_Kjeld_N_mg/l	<input type="text" value="1.1"/>
TDS_mg/l	<input type="text" value="534"/>	Phosphorus_total_mg/l_P	<input type="text" value="0.21"/>
N-Hexane Extractable-(Oil_Grease)_mg/l	<input type="text" value="<9.35"/>	Hardness_mg/l_CaCO3	<input type="text" value="270"/>
Fluoride_mg/l	<input type="text" value="<0.5"/>	Chlorine_mg/l	<input type="text" value="<0.05"/>

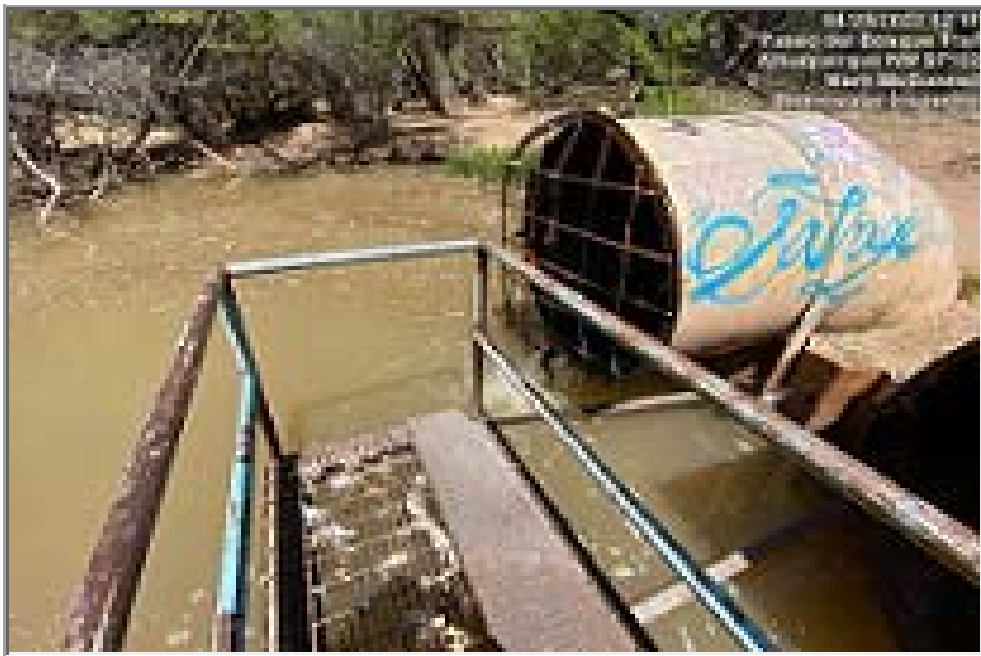
LOCATION	KIRTLAND CHANNEL AT MULBERRY NE						
OUTFALL_NO	5	QUAD	SE	GRID	M-15	SAMPLED	<input type="checkbox"/>
DATE_INSP	3/28/2022	TIME	11:05	Inspected by	MM		
WEATHER	PARTLY CLOUDY	flow	NO FLOW	FLOW_GPM	0		
APPEARANCE	na		GROSS POLLUTANT	na			
Source of Flow	na

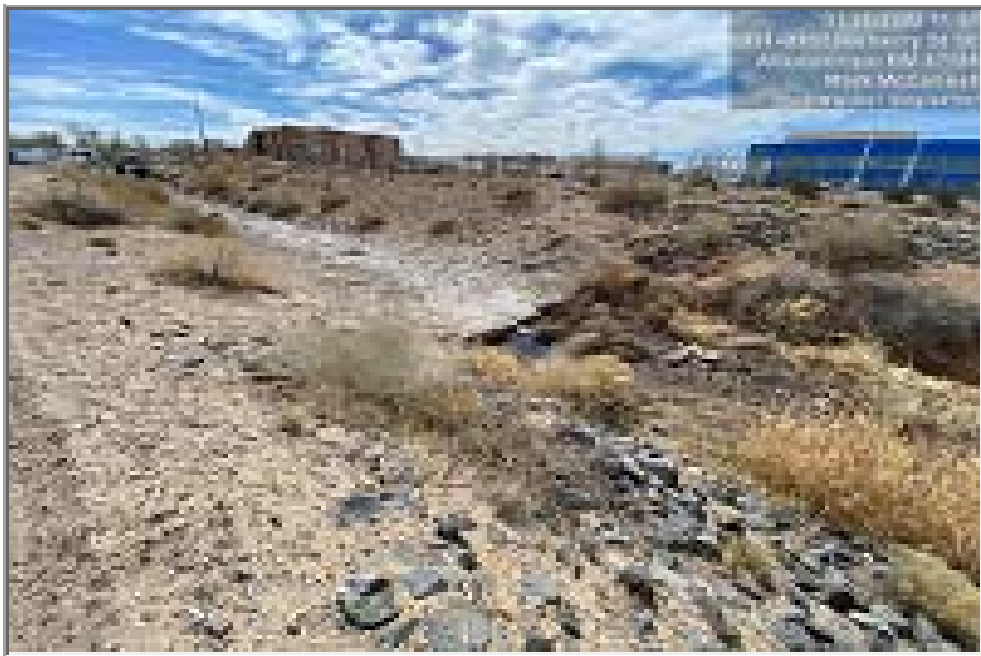
LOCATION **SAN ANTONIO ARROYO AT RIO GRANDE**

OUTFALL_NO **6** QUAD **NW** GRID **F-12** SAMPLED

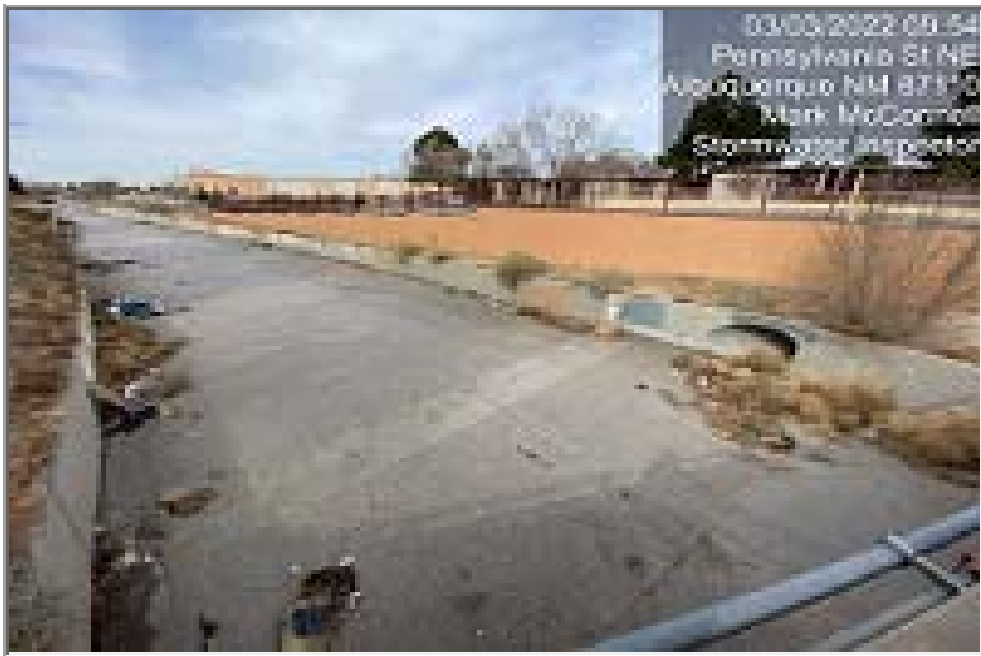
LOCATION	NDC AT TUCKER						
OUTFALL_NO	10	QUAD	NE	GRID	J-16	SAMPLED	<input type="checkbox"/>
DATE_INSP	3/25/2022	TIME	3:00	Inspected by	MM		
WEATHER	SUNNY	flow	NO FLOW	FLOW_GPM	0		
APPEARANCE	na		GROSS POLLUTANT	na			
Source of Flow	na

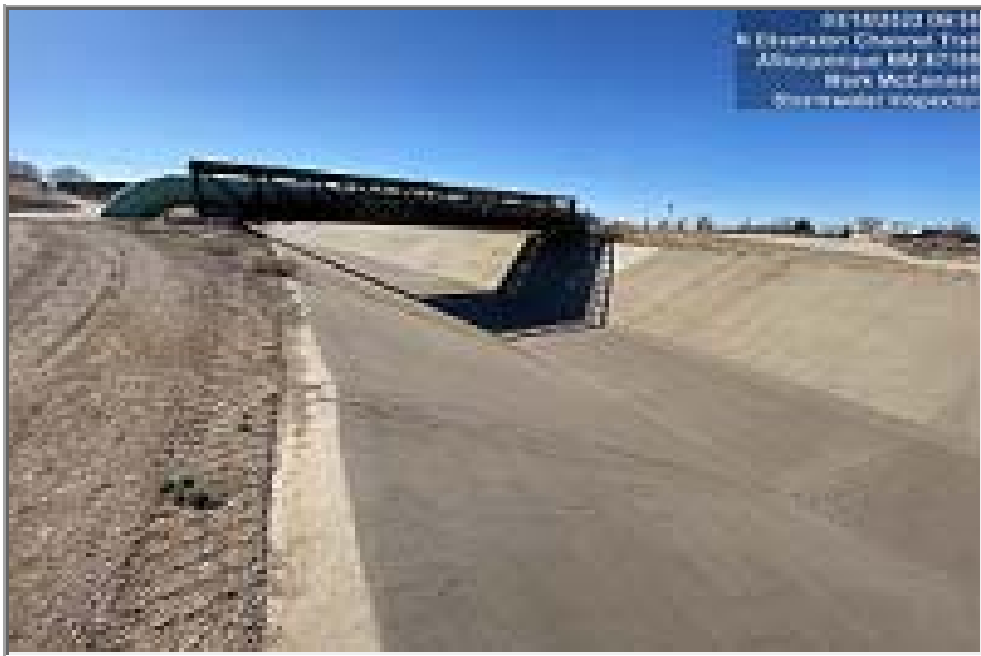
LOCATION	SOUTH PINO ARROYO AT WASHINGTON NE						
OUTFALL_NO	12	QUAD	NE	GRID	D-17	SAMPLED	<input type="checkbox"/>
DATE_INSP	3/18/2022	TIME	9:48	Inspected by	MM		
WEATHER	SUNNY	flow	NO FLOW	FLOW_GPM	0		
APPEARANCE	na	GROSS POLLUTANT	na				
Source of Flow	na

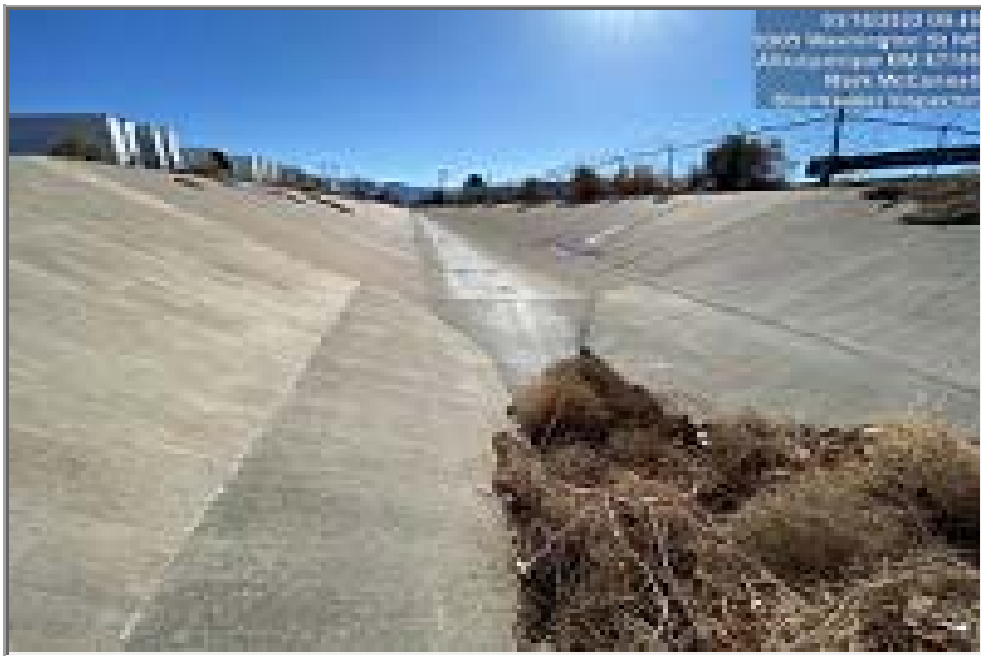
LOCATION **NORTH PINO ARROYO AT TIBURON NE**
 OUTFALL_NO **13** QUAD **NE** GRID **D-17** SAMPLED
 DATE_INSP **3/18/2022** TIME **9:23** Inspected by **MM**
 WEATHER **SUNNY** flow **NO FLOW** FLOW_GPM **0**
 APPEARANCE **na** GROSS POLLUTANT **na**
 Source of Flow **na**

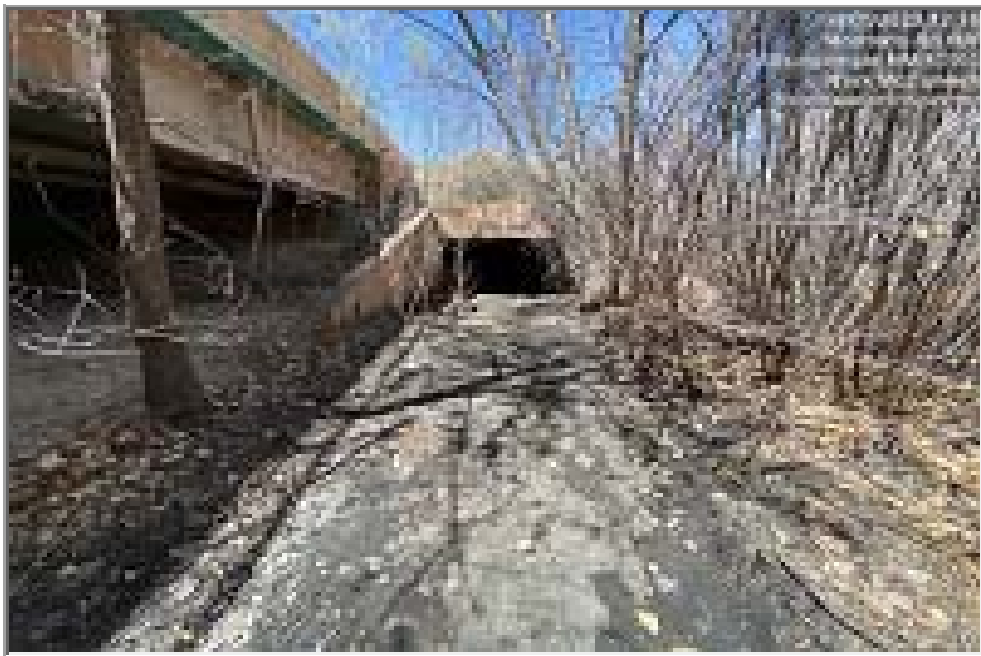
LOCATION **MONTANO NW PS-47 WEST OF RIO GRANDE BLVD**

OUTFALL_NO **19** QUAD **NW** GRID **F-12** SAMPLED

Source of Flow **groundwater Infiltration**

AIR_TEMP_F	54	Lab	HALL ENVIRONMENTAL
WATER_TEMP_F	46	Lab_Report	2204257
pH	7.10	E_coli_Coliform_mpn/100ml	677
CONDUCTIVITY_Umos/cm	450	Ammonia_mg/l	<1
BOD_mg/l	39	Nitrite_NO2_mg/l	<0.5
COD_mg/l	104	Nitrate_NO3_mg/l	<0.5
TSS_mg/l	<4	TKN_Tot_Kjeld_N_mg/l	1.4
TDS_mg/l	335	Phosphorus_total_mg/l_P	0.27
N-Hexane Extractable-(Oil_Grease)_mg/l	<9.56	Hardness_mg/l_CaCO3	140
Floride_mg/l	1.0	Chlorine_mg/l	<0.05

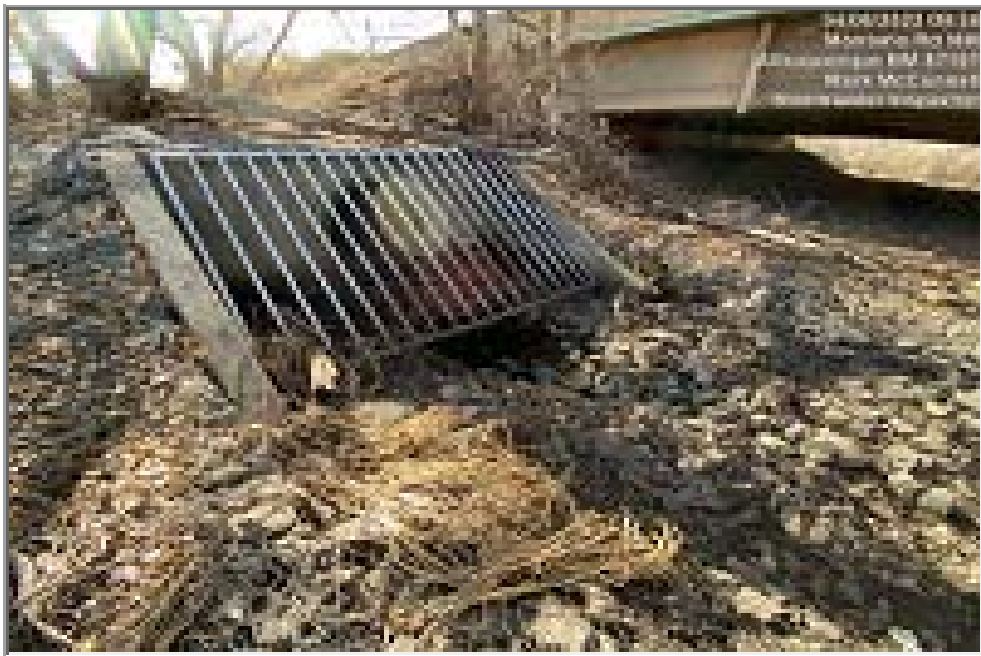
LOCATION **CANDELARIA NW PS-40 AT RIO GRANDE**

OUTFALL_NO **20** QUAD **NW** GRID **G-12** SAMPLED

AIR_TEMP_F	59	Lab	HALL ENVIRONMENTAL
WATER_TEMP_F	55	Lab_Report	2204257
pH	7.89	E_coli_Coliform_mpn/100ml	56.5
CONDUCTIVITY_Umos/cm	420	Ammonia_mg/l	<1
BOD_mg/l	30	Nitrite_NO2_mg/l	<0.1
COD_mg/l	<20	Nitrate_NO3_mg/l	<0.1
TSS_mg/l	<4	TKN_Tot_Kjeld_N_mg/l	<1
TDS_mg/l	285	Phosphorus_total_mg/l_P	0.063
N-Hexane Extractable-(Oil_Grease)_mg/l	<9.46	Hardness_mg/l_CaCO3	150
Fluoride_mg/l	0.34	Chlorine_mg/l	<0.05

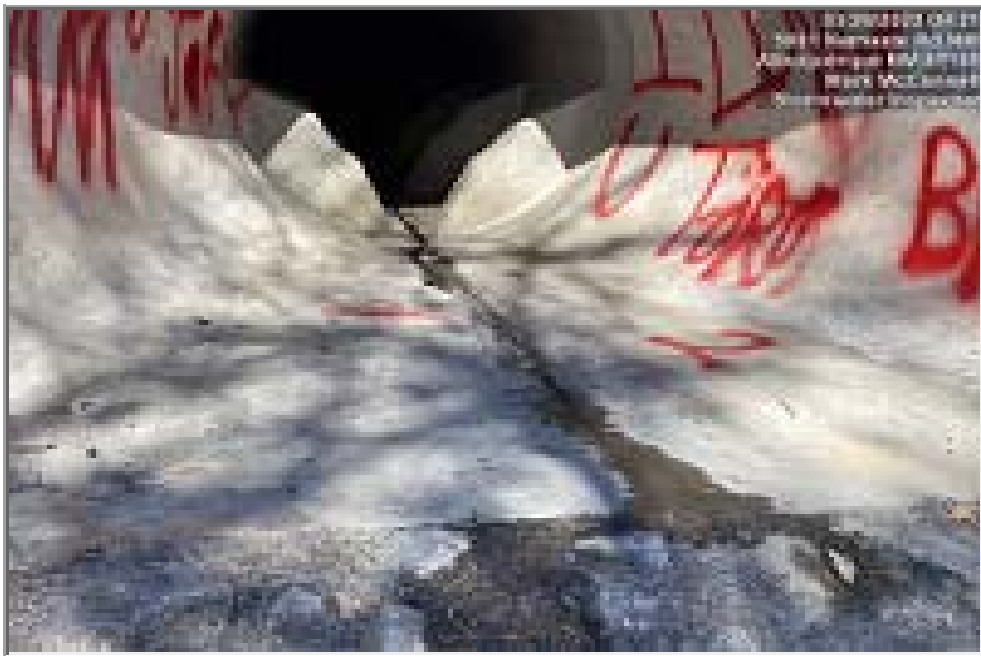
LOCATION	SNOW GOOSE AT OXBOW BLUFF NW						
OUTFALL_NO	22	QUAD	NW	GRID	G-11	SAMPLED	<input type="checkbox"/>
DATE_INSP	3/29/2022	TIME	11:18	Inspected by	MM		
WEATHER	PARTLY CLOUDY	flow	NO FLOW	FLOW_GPM	0		
APPEARANCE	na	GROSS POLLUTANT	na				
Source of Flow	na

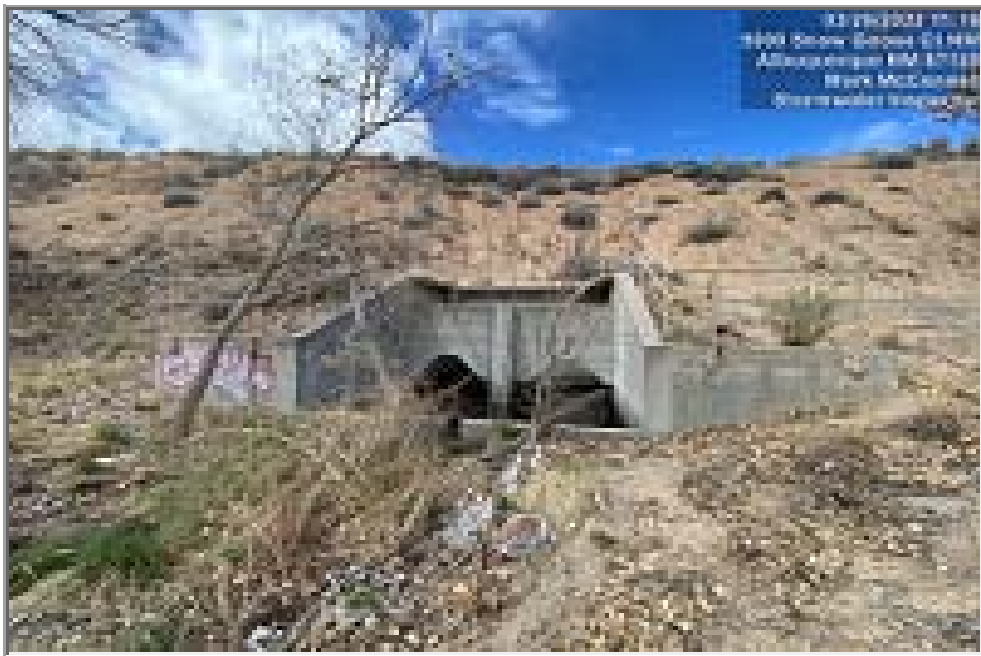
LOCATION	SEQUOIA NW AT RIO GRANDE						
OUTFALL_NO	23	QUAD	NW	GRID	G-11	SAMPLED	<input type="checkbox"/>
DATE_INSP	3/28/2022	TIME	2:24	Inspected by	MM		
WEATHER	PARTLY CLOUDY	flow	NO FLOW	FLOW_GPM	0		
APPEARANCE	na		GROSS POLLUTANT	na			
Source of Flow	na

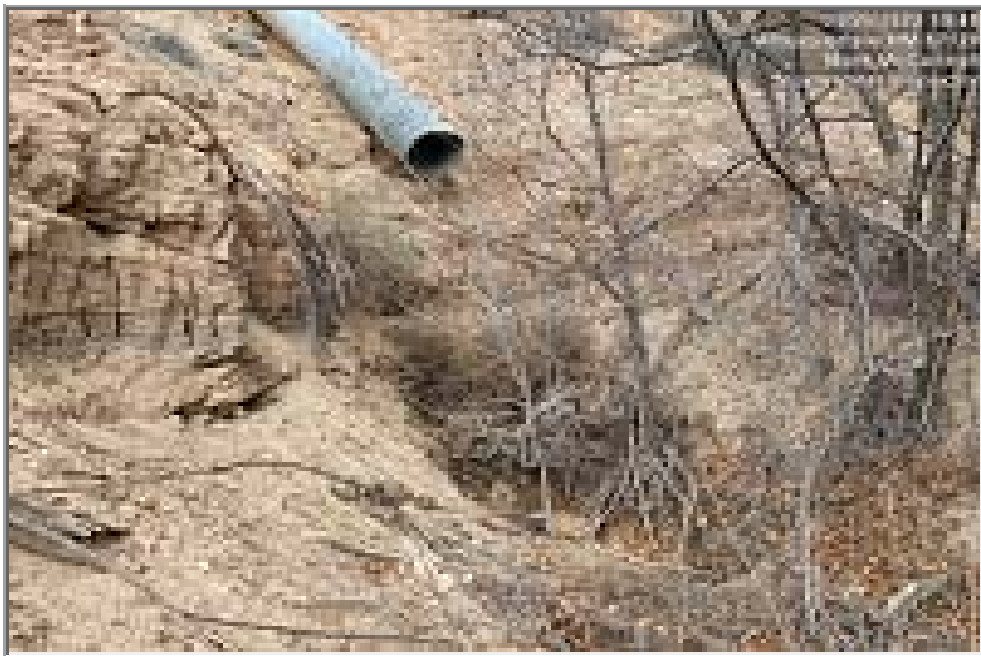
LOCATION **PASEO DEL REY - OURAY - VISTA GRANDE NW**
 OUTFALL_NO **25** QUAD **NW** GRID **H-11** SAMPLED
 DATE_INSP **3/28/2022** TIME **2:10** Inspected by **MM**
 WEATHER **PARTLY CLOUDY** flow **NO FLOW** FLOW_GPM **0**
 APPEARANCE **na** GROSS POLLUTANT **na**
 Source of Flow **na**

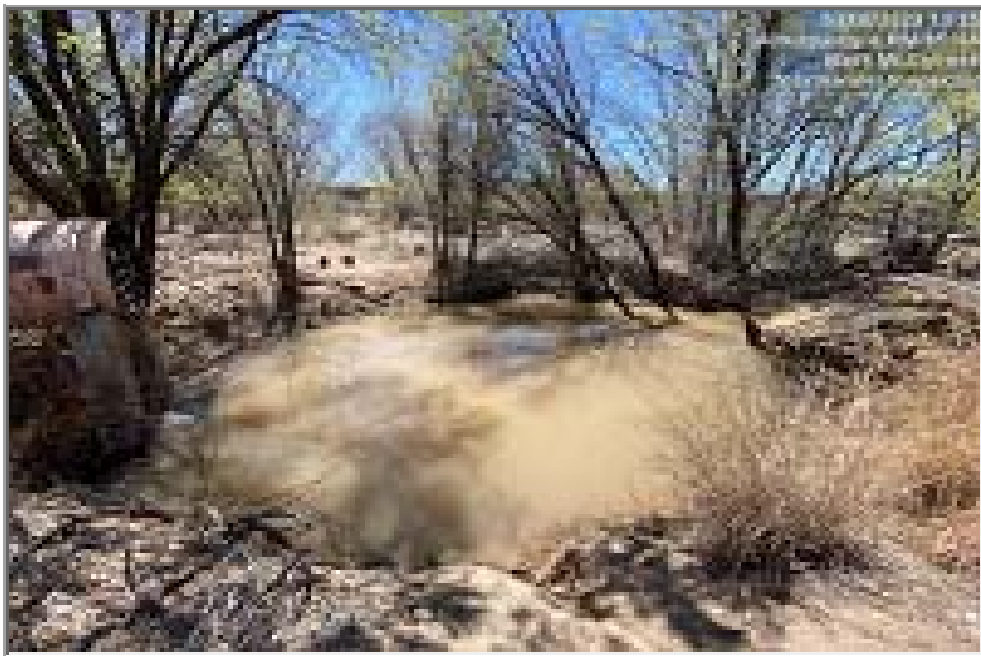
AIR_TEMP_F	69	Lab	HALL ENVIRONMENTAL
WATER_TEMP_F	55	Lab_Report	2204419
pH	8.09	E_coli_Coliform_mpn/100ml	488.4
CONDUCTIVITY_Umos/cm	520	Ammonia_mg/l	<1
BOD_mg/l	2.0	Nitrite_NO2_mg/l	<0.5
COD_mg/l	<400	Nitrate_NO3_mg/l	<0.5
TSS_mg/l	<4	TKN_Tot_Kjeld_N_mg/l	<1
TDS_mg/l	371	Phosphorus_total_mg/l_P	0.056
N-Hexane Extractable-(Oil_Grease)_mg/l	<9.93	Hardness_mg/l_CaCO3	180
Floride_mg/l	<0.5	Chlorine_mg/l	<0.05

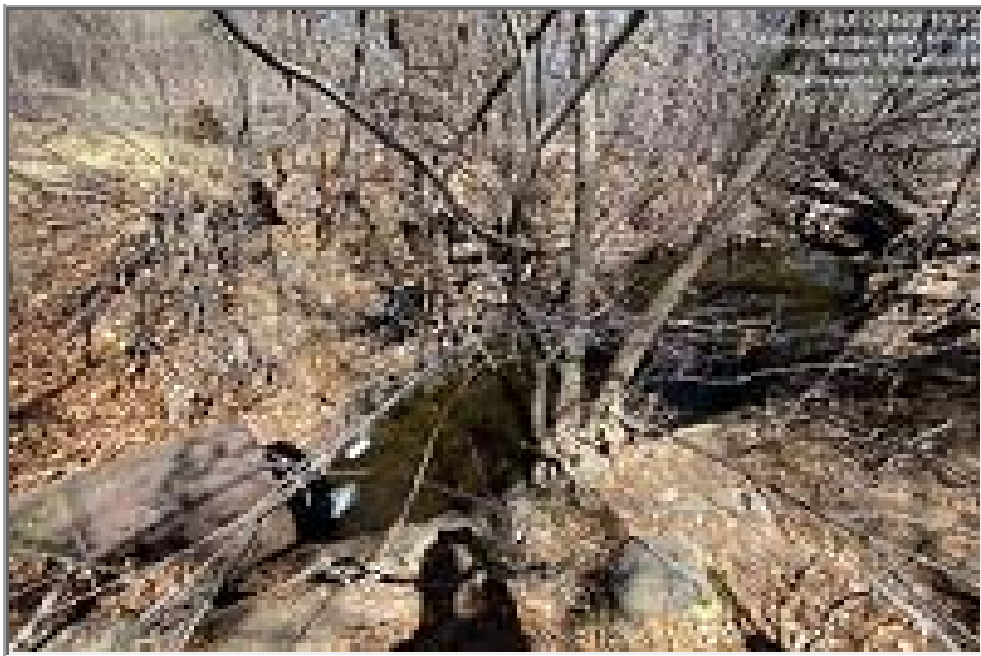
AIR_TEMP_F	63	Lab	HALL ENVIRONMENTAL
WATER_TEMP_F	69	Lab_Report	2204360
pH	7.53	E_coli_Coliform_mpn/100ml	5.2
CONDUCTIVITY_Umos/cm	590	Ammonia_mg/l	<1
BOD_mg/l	5.6	Nitrite_NO2_mg/l	<0.5
COD_mg/l	43	Nitrate_NO3_mg/l	<0.5
TSS_mg/l	54	TKN_Tot_Kjeld_N_mg/l	1.3
TDS_mg/l	378	Phosphorus_total_mg/l_P	0.32
N-Hexane Extractable-(Oil_Grease)_mg/l	<9.64	Hardness_mg/l_CaCO3	170
Fluoride_mg/l	0.67	Chlorine_mg/l	<0.05

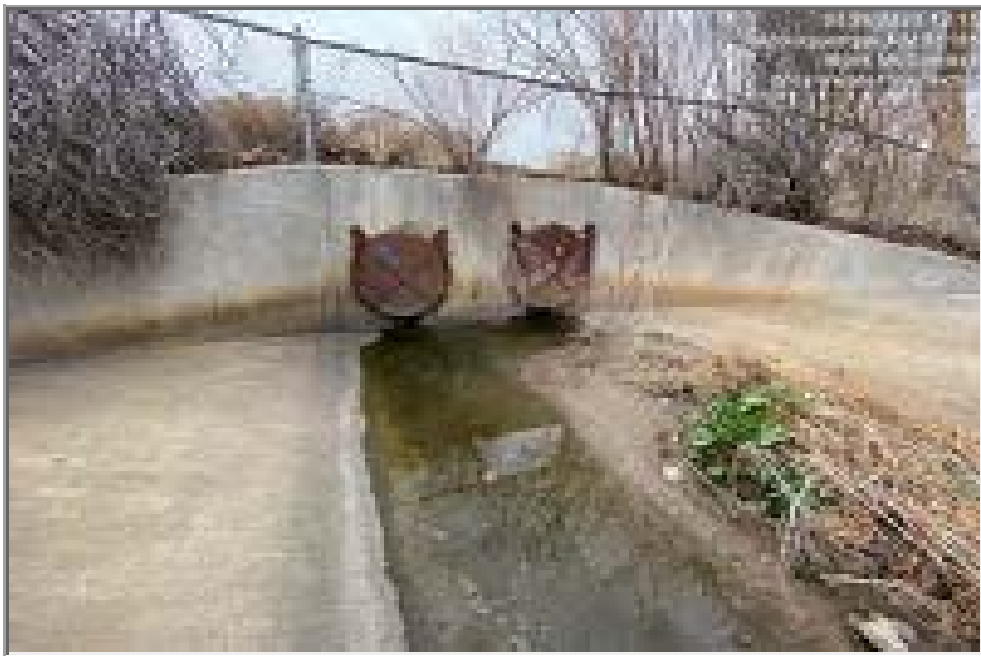
AIR_TEMP_F	63	Lab	HALL ENVIRONMENTAL
WATER_TEMP_F	69	Lab_Report	2204360
pH	8.16	E_coli_Coliform_mpn/100ml	4.1
CONDUCTIVITY_Umos/cm	590	Ammonia_mg/l	<1
BOD_mg/l	<2	Nitrite_NO2_mg/l	<0.5
COD_mg/l	<20	Nitrate_NO3_mg/l	<0.5
TSS_mg/l	4	TKN_Tot_Kjeld_N_mg/l	<1
TDS_mg/l	398	Phosphorus_total_mg/l_P	0.11
N-Hexane Extractable-(Oil_Grease)_mg/l	<9.69	Hardness_mg/l_CaCO3	210
Fluoride_mg/l	0.68	Chlorine_mg/l	<0.05

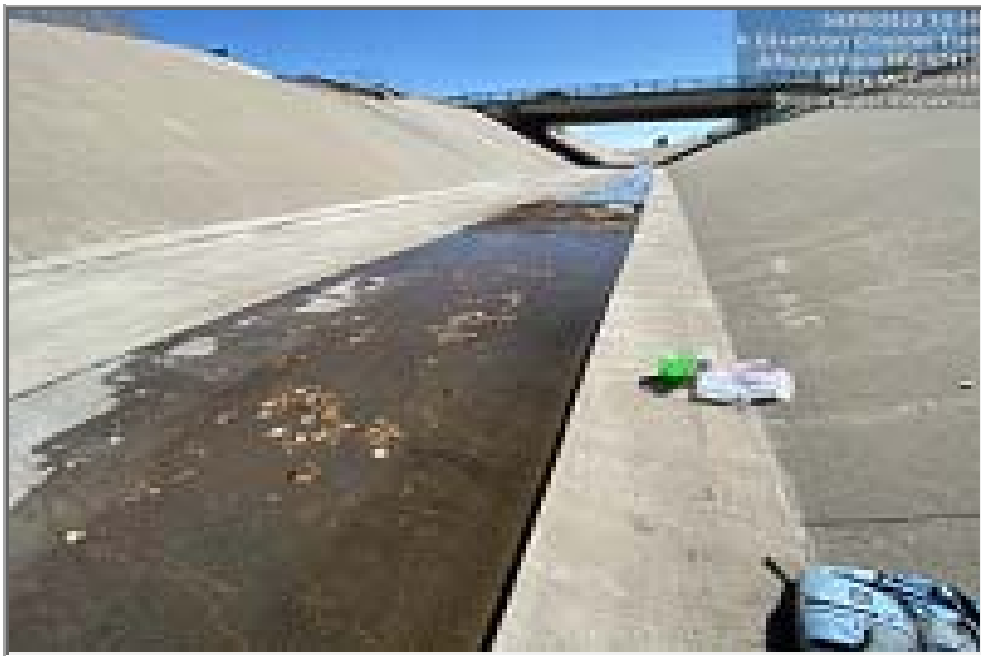
Source of Flow **well wash water, irrigation, water hydrant flushing and broken waterlines**

AIR_TEMP_F	78	Lab	HALL ENVIRONMENTAL
WATER_TEMP_F	70	Lab_Report	2204419
pH	9.98	E_coli_Coliform_mpn/100ml	18.9
CONDUCTIVITY_Umos/cm	1100	Ammonia_mg/l	<1
BOD_mg/l	6.1	Nitrite_NO2_mg/l	<0.5
COD_mg/l	62.2	Nitrate_NO3_mg/l	<0.5
TSS_mg/l	<4	TKN_Tot_Kjeld_N_mg/l	1.8
TDS_mg/l	726	Phosphorus_total_mg/l_P	0.074
N-Hexane Extractable-(Oil_Grease)_mg/l	<9.76	Hardness_mg/l_CaCO3	190
Fluoride_mg/l	1.4	Chlorine_mg/l	<0.05
