SPEED STUDY FOR SPANISH SUN AVENUE NE

NTMP P80500 Task #4

Speed Study for Spanish Sun Avenue NE

NTMP P80500

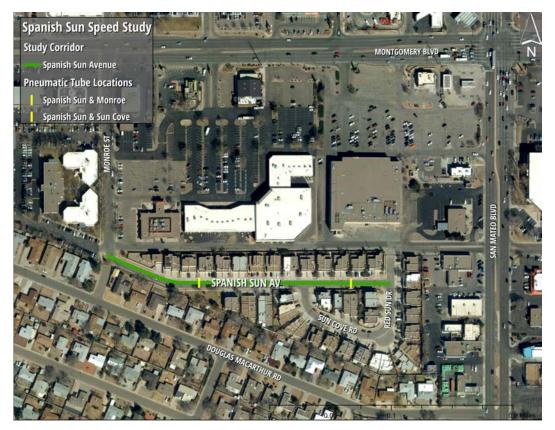
Figure 1: Study Area and Traffic Counter Locations

Spanish Sun Avenue is a two-lane undivided urban local street running east to west between Red Sun Drive and Monroe Street. This project focuses on potential speeding issues on the block of Spanish Sun Avenue, between Monroe Street and Red Sun Drive. Intersections within this segment are three-way with stop control at Monroe Street and stop control at Red Sun Drive. Vehicles entering Spanish Sun Avenue from Sun Cove Road are managed via stop-controlled intersections. Figure 1 shows the location of the project area and data collection sights.

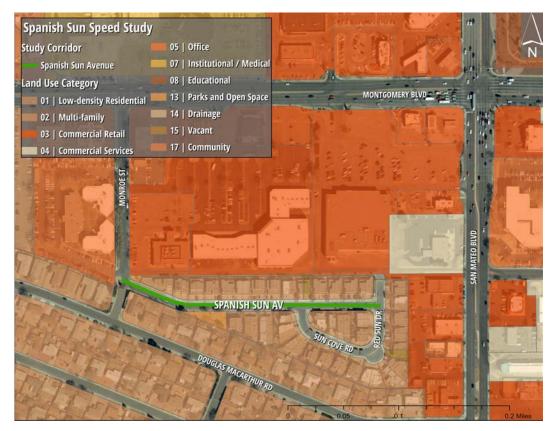
Figure 2: Surrounding Land Uses

This segment of road provides access to commercial retail and services, office, institutional/medical, community, and residential land uses. Figure 2 shows the surrounding land uses of the project area.

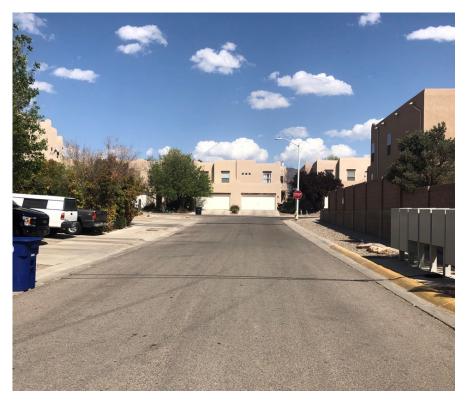
Figure 3: Spanish Sun Avenue Looking East

The study corridor is an undivided urban local street. The street is free of any road surface markings to delineate traffic lanes or indicate the presence of bicycle lanes. Figures 3 and 4 show the street's current conditions.

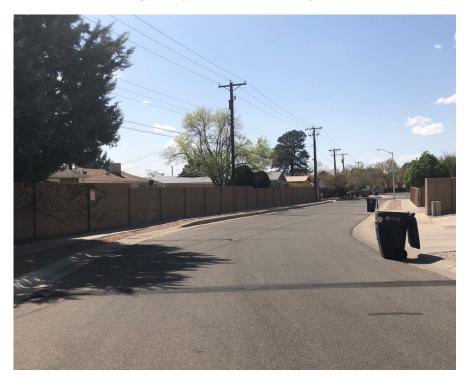
Figure 4: Spanish Sun Avenue Road Looking West

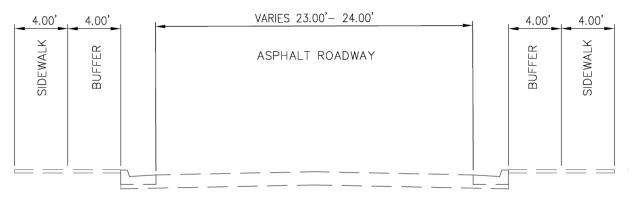
Figure 5: Existing Typical Section Spanish Sun Avenue Looking East

Spanish Sun Avenue is 27 to 28-feet-wide with a standard curb and gutter. Both sides include detached sidewalk that is 4-feet wide, with 4-feet of landscaping separating the sidewalk from the curb for the entire segment of road between Monroe Street and Red Sun Drive. Figure 5 is a schematic of the existing typical section.

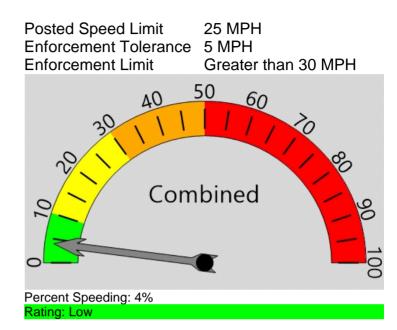
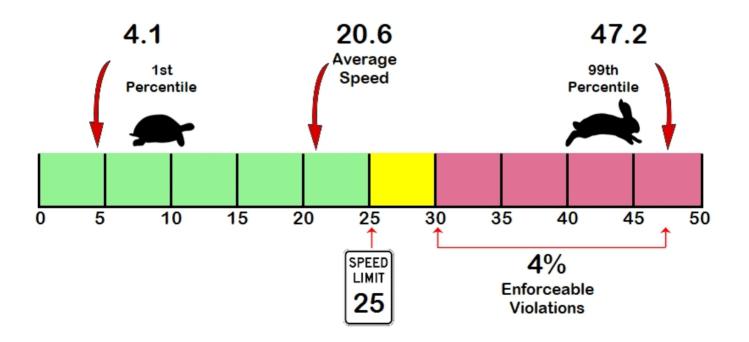
Total Percentage of Enforceable Violations

Vehicle Totals - Combined

V CHILCIC I	01013 0	ombineu											
<= 2	<= 4	<= 6	<= 8	<= 10	<= 12	<= 14	<= 16	<= 18	<= 20	<= 22	<= 24	<= 26	> 26
3	0	4	0	0	5	4	21	15	25	26	24	17	22
85th Perc	centile: 2	5.8

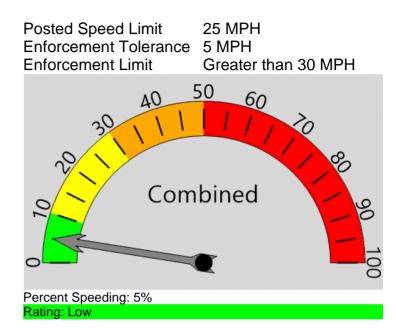
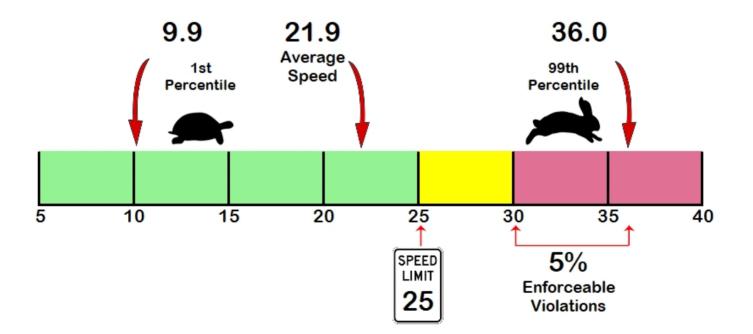
Total Percentage of Enforceable Violations

Vehicle Totals - Combined

V CHILCIC I	01013 0	ombineu											
<= 2	<= 4	<= 6	<= 8	<= 10	<= 12	<= 14	<= 16	<= 18	<= 20	<= 22	<= 24	<= 26	> 26
11	0	2	1	2	6	14	27	43	61	88	91	59	84
85th Pero	centile: 2	6.9

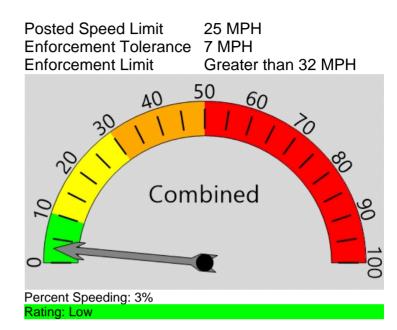
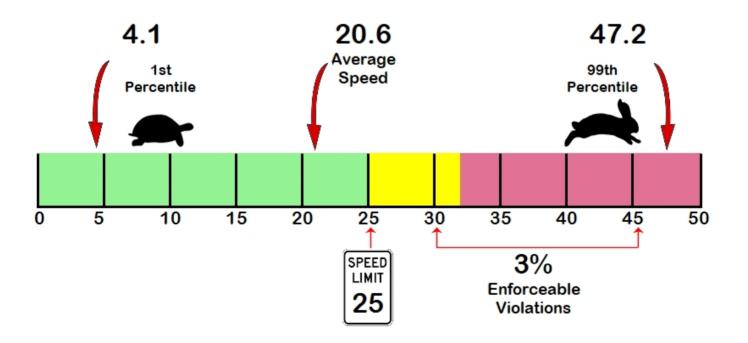
Total Percentage of Enforceable Violations

Vehicle Totals - Combined

V CHILCIC I	01013 0	ombineu											
<= 2	<= 4	<= 6	<= 8	<= 10	<= 12	<= 14	<= 16	<= 18	<= 20	<= 22	<= 24	<= 26	> 26
3	0	4	0	0	5	4	21	15	25	26	24	17	22
85th Perc	centile: 2	5.8

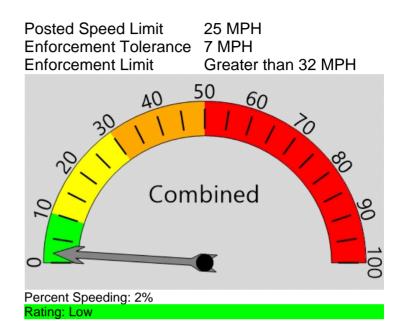
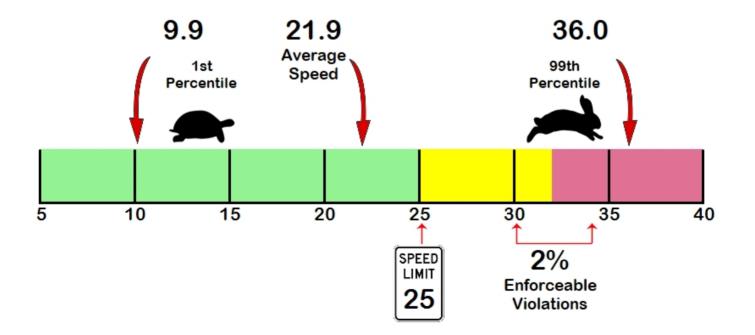
Total Percentage of Enforceable Violations

Vehicle Totals - Combined

vernere i	01013 0	ombineu											
<= 2	<= 4	<= 6	<= 8	<= 10	<= 12	<= 14	<= 16	<= 18	<= 20	<= 22	<= 24	<= 26	> 26
11	0	2	1	2	6	14	27	43	61	88	91	59	84
85th Pero	centile: 2	6.9

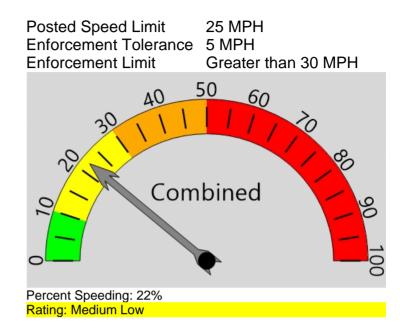
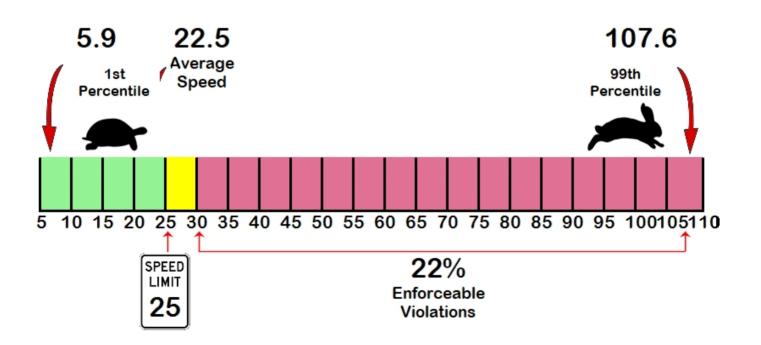
Total Percentage of Enforceable Violations

Vehicle Totals - Combined

01ais - 0	UTIDITIEU											
<= 2	<= 4	<= 6	<= 8	<= 10	<= 12	<= 14	<= 16	<= 18	<= 20	<= 22	<= 24	<= 26	> 26
10	0	0	4	1	2	3	7	7	4	8	5	2	23
85th Per	centile: 7	8.1

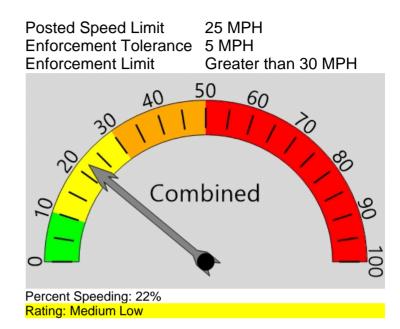
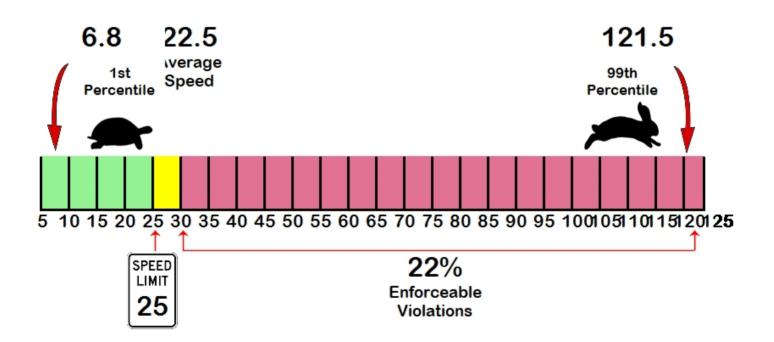
Total Percentage of Enforceable Violations

Vehicle Totals - Combined

v		01013 0	ombineu											
	<= 2	<= 4	<= 6	<= 8	<= 10	<= 12	<= 14	<= 16	<= 18	<= 20	<= 22	<= 24	<= 26	> 26
	156	0	1	1	2	1	1	0	1	2	1	5	5	56
8	5th Perc	centile: 7	8.1

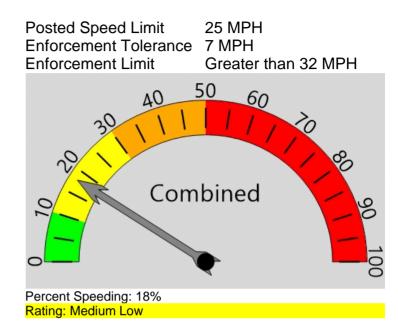
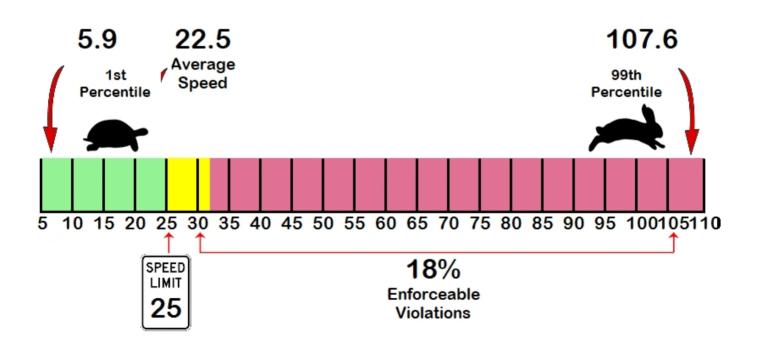
Total Percentage of Enforceable Violations

Vehicle Totals - Combined

01ais - 0	UTIDITIEU											
<= 2	<= 4	<= 6	<= 8	<= 10	<= 12	<= 14	<= 16	<= 18	<= 20	<= 22	<= 24	<= 26	> 26
10	0	0	4	1	2	3	7	7	4	8	5	2	23
85th Per	centile: 7	8.1

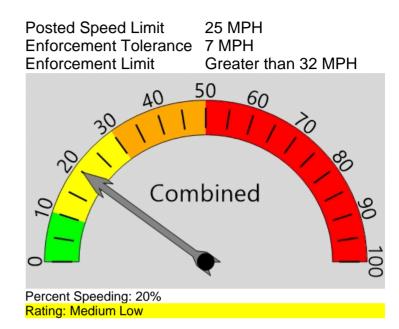
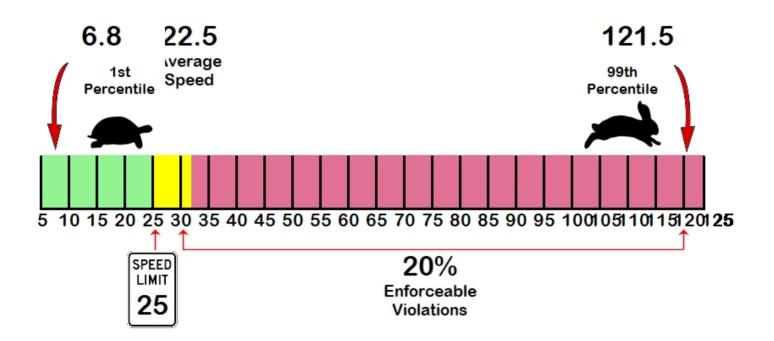
Total Percentage of Enforceable Violations

Vehicle Totals - Combined

v		01013 0	ombineu											
	<= 2	<= 4	<= 6	<= 8	<= 10	<= 12	<= 14	<= 16	<= 18	<= 20	<= 22	<= 24	<= 26	> 26
	156	0	1	1	2	1	1	0	1	2	1	5	5	56
8	5th Perc	centile: 7	8.1
