# Bear Canyon Open Space Visitor Use Plan

City of Albuquerque  
Parks & Recreation Department  
Open Space Division  
July 2021

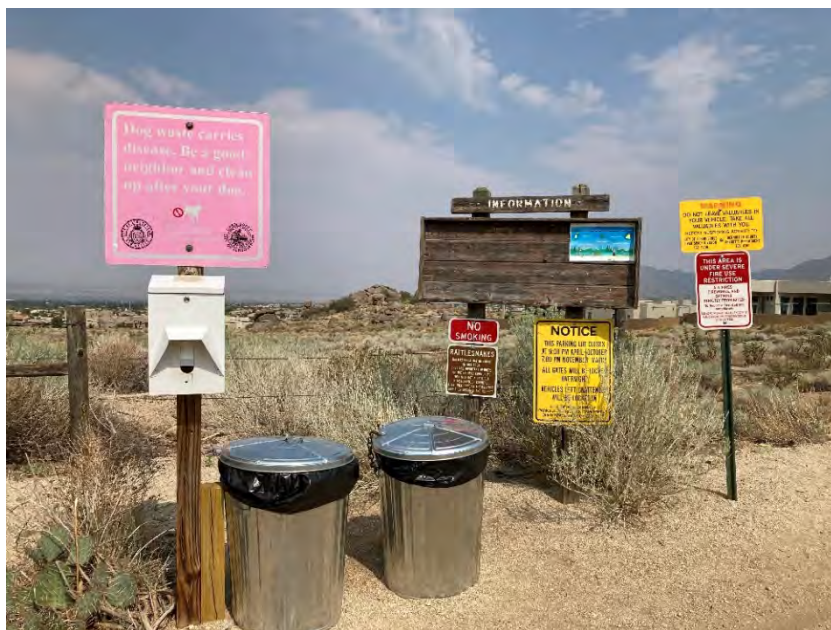
*Trailhead signage at Embudito Canyon trailhead*

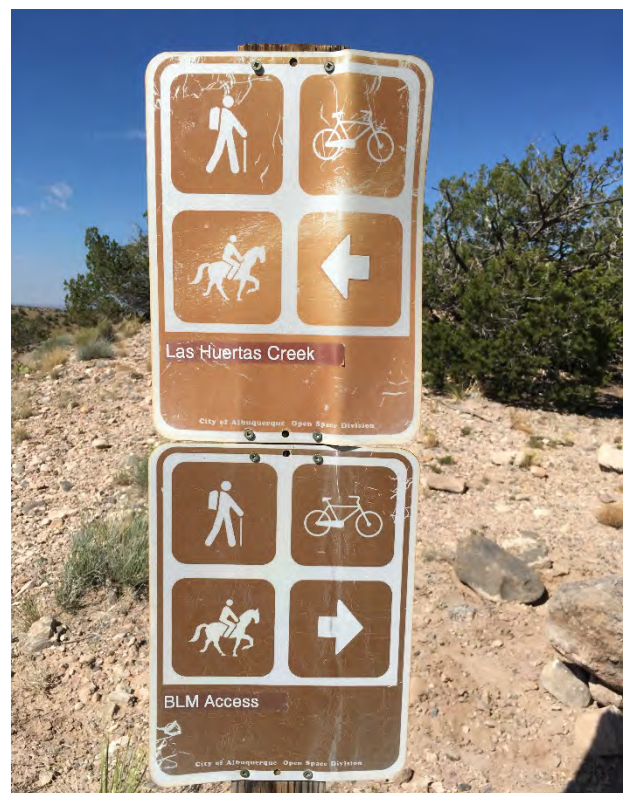
*Example of trail intersection signage at other MPOS locations*

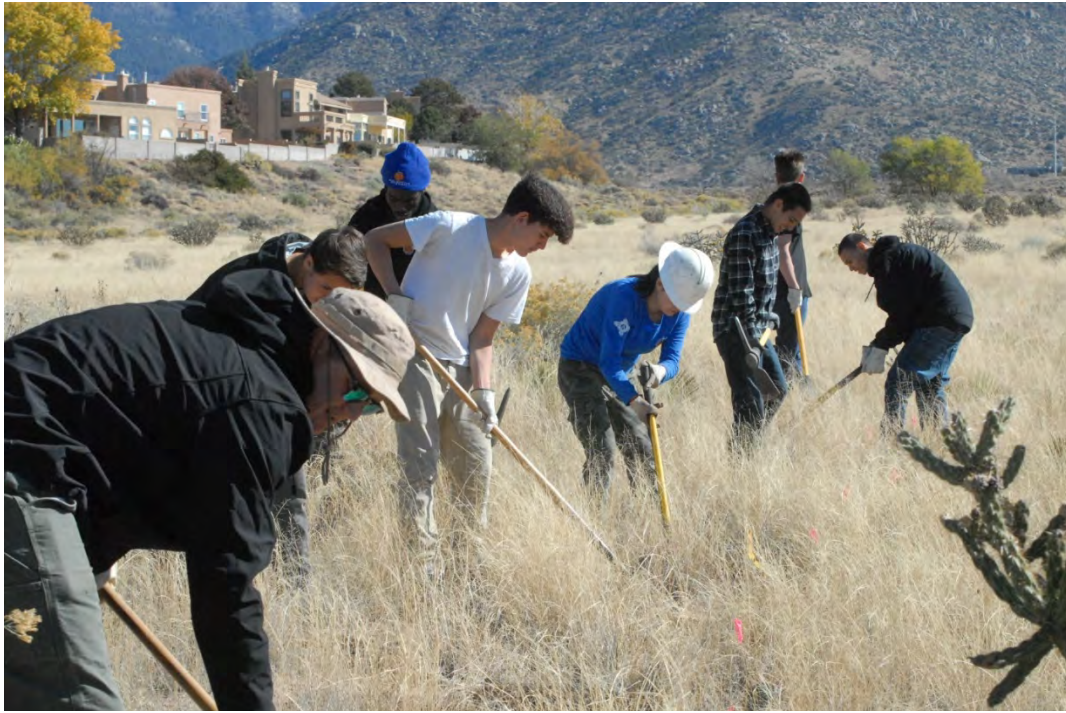
*Trail construction project at BCOS by a student volunteer group led by OSD staff*

The Open Space Division regularly conducts routine, annual, and specific one-time projects at Bear Canyon Open Space utilizing both internal and external labor. This includes a combination of the OSD's Visitor Services, Maintenance, and Bosque Reclamation staff time and resources; neighborhood and Trail Watch Volunteer time; other volunteer groups like the New Mexico Volunteers for the Outdoors (NMVFO), youth corps like the Rocky Mountain Youth Corps (RMYC) and Open Space Youth Corps (OSYC); and student groups interested in educational service experiences.

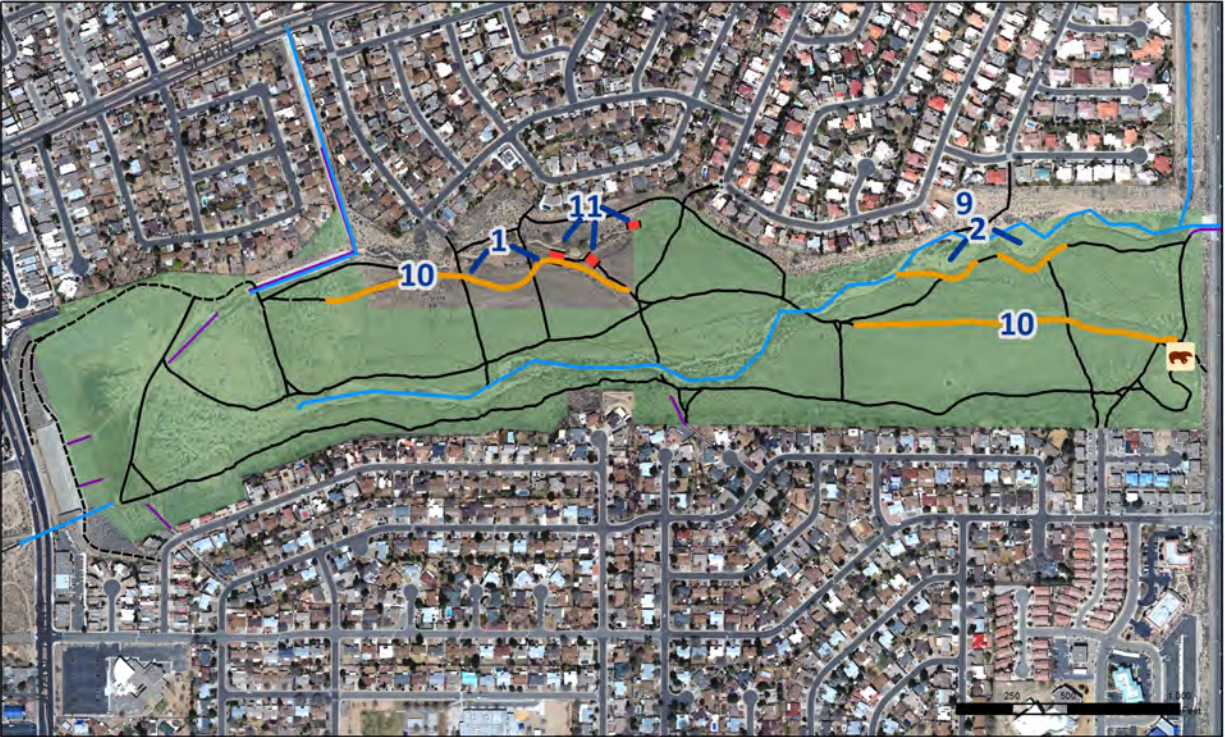
# Recent Projects 2018-2020

- Recent trail work
- Temporary fencing for trail closure
- Drainage Channel
- City Open Space
- Official Trail

1. The OSD performed trail work on the private open space north of Bear Canyon West during October 2018 and July 2019, closing an eroding trail near incised drainage and formalizing a lower trail to form a connection across the private open space. There are two access points on the private open space at this location that BCOS visitors may utilize, and unmanaged trails on the private open space encourage further unsustainable user trails and erosion on the adjacent MPOS.

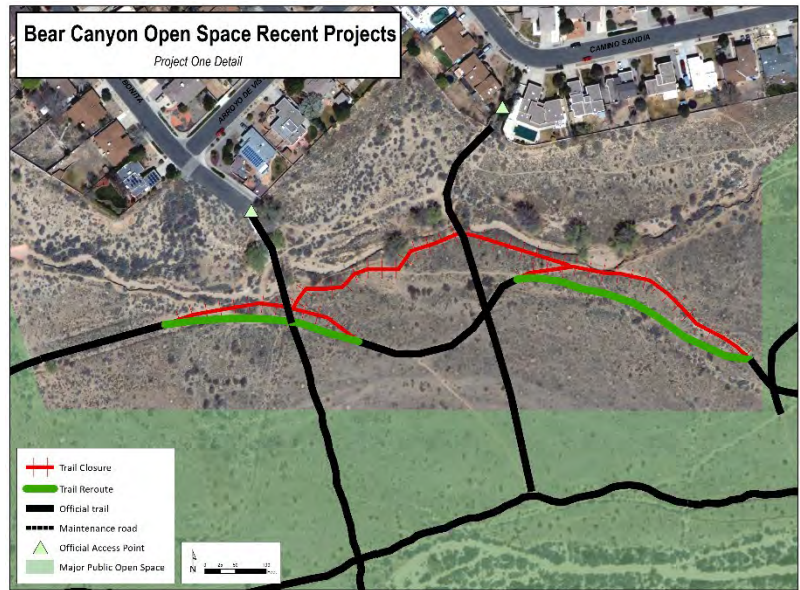
2. The OSD worked with ACE Charter School in 2018 to close and reroute additional sections of official trail in BCW that had partially collapsed into the drainage channel during a heavy rain event. The OSD did additional cactus plantings in 2019 to increase vegetation coverage and prevent usage of the closed section.

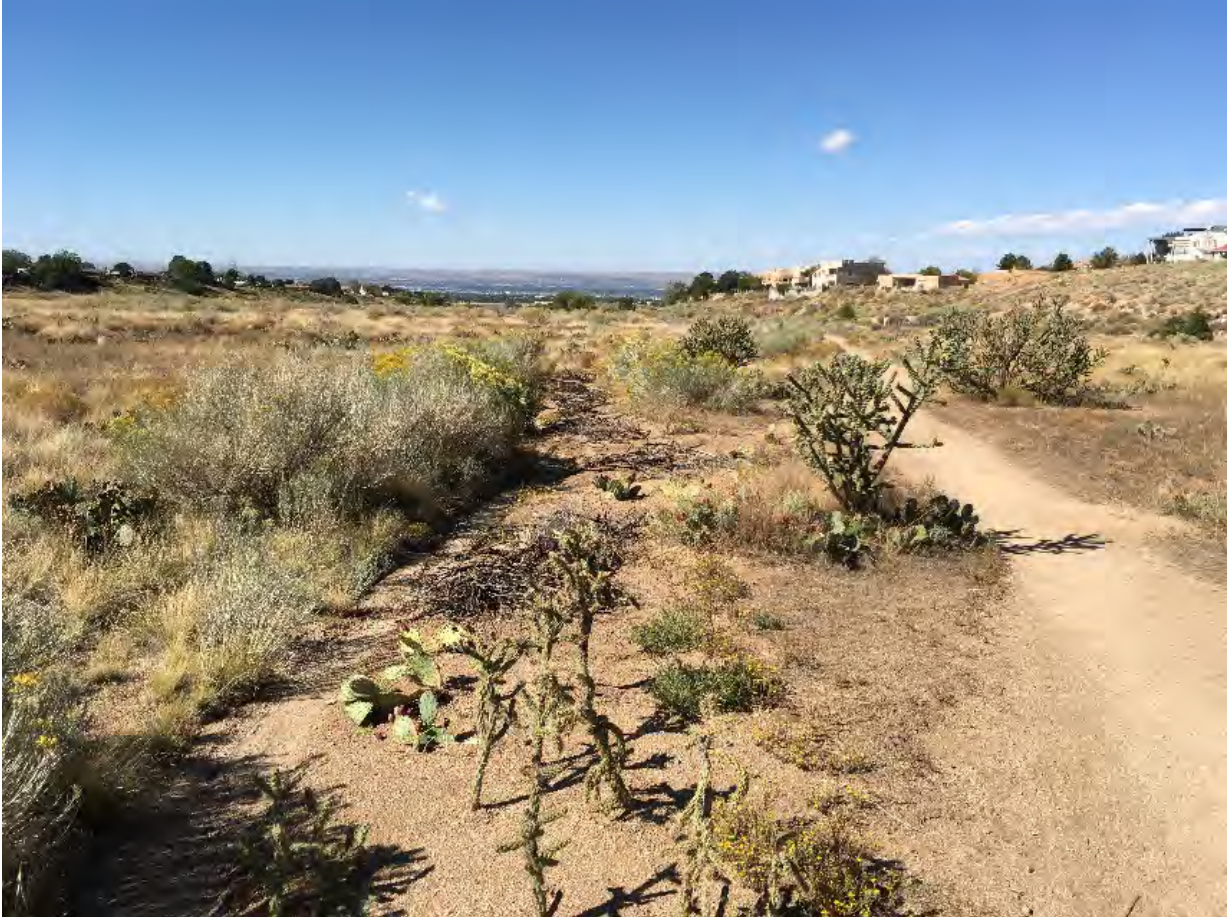
*Trail closure by ACE Charter School student volunteers (Project 2)*

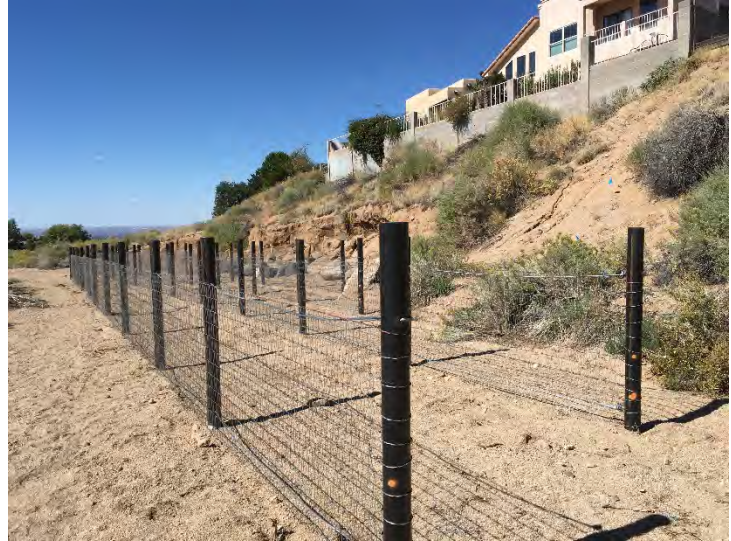
*Erosion control system constructed by COA Hydrology in Bear Canyon West (Project 9)*

9. During summer 2019, City Hydrology (DMD) constructed erosion control structures within a section of private open space in BCW. This work is intended to prevent undercutting near residences during heavy rain events (general area indicated on map).

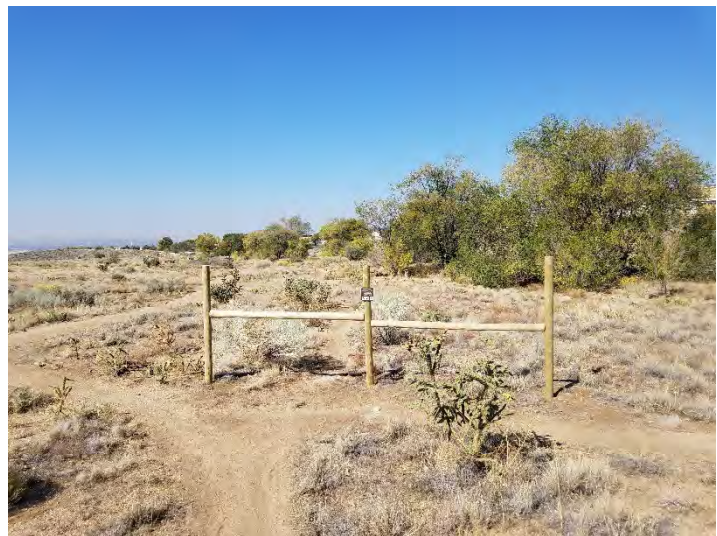
*Example of temporary fencing to help permanently close trails*

11. In October 2020, Open Space staff built temporary fencing along sections of closed trail that were still being used to allow the area to revegetate; after revegetation is successful, the fence will be removed. This temporary fencing will serve as a test run to determine if it is an effective method to prevent repeated use of closed trails.

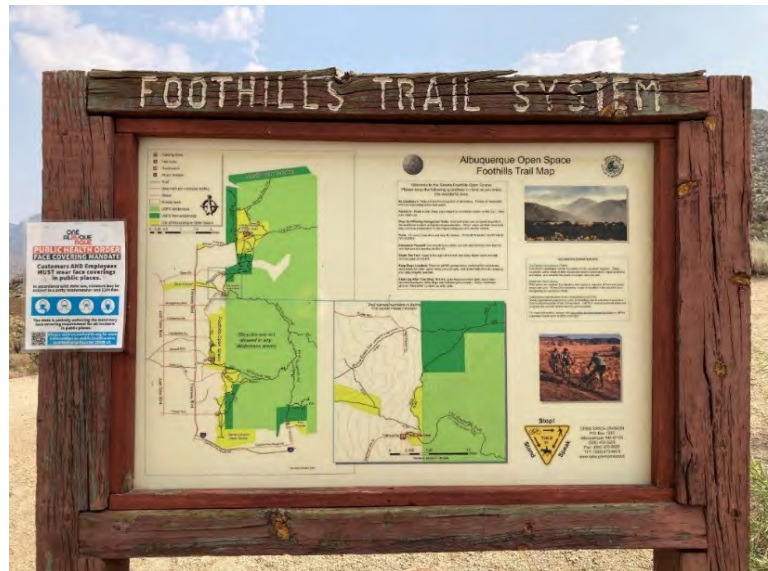
*Current kiosk with trail maps and other information at Embudito Trailhead; note that the OSD is developing a new signage design so this may not represent the design of future kiosks*

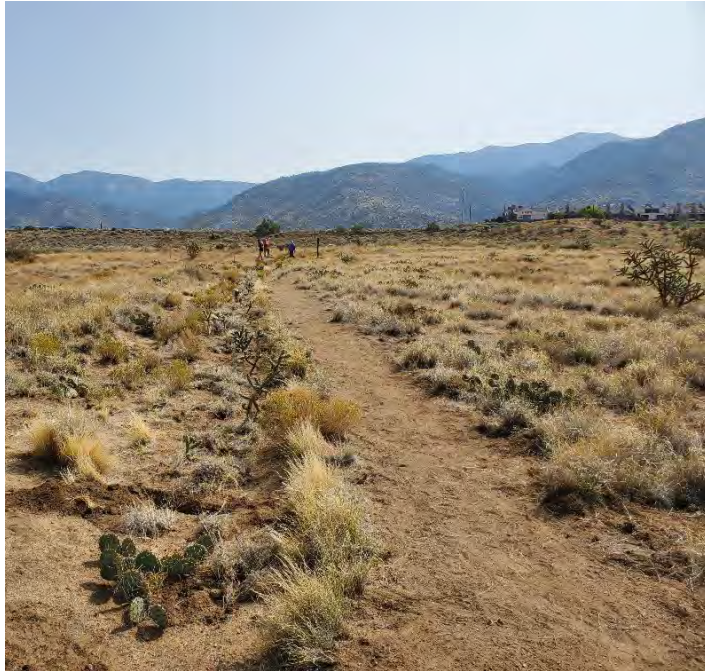
*Recently constructed by a Boy Scout group, this is an example of “bumping up” an eroded trail to take advantage of higher ground and improved runoff. The closed trail is just to the left of the new trail.*

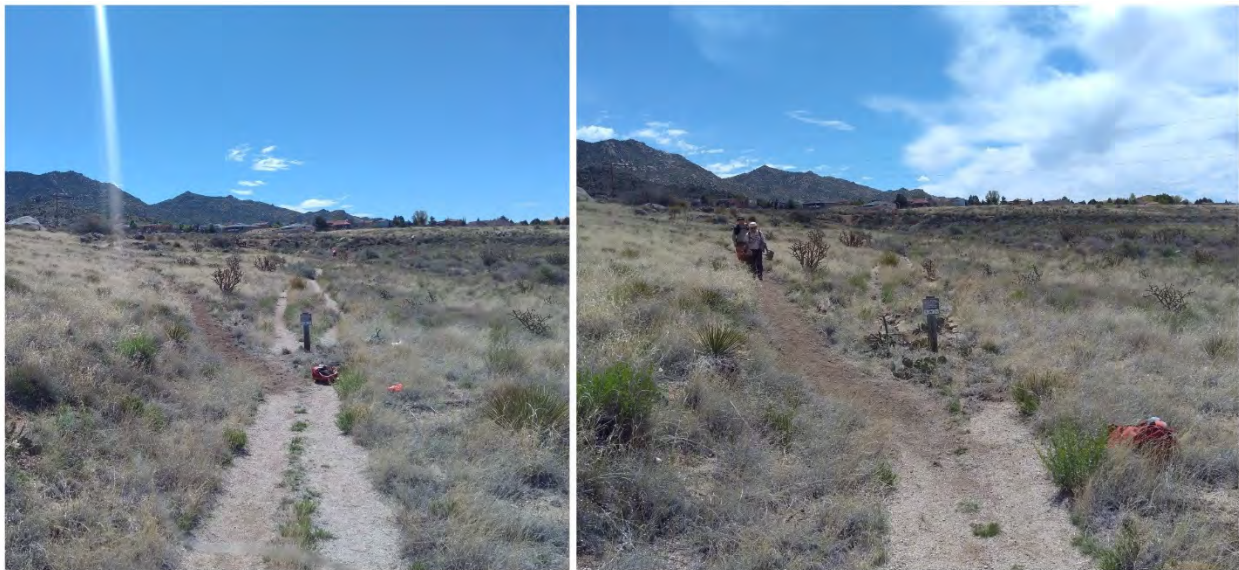
*Example of a trail reroute with the retired trail revegetated with locally sourced native cacti*

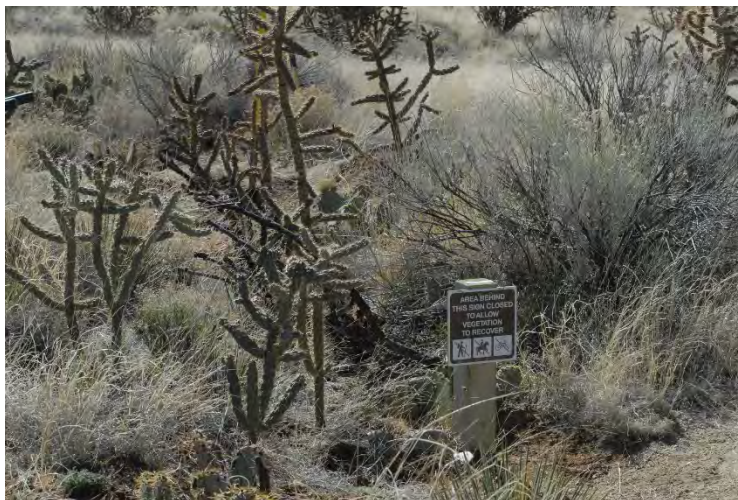
*Trail closure including plantings, vegetation debris, and a sign reading “Area behind this sign closed to allow vegetation to recover”*

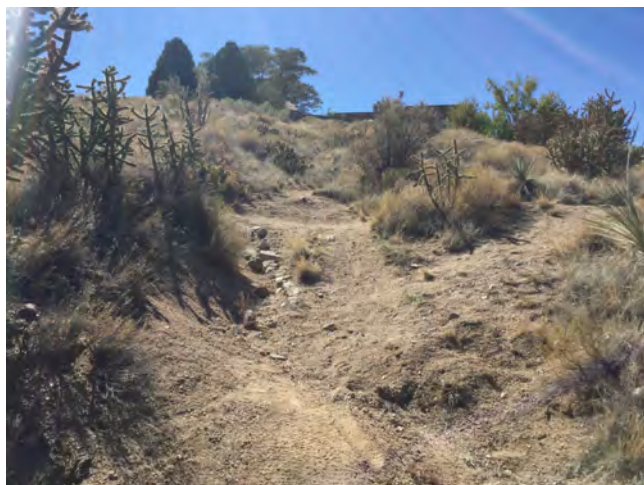
Photograph 2. Erosion from unofficial trails.

Several areas with active erosion were noted. Active erosion was generally indicated by a lack of vegetative cover and evidence of eroded soil material resulting from steep trail alignments or channel formation parallel and adjacent to existing trails. Images of these typical erosion types are shown in Photographs 1 and 5 (Appendix B).

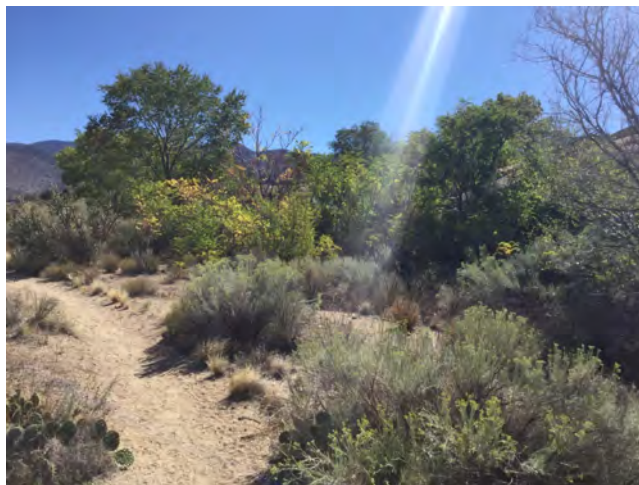
Photograph 1. Patch of noxious plant species adjacent to trail.

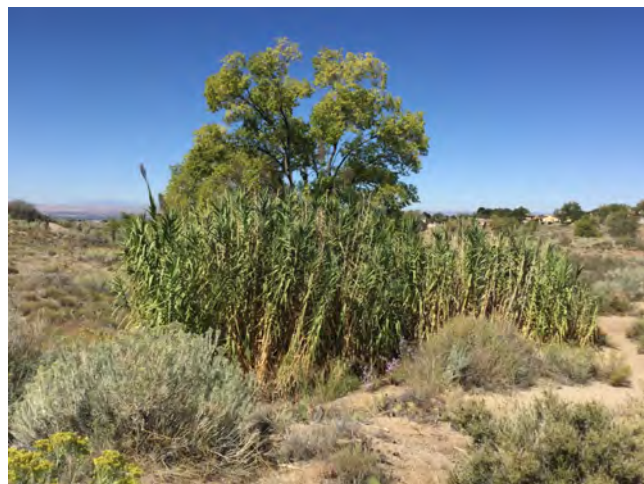
Photograph 3. Isolated patch of giant reed (*Arundo donax*) supported by stormwater flows.

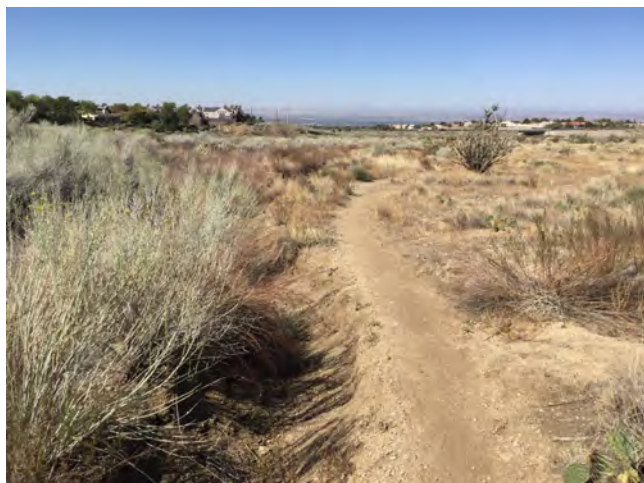
Photograph 6. Erosional feature parallel and adjacent to existing trail.

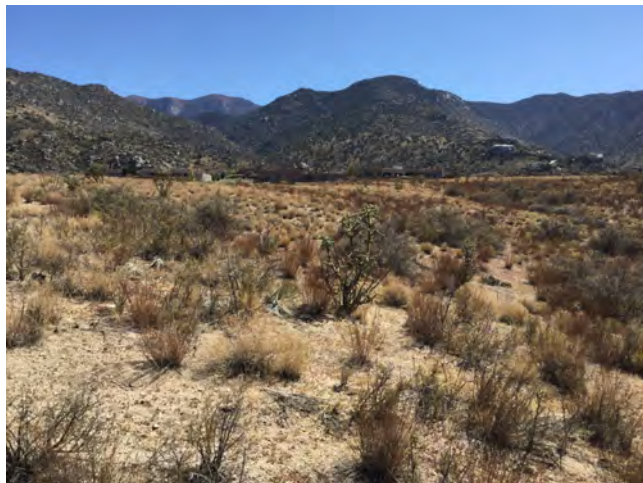
Photograph 7. Dodder (*Cuscuta* sp.) infested hillslopes.

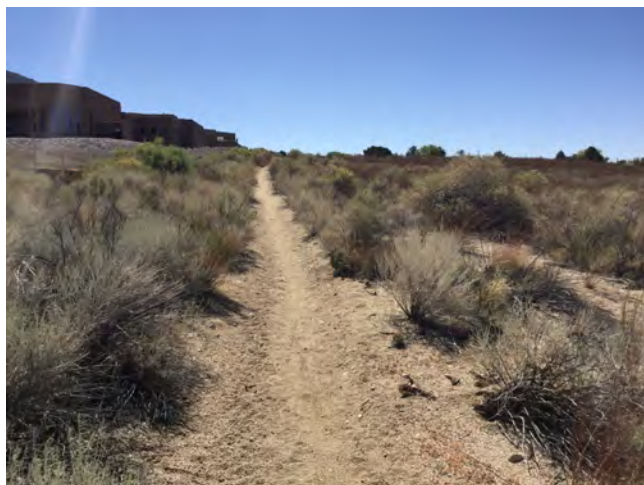
Photograph 8. Existing stable trail alignment.

is adjacent to a stable trail alignment paralleling private residences where no erosion or other degradation was observed (Photograph 7).
