BOSQUE ASSESSMENT AND UPDATE PRIORITIZATION

FINAL • DECEMBER 2023

Tetra Tech
6121 Indian School NE
Suite 205
Albuquerque, NM 87110

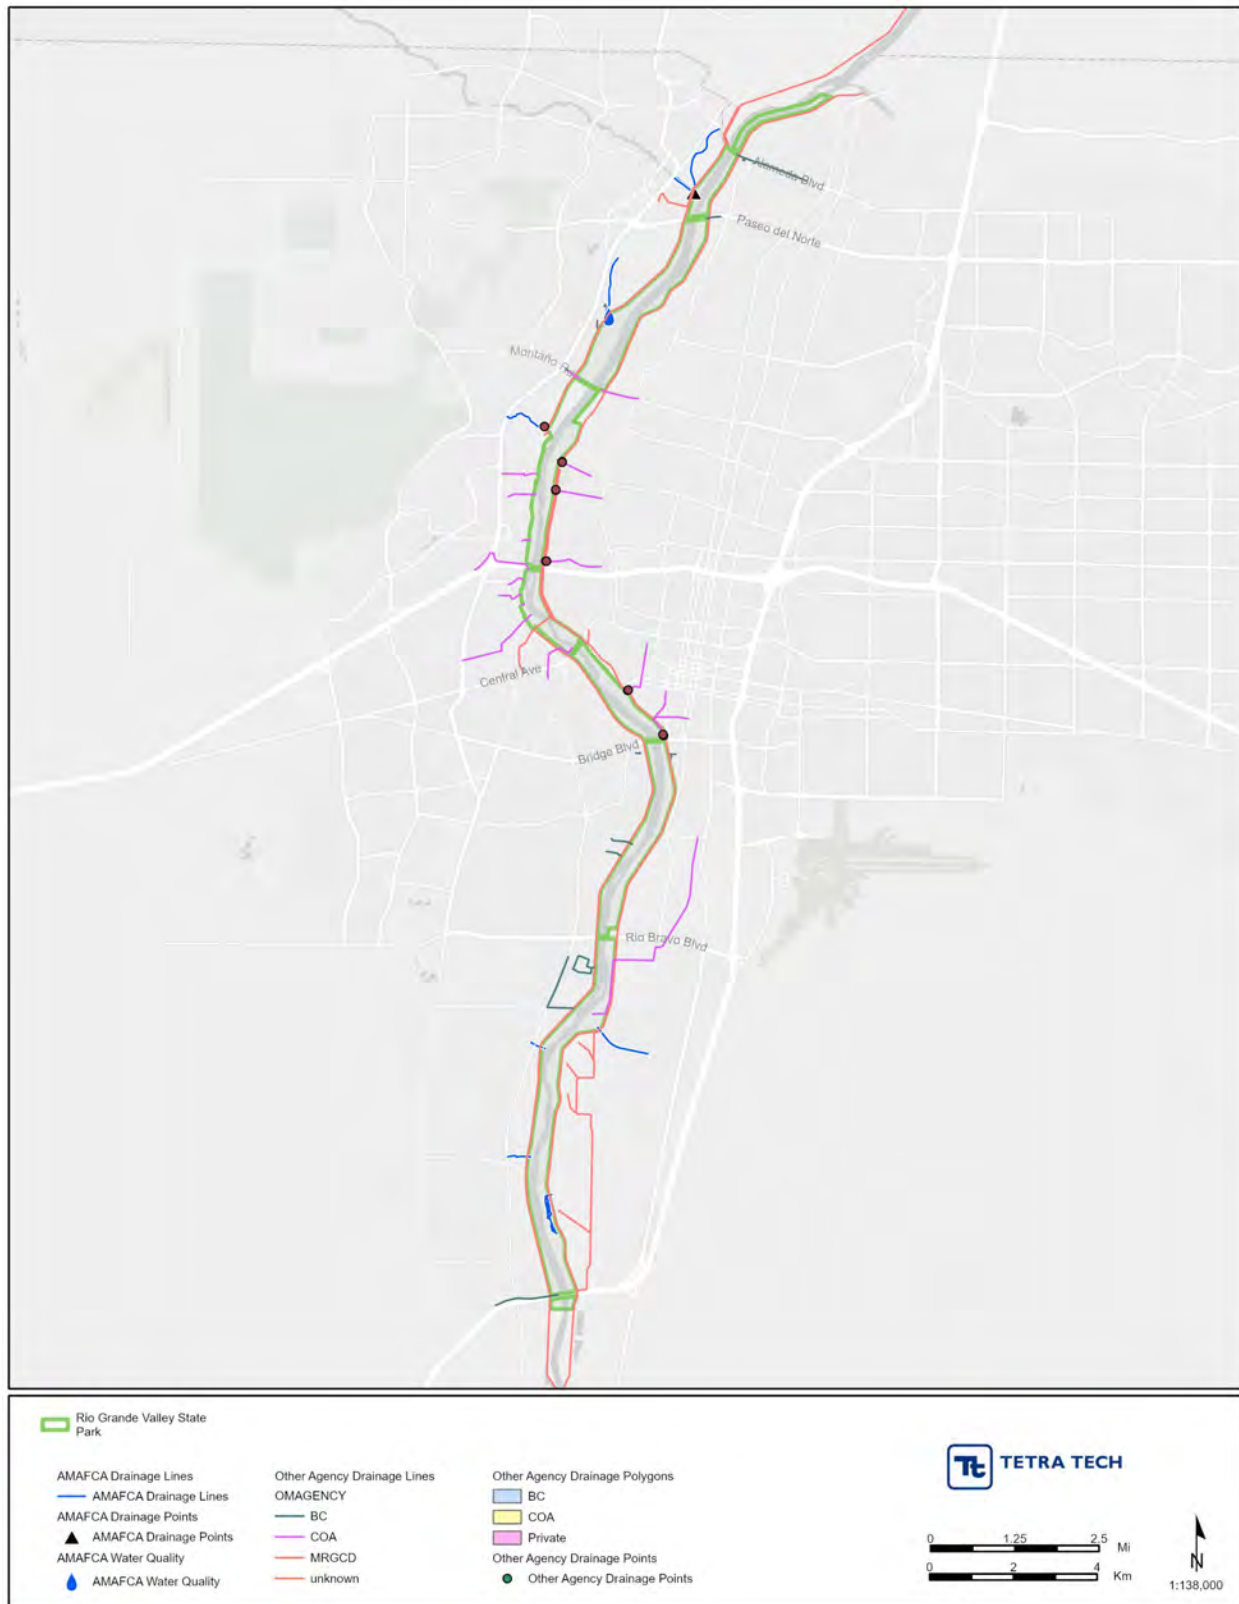
Figure 3. Water Infrastructure Facilities in the Project Area

Water management infrastructure in the area includes flood control levees, riverside drains, stormwater facilities, the ABCWUA Drinking Water Project (DWP), and the City's Wastewater Treatment Plant (WWTP) (Figure 3). This infrastructure influences water supply, impacts flow alignment, protects property, and provides recreational access and habitat for wildlife. The existing infrastructure needs to be considered in restoration plans as it affects surface and groundwater movement at the site, restoration site access, and plant community recommendations.

Water resource-related infrastructure includes jetty jacks, flood control levees, riverside drains, stormwater facilities, water treatment facilities, and the DWP (see Figures 3, 4, and 5). Water is a critical component to the health of the Bosque ecosystem. Habitat restoration projects are impacted by water resource facility operations as vegetation communities and wildlife populations in the riparian forest rely on the availability of both surface and ground water. Operation of these facilities also impacts project priorities as some offer recreational opportunities, and some of them affect water availability and river access.

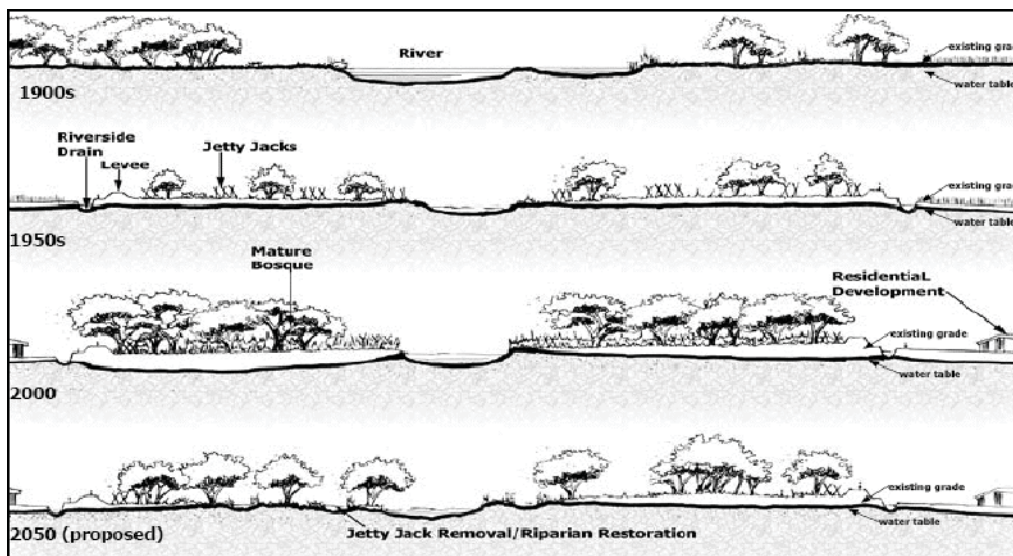
Figure 4. Flood protection projects (USACE 2003a)

Flood control projects, such as levees, dams, riverside drains, and jetty jacks, altered historical annual peak discharges, and resulting changes in channel morphology affecting Bosque and riverine habitat. These features are constructed and maintained by a variety of agencies including AMAFCA, ABCWUA, DMD, and MRGCD. The change in infrastructure since 1900 is illustrated below.

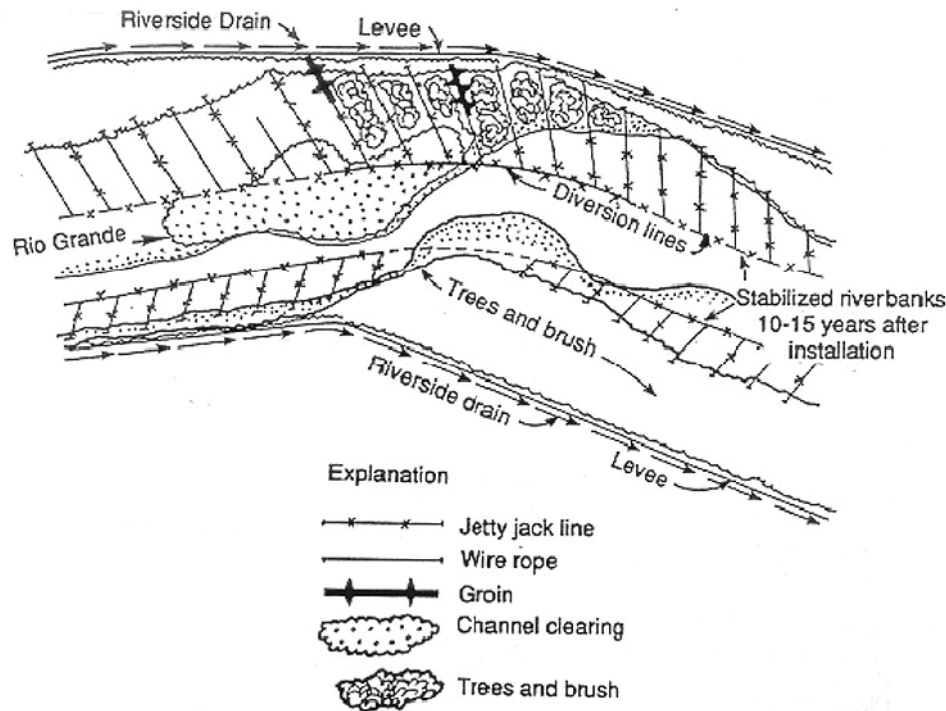
Figure 5. Jetty Jack alterations in the MRG Channel and Bosque

Approximately 30,000 jetty jacks were deployed (Figure 6) in the Albuquerque Reach within the Bosque for bank stabilization and to reduce flooding. Within various restoration projects, approximately 10,000 jetty jacks have been removed. Jetty jacks reduce water flow velocity which causes suspended sediment to settle-out of the water column resulting in deposition (see Figure 5). This results in a well-defined river channel, raises the floodplain, increases the river channel capacity, reduces river meandering, and disconnects the river from the floodplain. Over time, as the depositional process continues, the vegetation armors the bankline and thus provides the same role as the jetty jacks. Since the construction of Cochiti Dam in the 1970s, sediment loads have dropped in the Rio Grande by up to 70

percent. The decrease in the Rio Grande's sediment load, combined with the armoring of the bankline by the vegetation has greatly reduced the usefulness of jetty jacks. Additionally, these structures are hazardous to first responders during wildfires and make it difficult to maintain vegetation, including the removal of invasive and non-native species. Removing jetty jacks from the floodplain would alleviate these issues and allow for more natural floodplain processes and natural recruitment and establishment of native riparian vegetation.

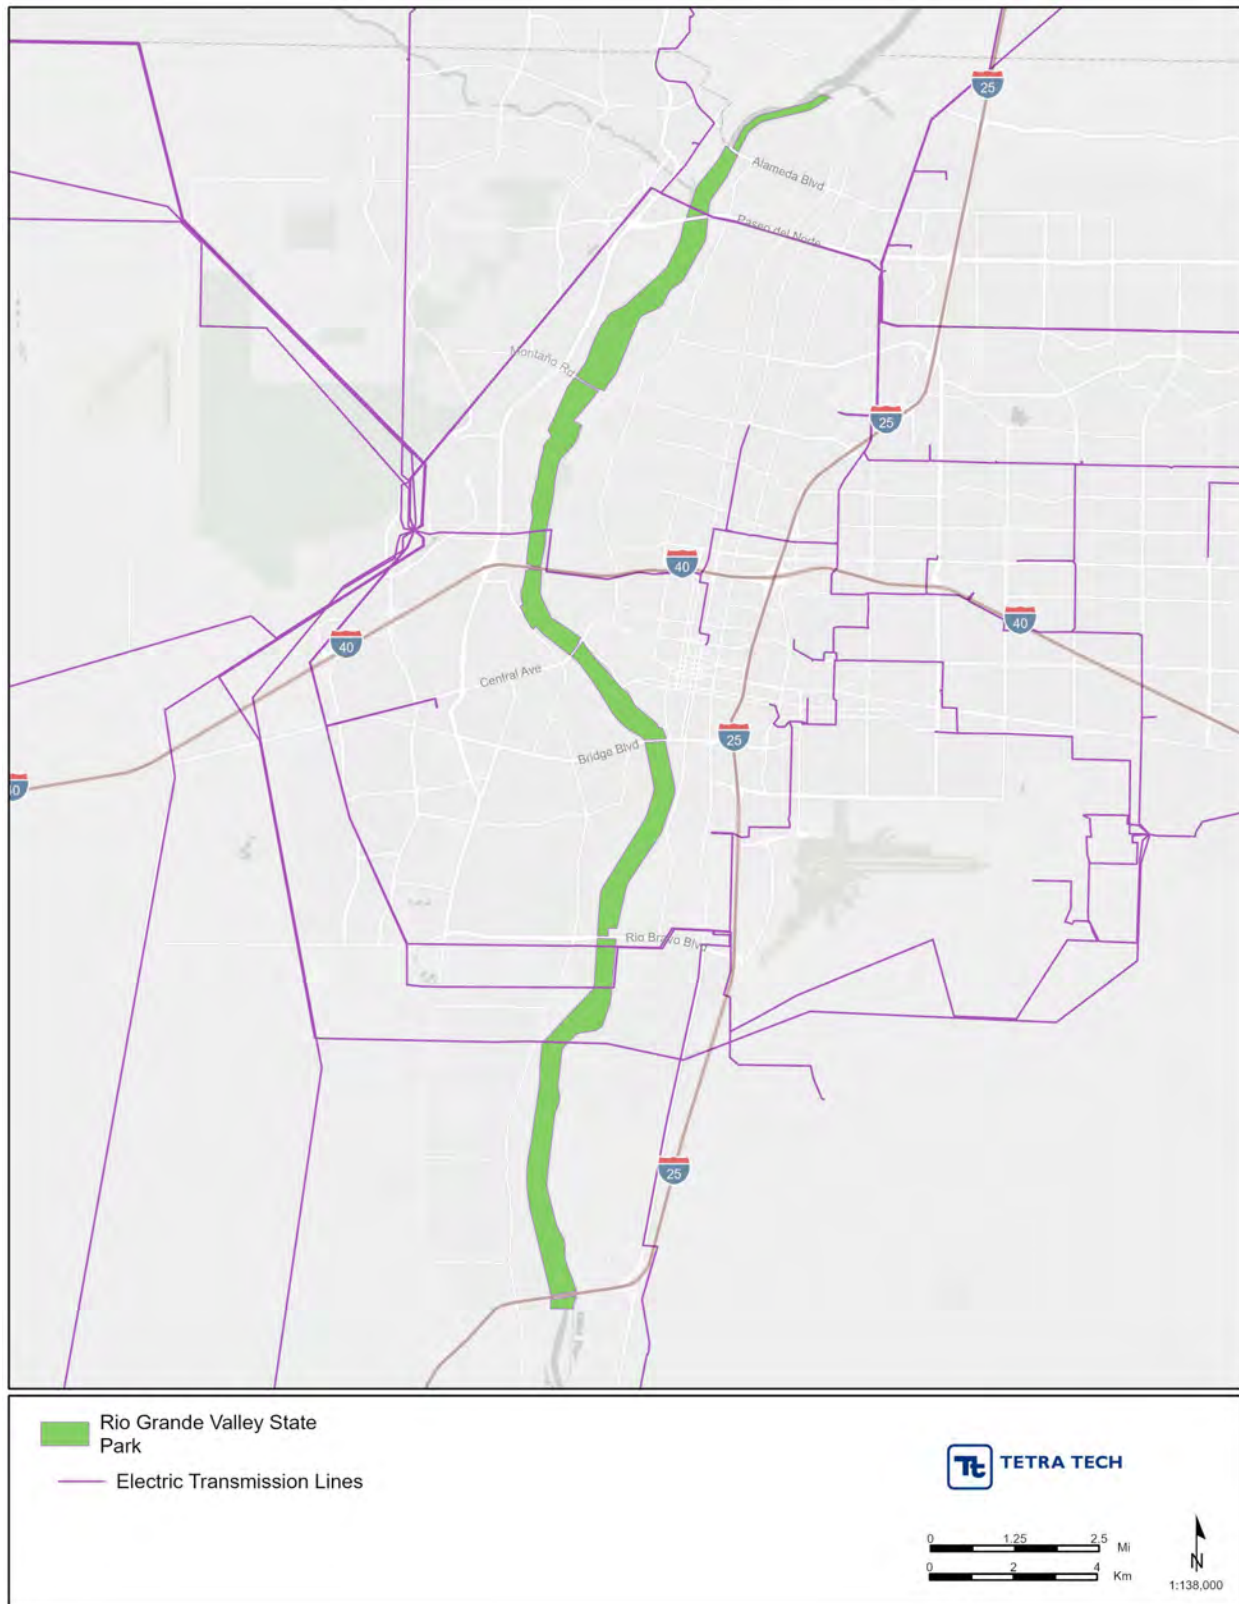
Figure 7. Utility Infrastructure

Ongoing development of new and maintenance of old transportation facilities (e.g., roads and bridges) and existing utility infrastructure (such as electric lines) (Figure 7) influence OSD's management decisions and project priorities. Continued urban growth near the Bosque leads to the need for continuous updates to existing infrastructure and development of new infrastructure. Some of these structures occur within and adjacent to the Bosque areas managed by the City OSD and the MRGCD.

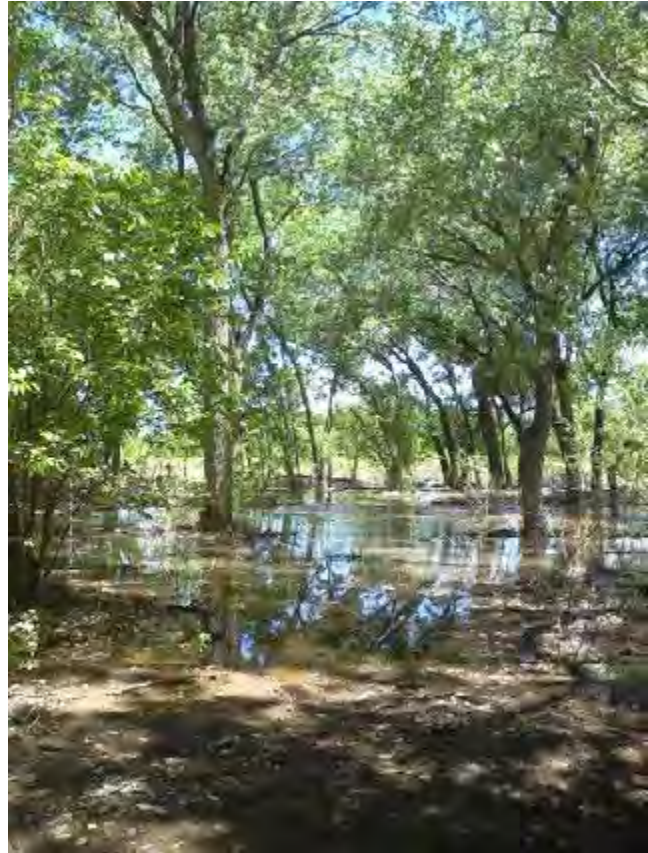
High flow inundation south of Central on the west side in the Ecosystem Restoration @ RT66 Project, 2010

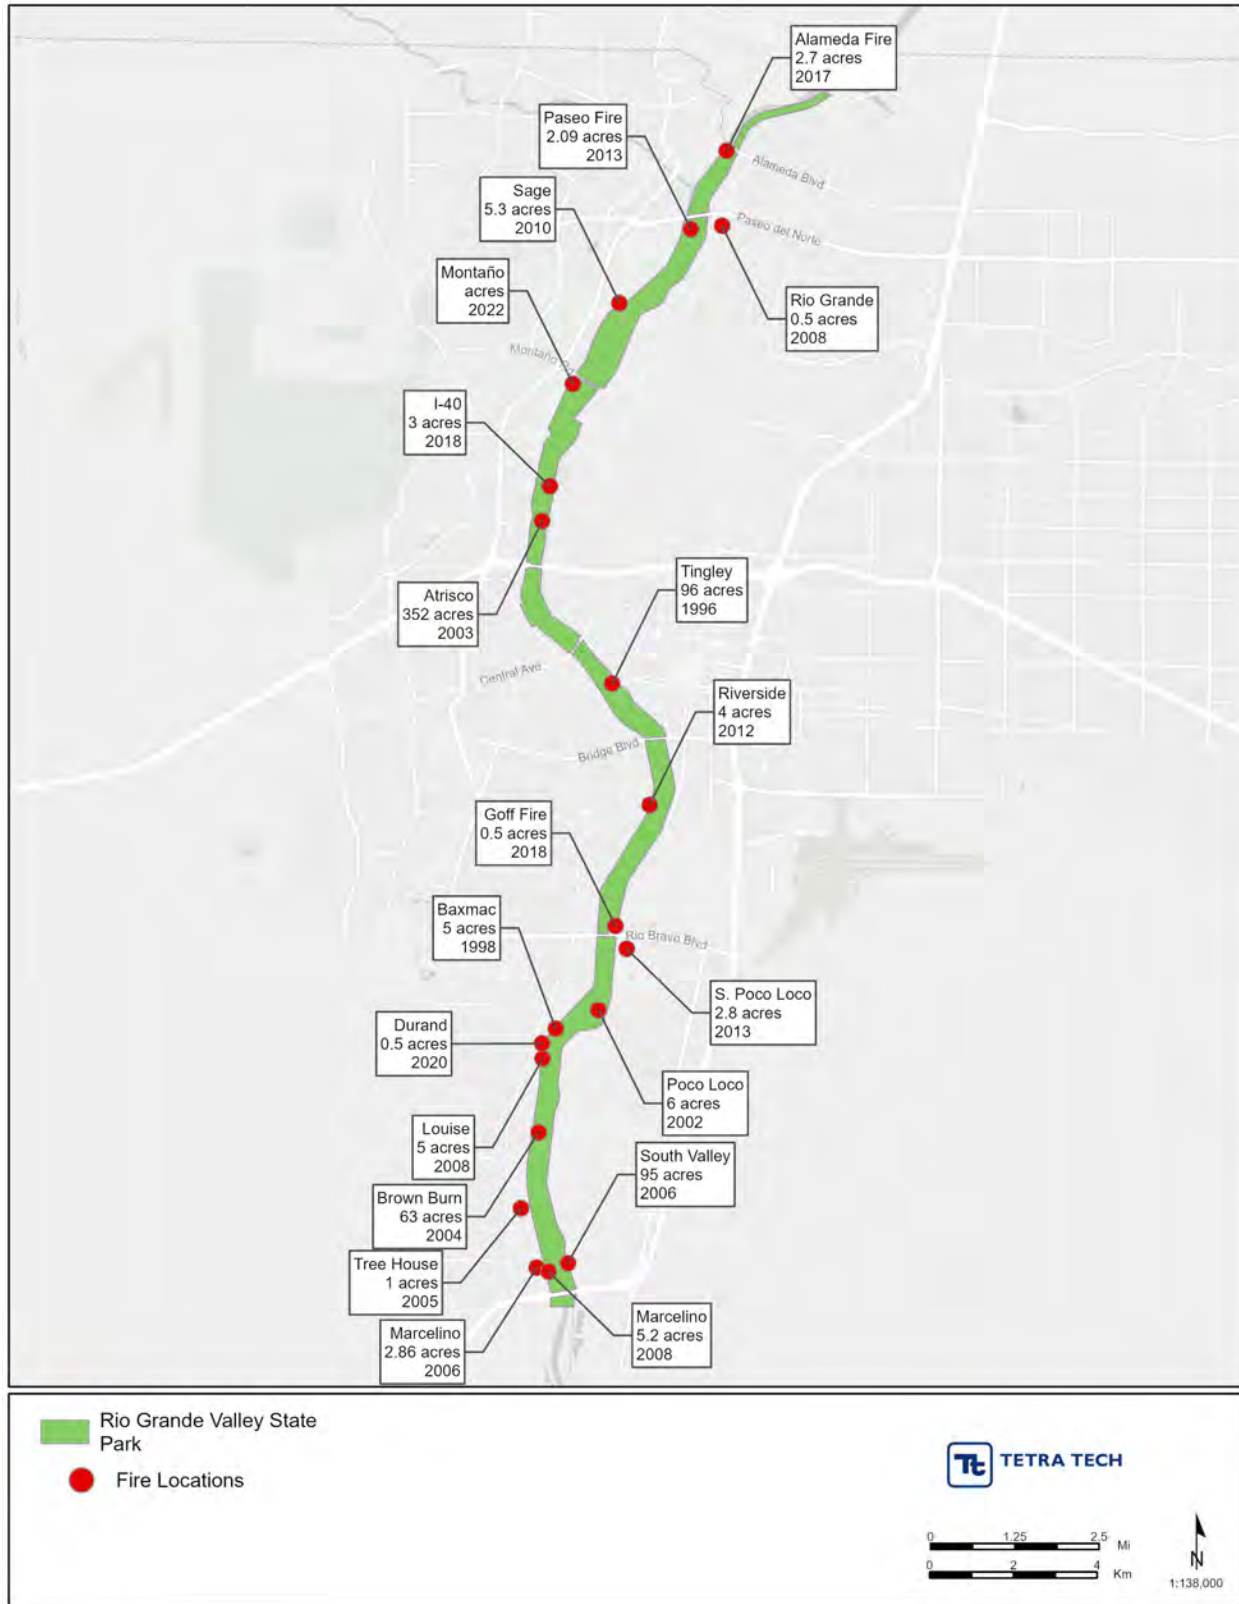
Figure 8. Recent Fire History in the Bosque (2003-2022)

Since 1996, several fires have burned approximately 799 acres in the Bosque (Figure 8 and Table 10). The two largest fires both occurred in 2003: the Atrisco Fire started on June 24 near the Interstate 40 (I-40) bridge, burning approximately 150 acres, and the Montaña Fire started two days later on June 26 near the Montaña Bridge, burning approximately 113 acres. Combined, the two fires burned approximately 263 acres within the Bosque. This spurred the USACE to become involved in the restoration of burned areas and other work required to prevent future fires (USACE 2004a). Following the fires, the City of Albuquerque removed the invasive species understories throughout the Bosque. This eliminated most understory canopies within the Albuquerque reach of the MRG, which eliminated substantial amounts of bird habitat. As a result, it created a need for new revegetation work to replace bird habitat and additional invasive species treatments.

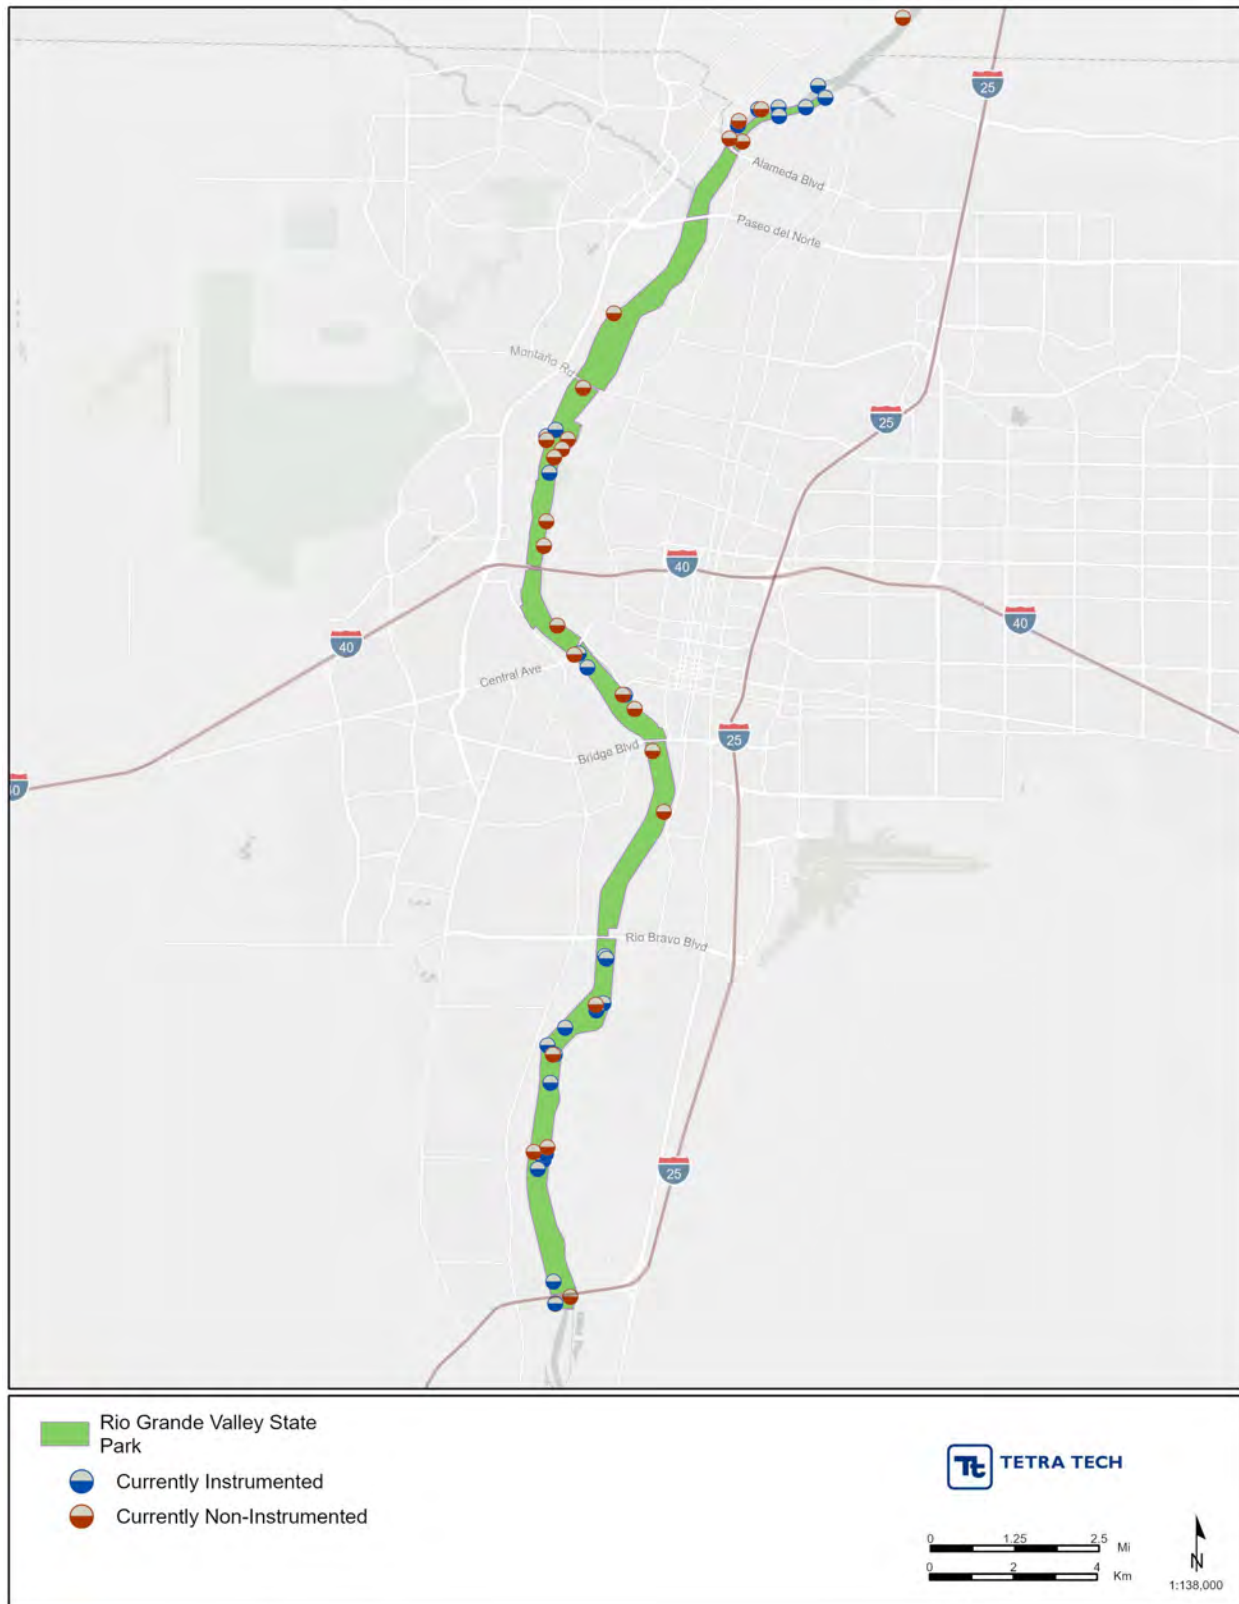
Figure 9. Groundwater Wells Within the Bosque and Adjacent MPOS

Existing well data from wells within the Project Area were reviewed to determine groundwater status throughout the Project Area (see Figure 9). Average groundwater levels throughout the proposed Project Areas varied greatly, with the shallowest of 0.19 feet above ground level occurring at the Oxbow N Scallop well in 2019, and the deepest of 11.88 feet occurring at the Alameda well in 2020 (see Table 18 below for the average groundwater depth of each well site in the proposed Project Area). Also, a trend of decreased depth to groundwater occurred in the late spring and summer months, which correlates with seasonal precipitation patterns.

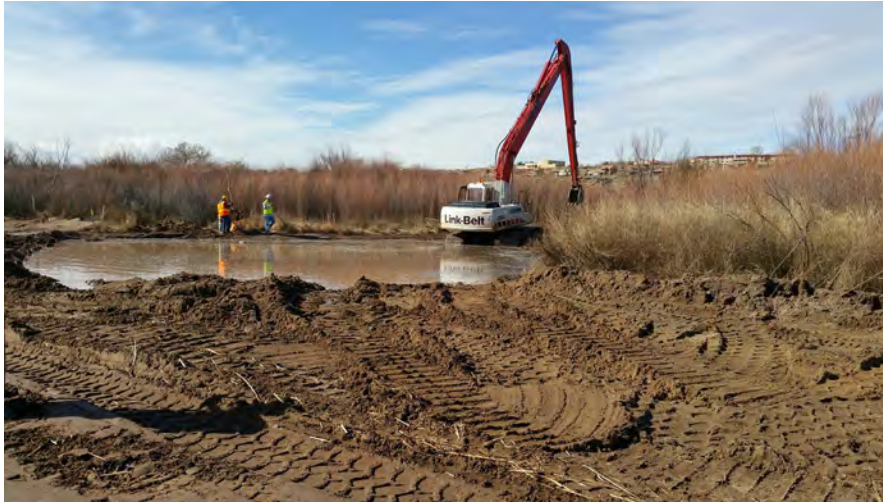
Excavation of the open water area at the San Antonio Oxbow, March 2016

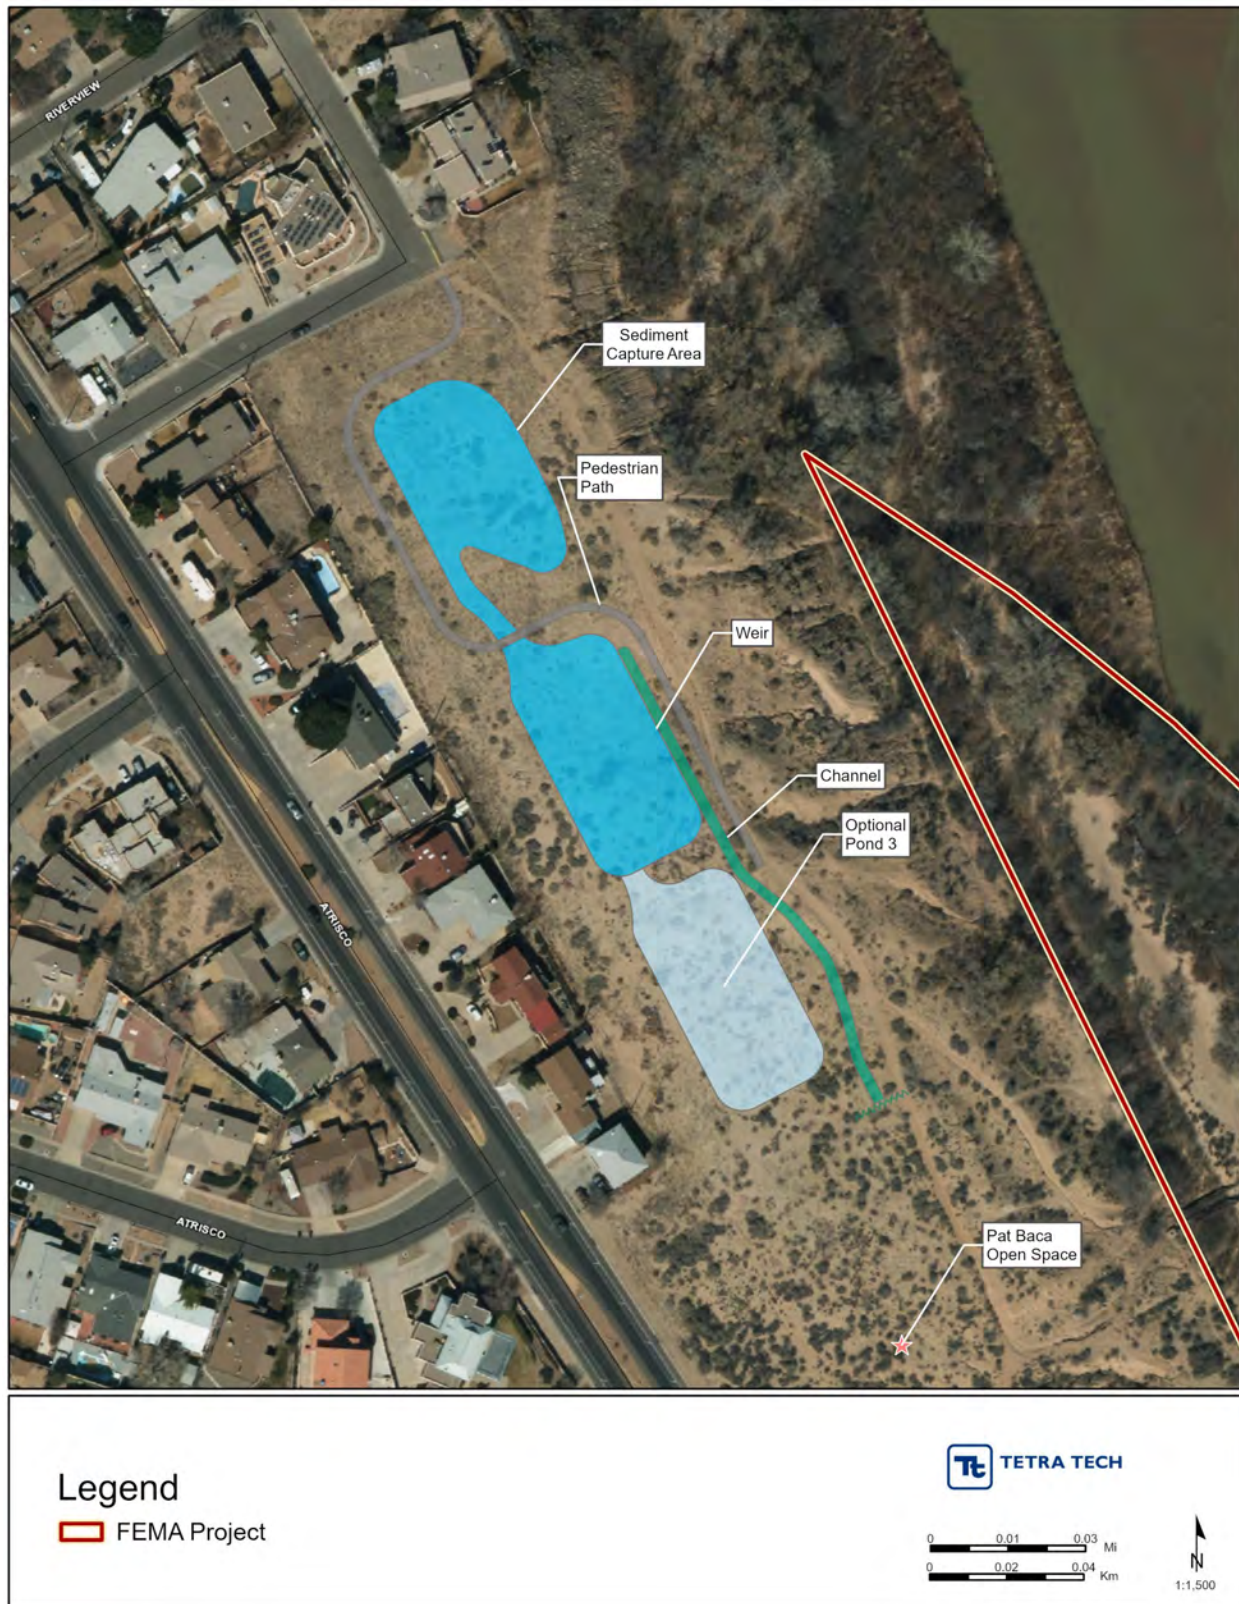
Figure 18. Outfall Restoration Alternatives

Components of the RGEMP (USACE) are planned at this location including invasive species treatment as well as a swale and other water features. Bernalillo County is also rehabilitating a stormwater drain outfall and this project may provide some benefits to the Bosque through developing swales and native plantings that will help clean the stormwater.

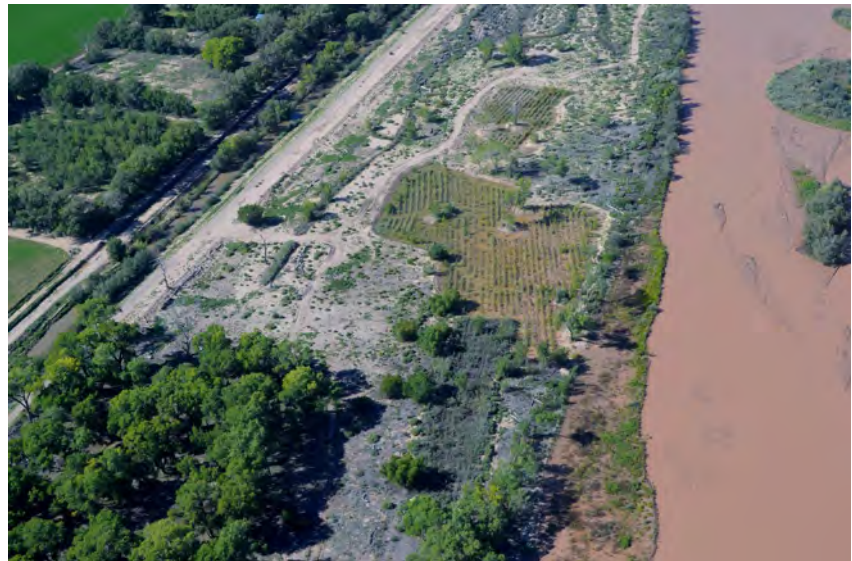
Inundation of the Middle Rio Grande Restoration Project at Sites 5D and 5E, September 2013
