Uptown Pedestrian Study

Task #8 of Procurement No. 2013-02

Mid-Region Council of Governments

October 27, 2014

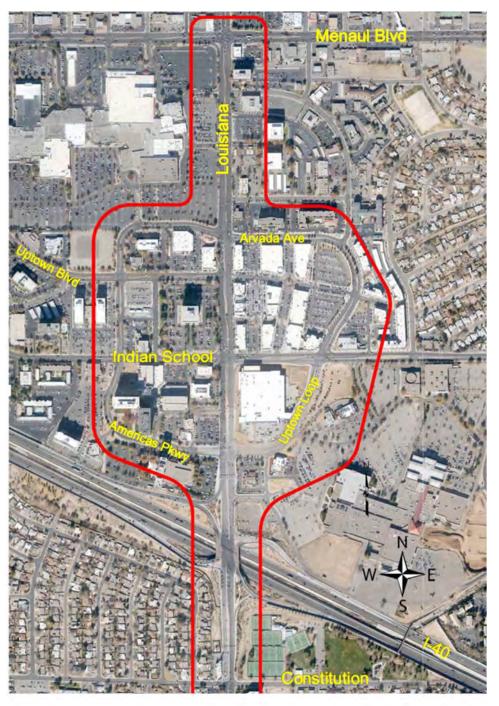
Figure 1. Uptown Study Area

The Uptown Area around Louisiana Boulevard and Indian School Road in Albuquerque, New Mexico, is the focus of this task. The purpose of the study is to identity potential improvements that will promote pedestrian safety and improve vehicular flow through the area. The study area is shown in Figure 1 below.

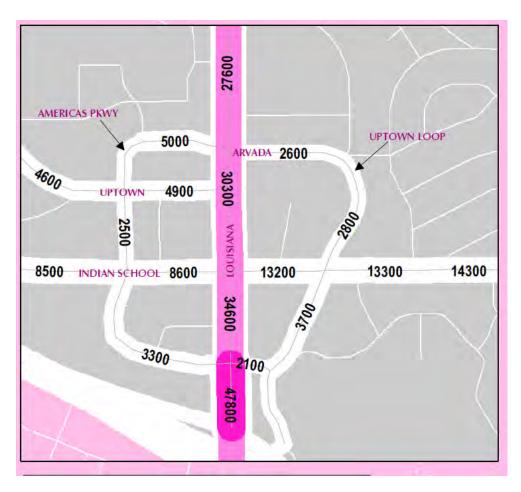
Average weekday daily traffic volumes (AWDTs) were obtained from the Mid-Region Council of Governments (MRCOG) and are shown in Figure 2 below.

Figure 2. Year 2012 AWDTs in Study Area (vehicles per day)

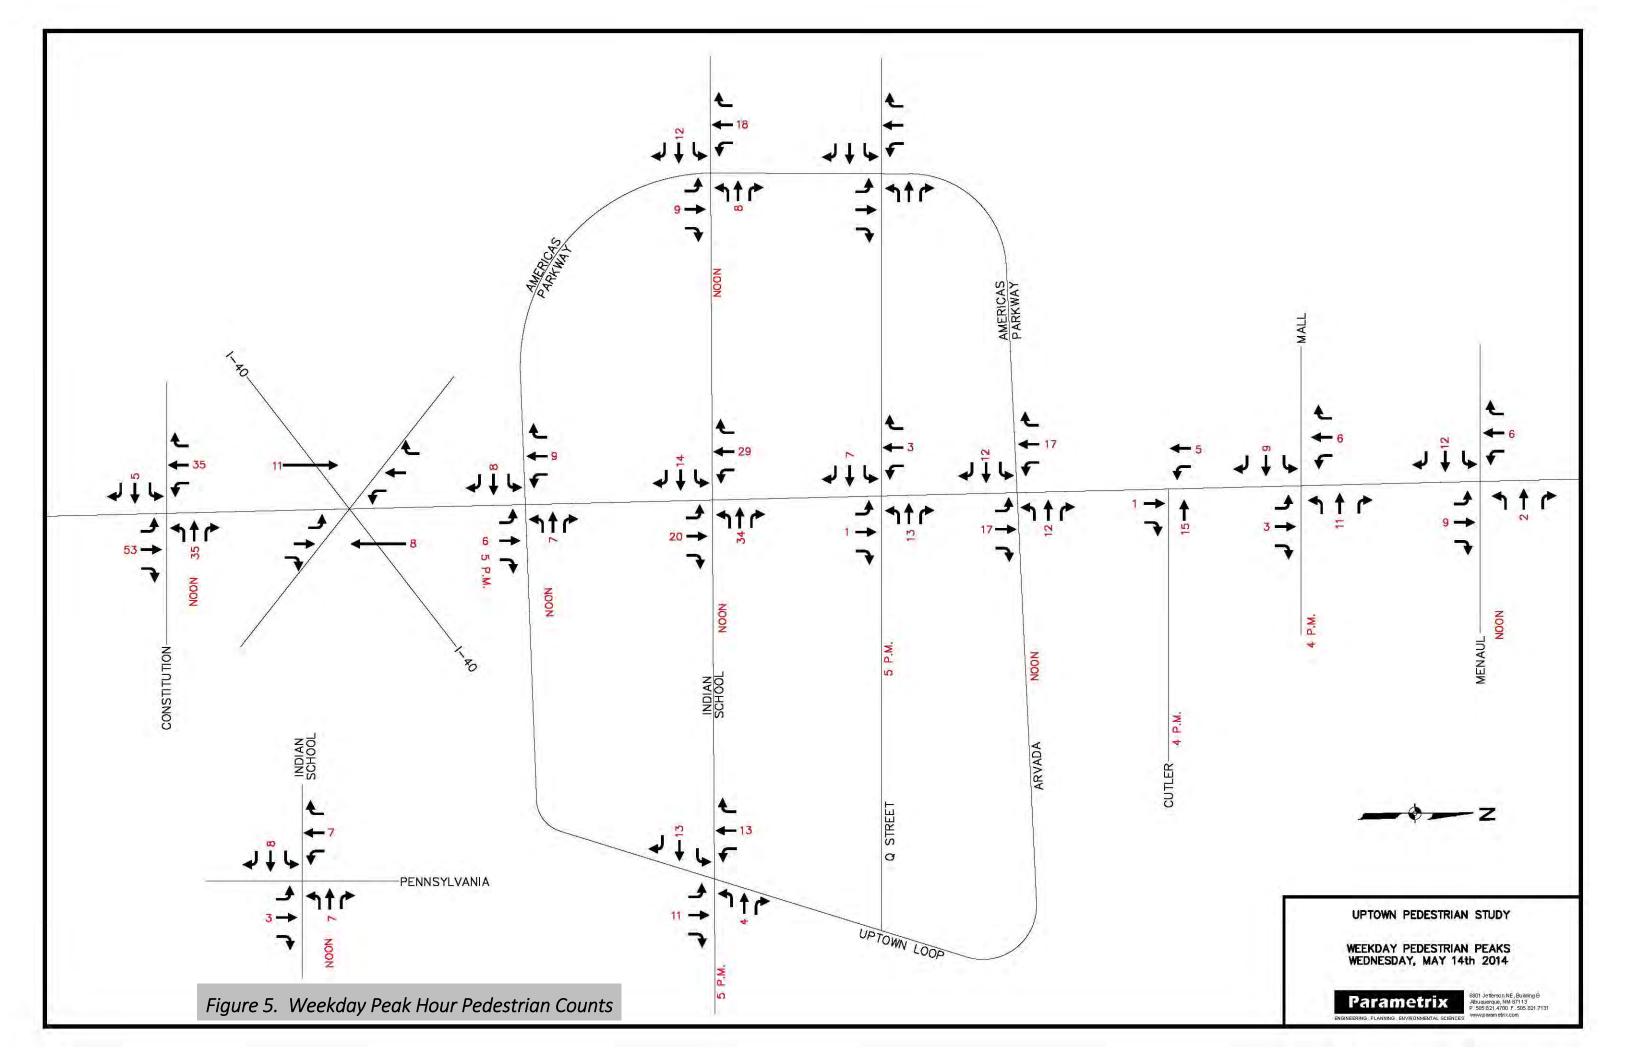
Figure 6. Video Camera Screenshot Looking West on Indian School Road at Q Street

A screen shot from the camera mounted at Q Street-Target/Indian School Road is shown in Figure 6. A driveway to the Target underground parking garage makes up the south leg of this intersection, and a main pedestrian entrance to Target lies in the southwest quadrant of the intersection. Target shoppers are often observed crossing Indian School Road at this uncontrolled intersection to visit the shops at ABQ Uptown. Additionally, the large underground Target parking lot is frequently used by ABQ Uptown shoppers because of its proximity "as the crow flies" to the ABQ Uptown shops.

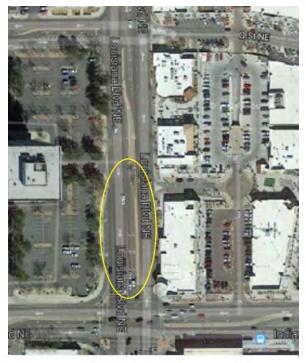
Pedestrian movements were also observed across Louisiana Boulevard north of Indian School Road and south of Uptown Boulevard, to assess the activity of pedestrians crossing mid-block in the area circled in Figure 7. The counts were near the uncontrolled area around the driveway to 2155 Louisiana (the City Place building) and the right-in, right-out driveway to ABQ Uptown. A screen shot from the camera is shown in Figure 8. Unfortunately, problems with the video recording limited the observation time to just over four hours. Data was collected on Thursday, April 10, 2014 from 6:30 to 9:30 am and for a short period just after 11:00 am, and then again on Friday, April 11, 2014 from 7:00 to 8:00 pm. During the four hours of observations seven pedestrians crossed Louisiana mid-block south of Uptown Boulevard, all of them in the Thursday morning period. Table 2 summarizes the pedestrian observations.

Figure 7. Area of Pedestrian Crossing Observations on Louisiana Blvd.

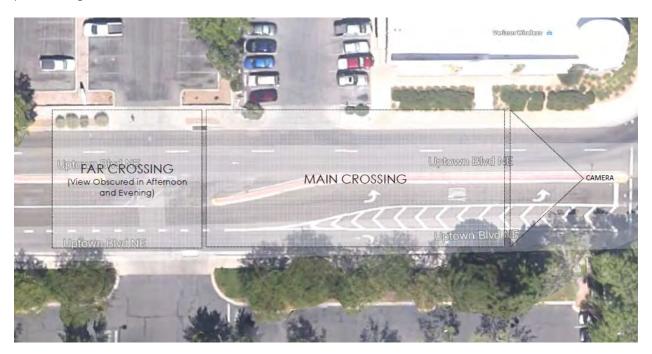
As this study was concluding, a third location was identified by City and MRCOG staff, where a high number of pedestrians were crossing mid-block at an uncontrolled location. The crossing is occurring west of Louisiana Boulevard across Uptown Boulevard, between the City Place office building and the Total Wine/Pei Wei/Satellite shopping area. Staff from MRCOG counted pedestrian crossings at this location on Thursday, September 25, and Friday, September 26, 2014, in the area shown in the aerial photo in Figure 9.

Figure 9. Location of Mid-Block Pedestrian Crossings of Uptown Boulevard

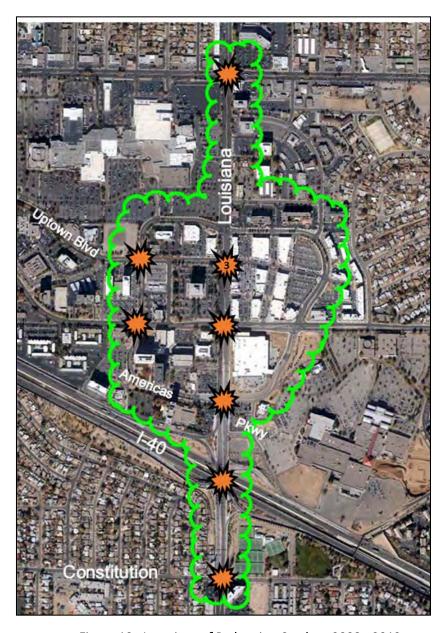
Crash data were provided for the study area for the six-year period of January 1, 2008 through December 31, 2013; they are included in Appendix C. Because pedestrians are the focus of this study, only the crashes involving pedestrians were extracted and considered. It should be noted that at the area of greatest concern, the informal pedestrian crossings between Target and Q Street, the Target store was not opened until the middle of 2013, and there were no pedestrian crashes at that location in 2013. The locations of the pedestrian crashes are shown on Figure 10. Each pedestrian crash in the study area is listed in Table 4.

Figure 10. Locations of Pedestrian Crashes, 2008 - 2013

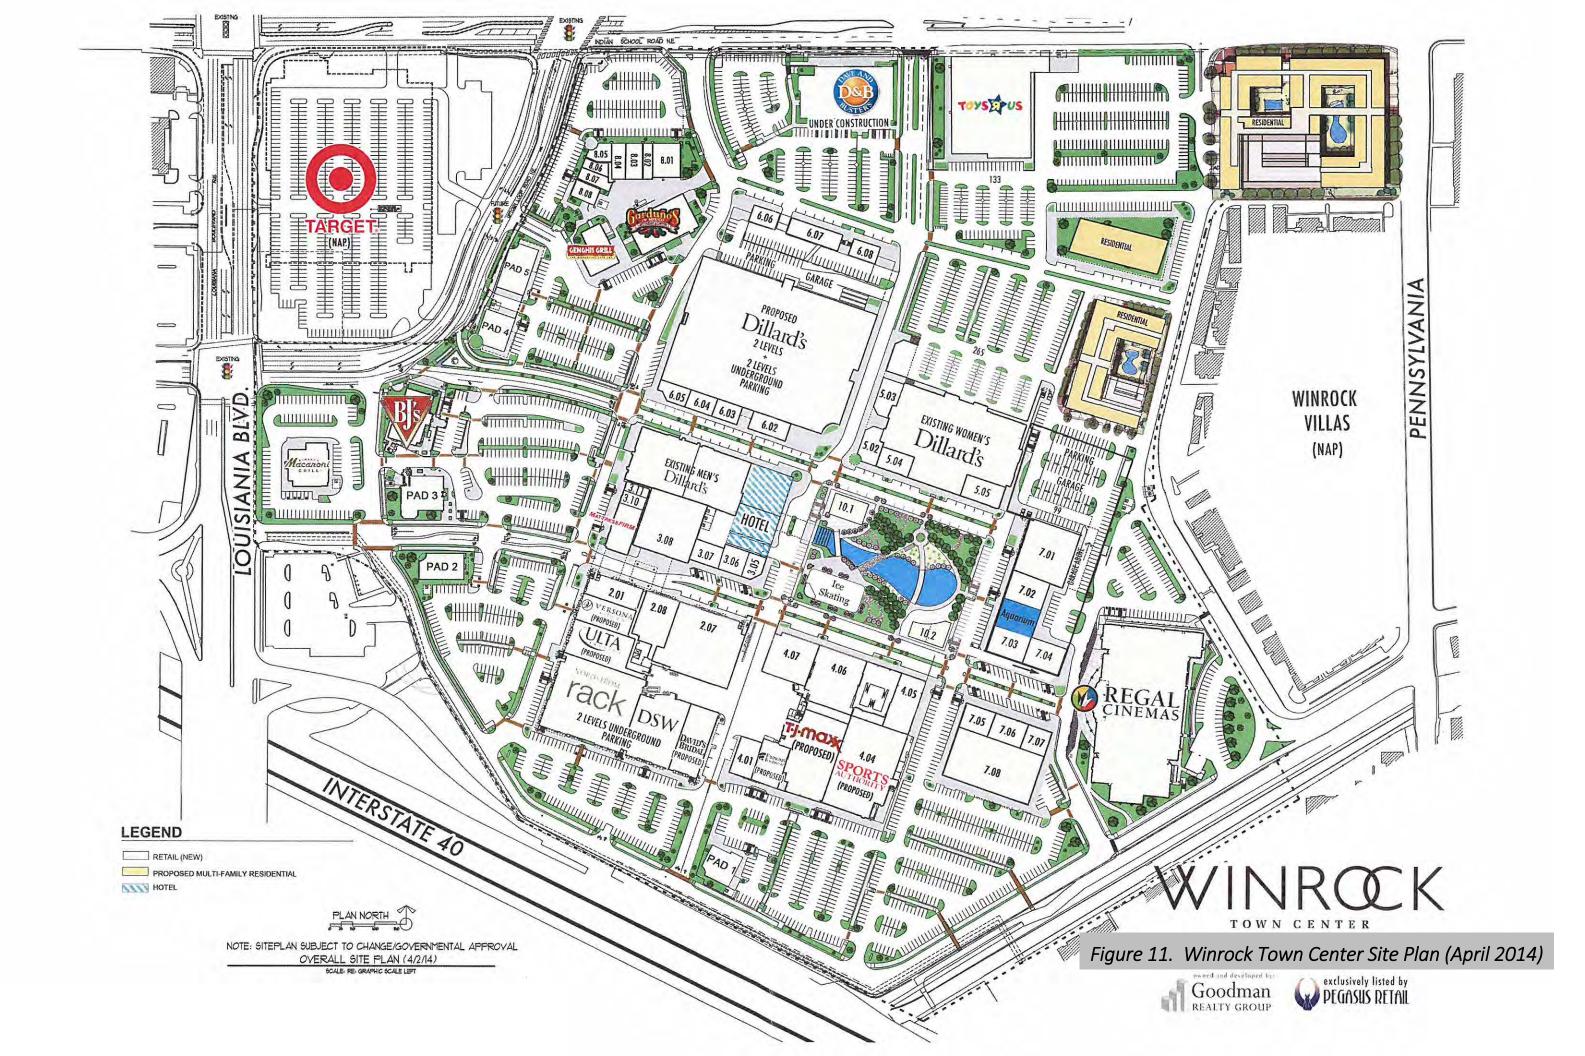
Figure 12. Pedestrian Circulation System (PCS) from the Uptown Sector Plan

- Building the Pedestrian Circulation System (PCS, shown in Figure 12). The PCS facilitates access to all parts of Uptown by connecting walkways to pedestrian plazas, parking structures and other areas of interest created to excite people who are walking in Uptown.

- Goal: Building the Pedestrian Circulation System (PCS, shown in Figure 12). The PCS facilitates access to all parts of Uptown by connecting walkways to pedestrian plazas, parking structures and other areas of interest created to excite people who are walking in Uptown.

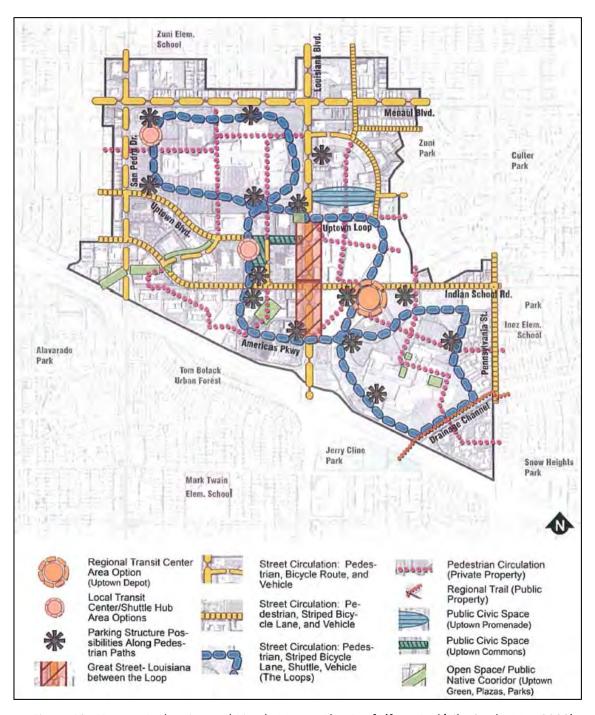
The Uptown District Pedestrian and Bicycle Study and Wayfinding Program (Ped/Bike Study) was also led by the City of Albuquerque Planning Department, and is considered a supplement to the Sector Plan. The Ped/Bike Study presents a draft master plan for pedestrian and bicyclists, shown in this report as Figure 13, and makes the following recommendations for the Uptown study area:

Figure 13. Uptown Pedestrian and Bicycle Master Plan Draft (from Ped/Bike Study, May 2008)

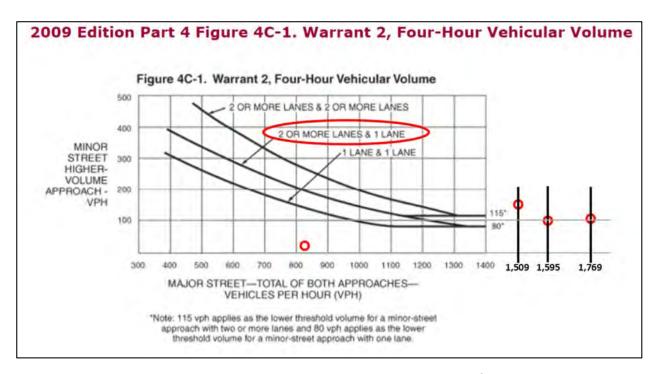
Signalizing the Q Street-Target/Indian School intersection is not recommended.

Figure 14. Four-Hour Vehicle Volume Warrant at Q Street-Target/Indian School

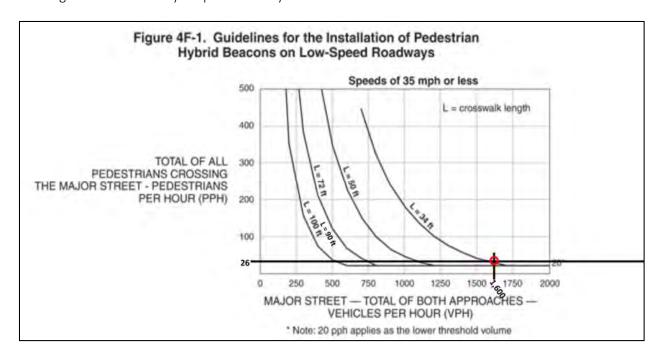
Per the MUTCD, for a major street where the posted or statutory speed limit or the 85th-percentile speed is 35 mph or less, the need for a pedestrian hybrid beacon should be considered if the engineering study finds that the plotted point representing the vehicles per hour on the major street (total of both approaches) and the corresponding total of all pedestrians crossing the major street for one hour (any four consecutive 15-minute periods) of an average day falls above the applicable curve shown in Figure 16 for the length of the crosswalk (L=90'). The highest crossing volume observed in an hour was 26 pedestrians, which with the cross traffic volume of 1,600 vph places the point just above the threshold curve. However, because none of the other criteria is met – observations show that pedestrians are crossing now without delay – a pedestrian hybrid beacon is not recommended at this location.

Figure 16. Pedestrian Hybrid Beacon Warrant

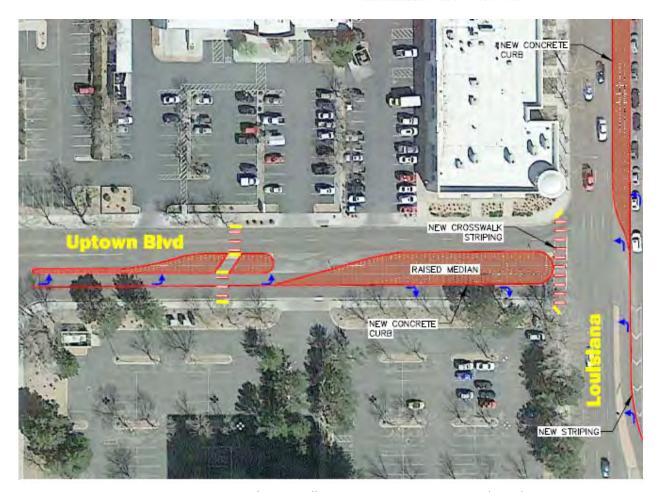
Figure 23. Potential Crosswalk Location across Uptown Boulevard

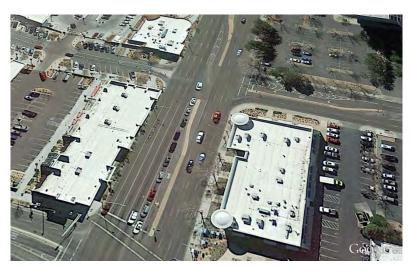
Figure 24. Northbound Left-Turn Queue at Louisiana/Americas

Parkway (North)

Recommendation at Louisiana Boulevard/Americas Parkway (north): the median should be modified to remove the inside left turn lane northbound. The remaining lane should be lengthened as much as possible across Uptown Boulevard. With the left-turn movement in one lane only, modifying the signal phasing to allow permitted left turns onto Americas Parkway (north) should be considered, in addition to the protected left-turn phase. With the modified, wider, median on the south leg of the Louisiana/ Americas Parkway (north) intersection, the crosswalk should be striped and oriented so that a pedestrian could take refuge in the median. Additionally, the crosswalk across the north leg of that intersection should be restriped to be more normal to the street centerline, requiring a shorter crossing distance.

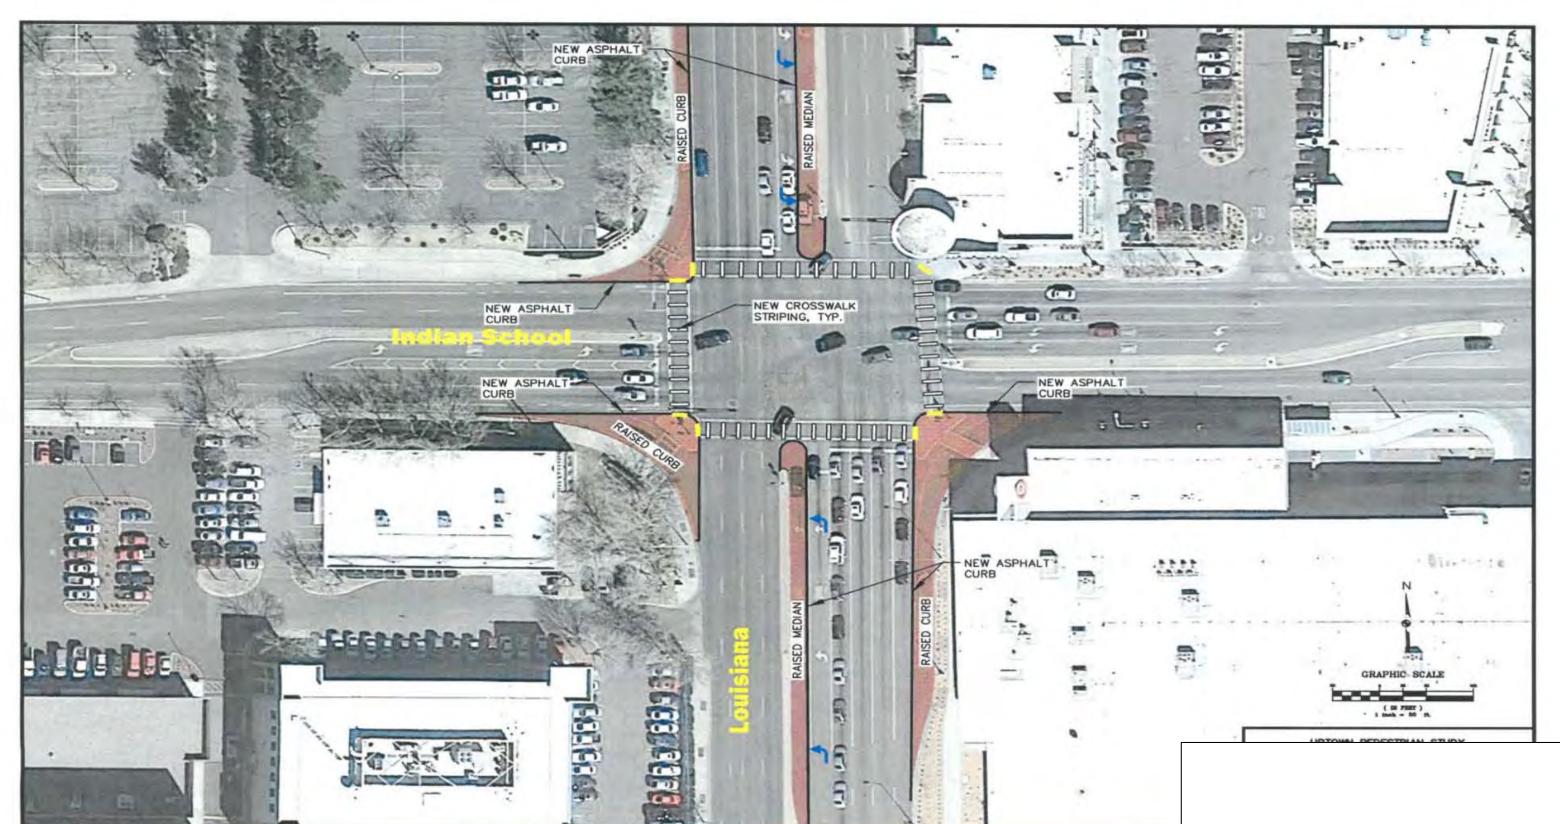
Figure 25. Recommended Improvements at Louisiana/Indian School

Recommendation at Louisiana Boulevard/Indian School Road: The pork chop islands and exclusive right-turn lanes should be removed from all corners where they exist now. Right-turning traffic should share the outside lane with through traffic. At this intersection and all intersections along and within the loop

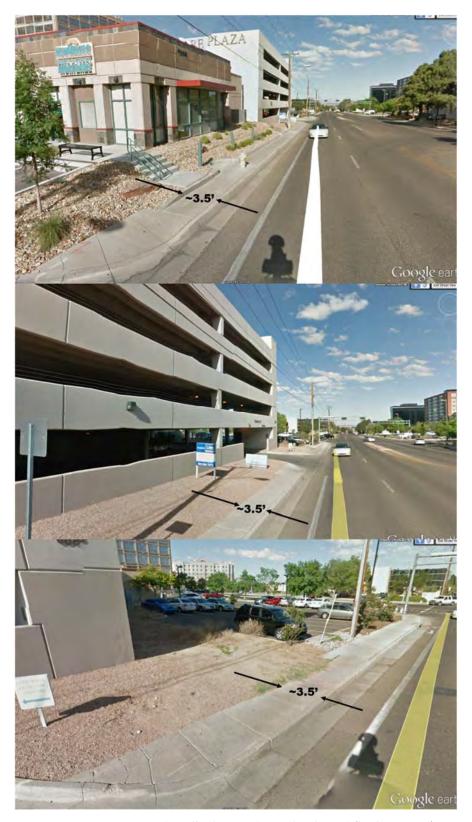
Figure 31. Narrow Sidewalk Along Indian School Road (looking west)

Recommendation: The Sector Plan's goal of 10-foot sidewalks throughout the Uptown area is an ideal that should be required with new construction in the area, but the City should focus its efforts now on the location where the sidewalk is less than 6-feet wide.

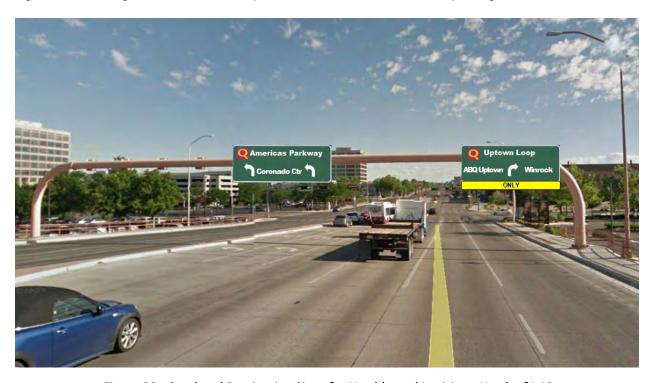
About two-thirds of the traffic coming to the Uptown area comes from I-40 and Louisiana from the south. There already exists across Louisiana just north of I-40 a monotube sign bridge that spans the entire road. The sign structure is used to mount regulatory lane use signs for southbound Louisiana, and is not being used for any signs for northbound traffic. One idea is to mount destination guide signs on this structure to direct northbound traffic immediately onto the loop road if they are destined for Coronado Center, ABQ Uptown, or Winrock Town Center (Figure 32). This recommendation also involves the conversion of the outside through lane on northbound Louisiana at Americas Parkway (south) into a right-turn only lane.

Figure 32. Overhead Destination Signs for Northbound Louisiana North of I-40

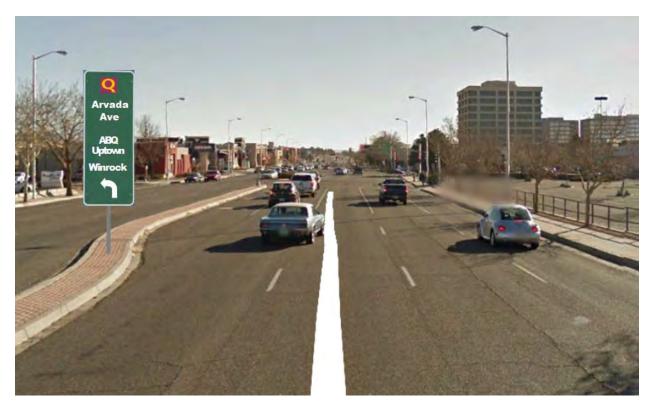
Likewise, destination guide signing could be used for drivers coming to Uptown from the north on Louisiana. While there is no overhead structure to mount signs on, with the modification of the median across Cutler Avenue there would be space available to mount a guide sign similar to what is shown in Figure 33, directing drivers to the ABQ Uptown and Winrock Town Center parking areas.

Figure 33. Destination Sign for Southbound Louisiana North of Arvada Avenue

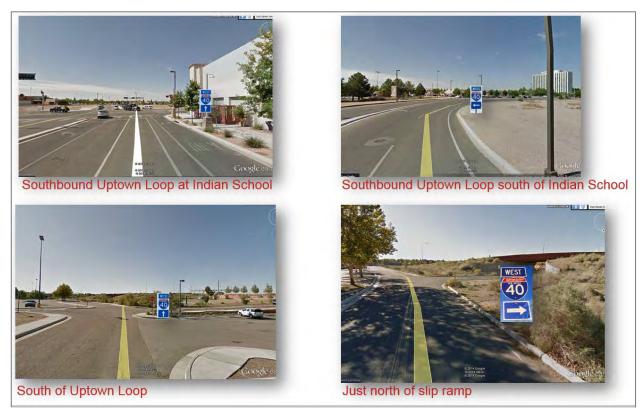
Figure 34. Directional Signs for Westbound I-40 Slip Ramp

Another recommendation is to better sign the existing slip ramp from the Winrock Town Center parking lot to westbound I-40. This is a little-known ramp that is currently not signed at all, and if better used,

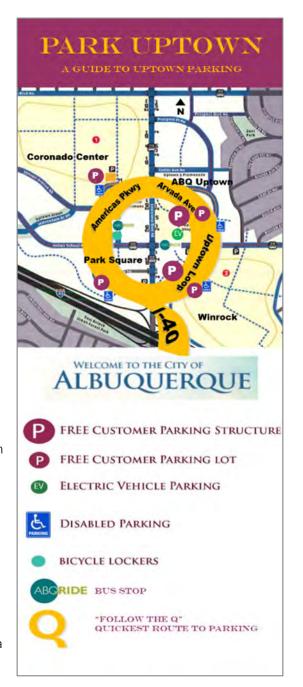
Figure 36. Informational Parking Brochure
Concept

Recommendation: The City should consider methods of encouraging drivers to turn off of Louisiana or Indian School and to use the loop road if they are accessing one of the businesses in Uptown. These methods may include interconnection and coordination of the traffic signals along the loop road; the installation of parking signs, destination guide signs, and advance signing for the westbound I-40 slip ramp; and renaming the loop road so that all of the roads have the same name. Informational parking brochures for the Uptown area may also be useful.

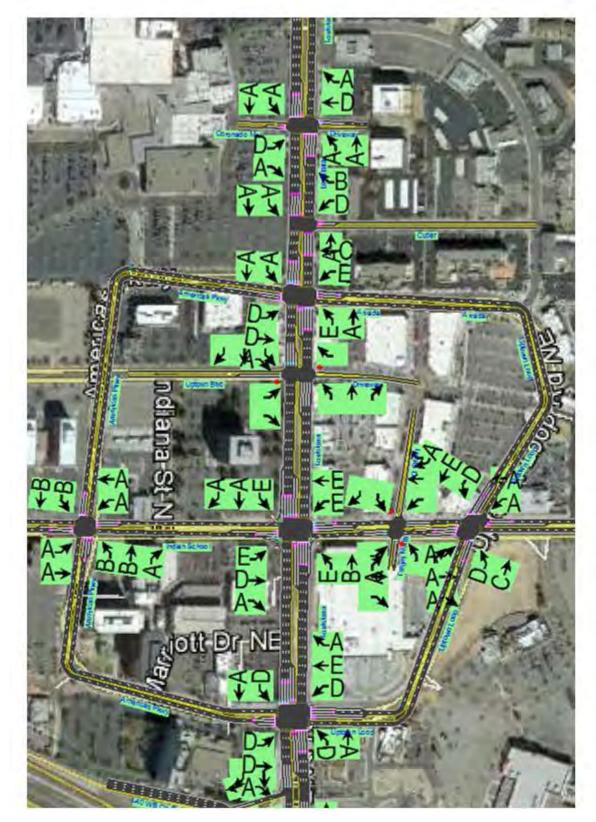
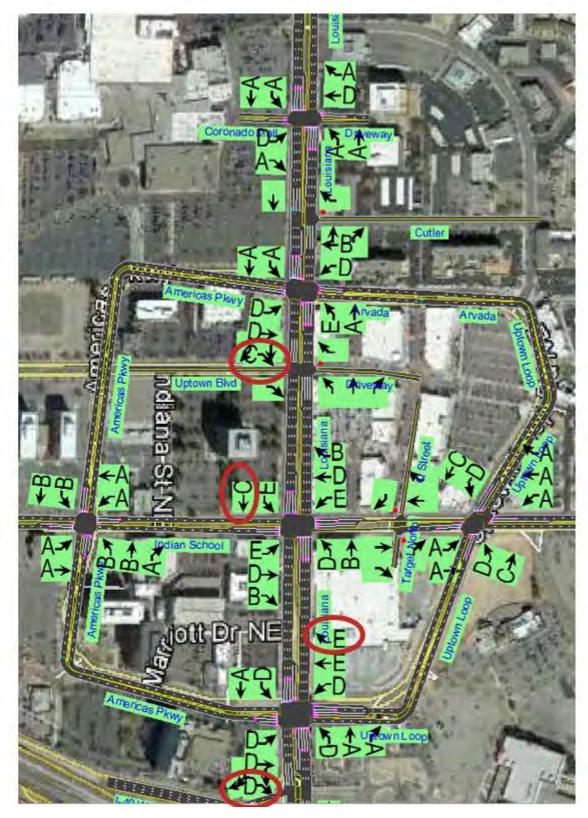
Figure 37. Current Year AM Peak Hour Movement Level of Service — Existing Conditions (left) and With Recommendations (right)

Two scenarios were considered. The first scenario analyzed the existing geometric and signal timing conditions. The second scenario analyzed the proposed geometric improvements (including the alternative of narrowing Indian School to one driving lane in each direction between Louisiana and Uptown Loop) still using the existing signal timing plans. Also, in the second scenario, right turns were

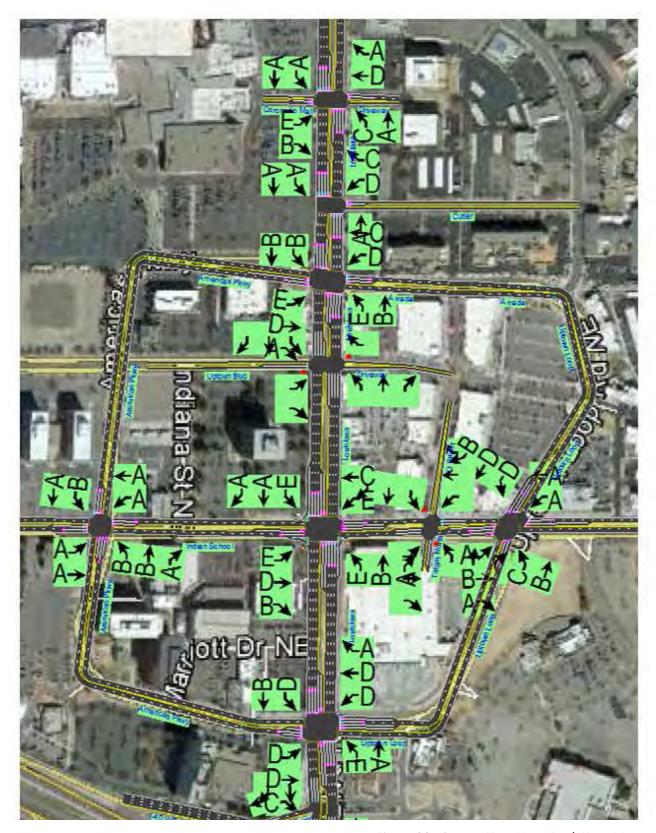
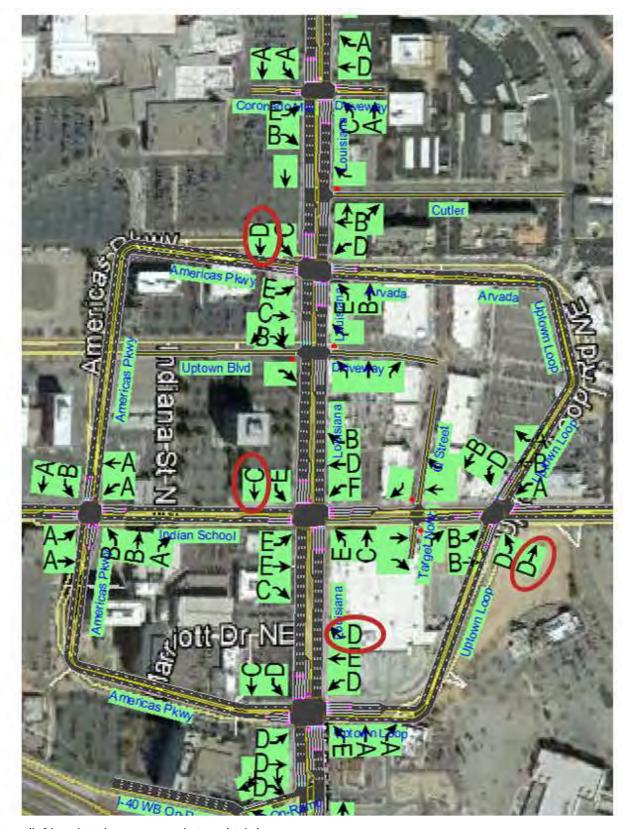
Figure 38. Current Year Noon Peak Hour Movement Level of Service – Existing Conditions (left) and With Recommendations (right)

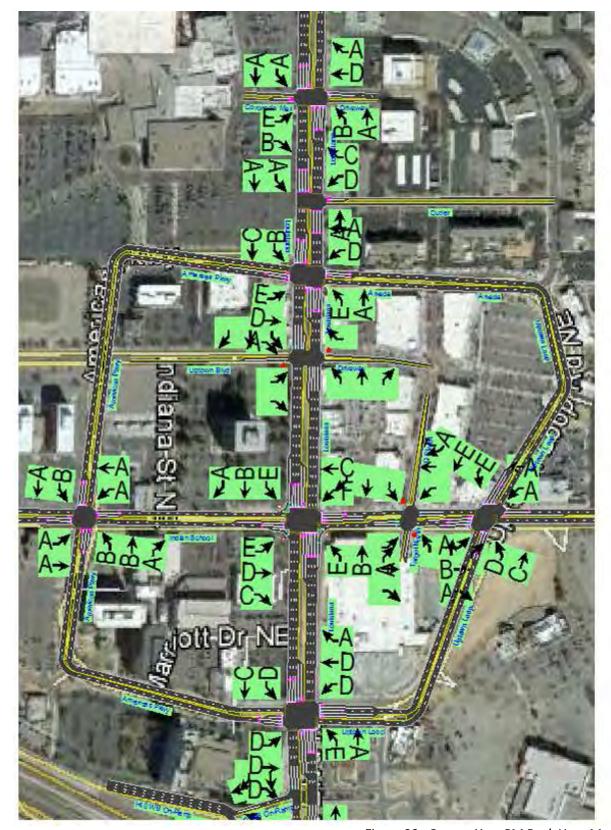
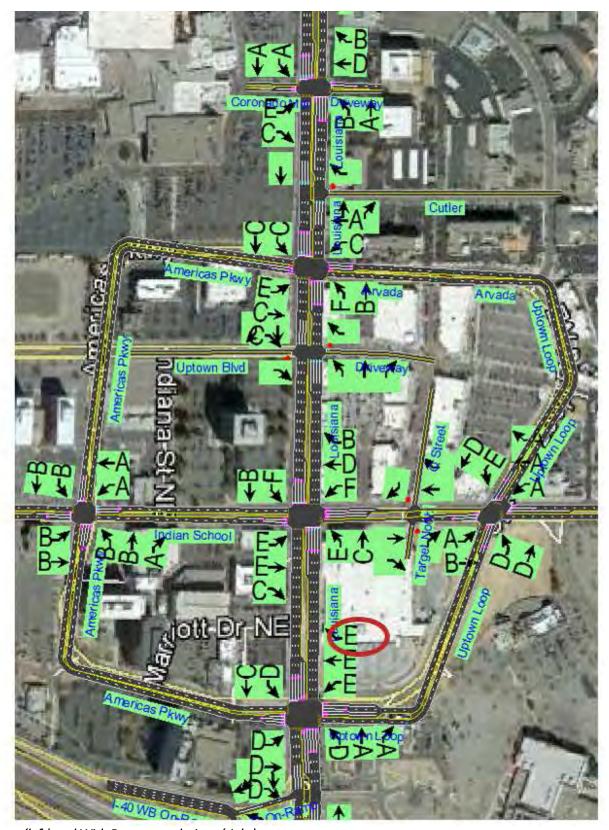
Figure 39. Current Year PM Peak Hour Movement Level of Service – Existing Conditions (left) and With Recommendations (right)

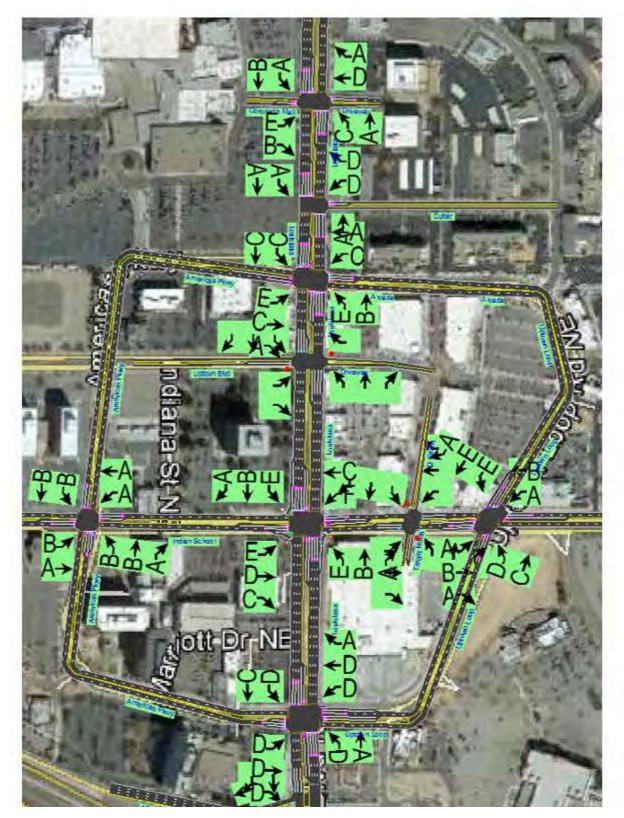
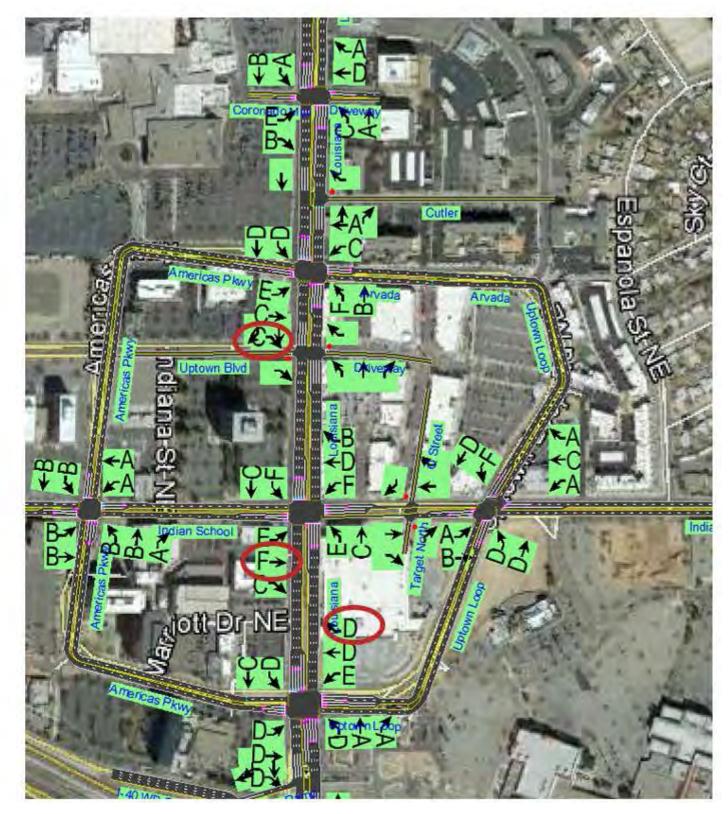
Figure 40. Current Year Friday PM Peak Hour Movement Level of Service — Existing Conditions (left) and With Recommendations (right)
